# Continuing Airworthiness Notice – 05-009

## Breeze Eastern Hoist Systems – Wire Rope Cable Failure

27 April 2018

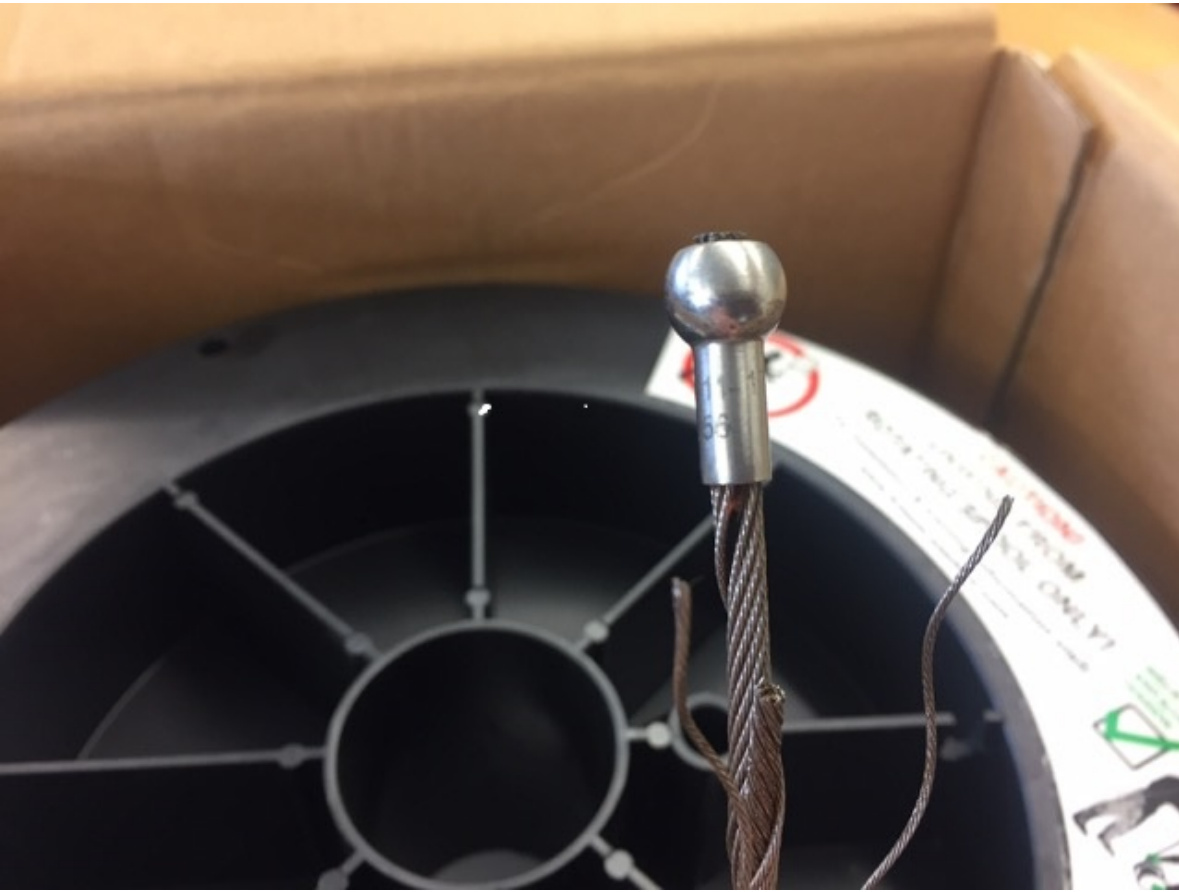
This CAN is prompted by a report of finding the wire rope core and two outer strands of the cable broken near the ball end termination on a Breeze Eastern hoist P/N BL-20200-431. For further detail refer to the photograph in this CAN.

An inspection revealed flattened outer wires, and significant nicking and notching on the core wires where they contact the outer strands. The hoist manufacturer examined the broken cable and determined that the damage was likely due to vibration fatigue caused by the hook not being homed securely and the bumper spring not sufficiently compressed while in flight.

Inner wire and two outer strands found broken.

Maintainers of Breeze Eastern hoists with P/N BL-20200 and P/N HS-20200 should inspect all cables on their hoists for damage near the ball end. If any damage is found the cable should be replaced before the next hoist mission.

Operators of Breeze Eastern hoists with P/N BL-20200 and P/N HS-20200 should review manual TD-08-002 for applicable instructions on how to correctly home the hook to prevent cable damage.
