Continuing Airworthiness Notice – 76-001

Gippsland GA8 Throttle Cable

05 July 2007

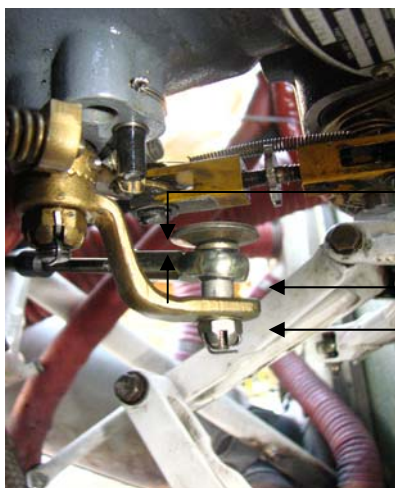
Investigation revealed that the throttle cable female rod end P/N GA8-270021-31 to throttle lever P/N GA8-7140-11-11 attachment was found to be very loose. When nut P/N MS21042-3 was retightened, it was noted that the female rod end P/N GA8-270021-31 was in contact with the penny washer P/N AN970-3 due to the approach angle of the throttle cable being too sharp relative to the throttle lever. Movement of the throttle control transferred rotational forces to the penny washer which resulted in rotation of the bolt causing the lightweight locknut to loosen.

The photo below shows the reconfigured installation to achieve adequate clearance between the female rod end, the penny washer and the throttle lever.

A thicker spacer fitted to allow sufficient clearance to avoid contact between the penny washer and the female rod end.

Longer spacer fitted.

Nut P/N MS17825-3

To minimise the potential of contact between the female rod end and the penny washer, replace the rod end spacer P/N GA8-710011-17 on the penny washer side of the female rod end with a thicker spacer of the same specification.

To reduce the angle between the throttle cable and the throttle lever replace the rod end spacer P/N GA8-710011-17 on the throttle lever side of the female rod end with a longer spacer of the same specification. The longer spacer increases the clearance between the female rod end and the throttle lever and reduces the angle of approach of the throttle cable.

To prevent loosening of the bolt and nut, replace bolt P/N AN3-11 with a drilled bolt P/N AN3-11 and replace nut P/N AN3-11 with a castellated nut P/N MS17825-3 and a split pin.
