Continuing Airworthiness Notice 51-002

Robinson R44 Hydraulic Hoses – Clearances from Adjacent Structure

31 August 2022

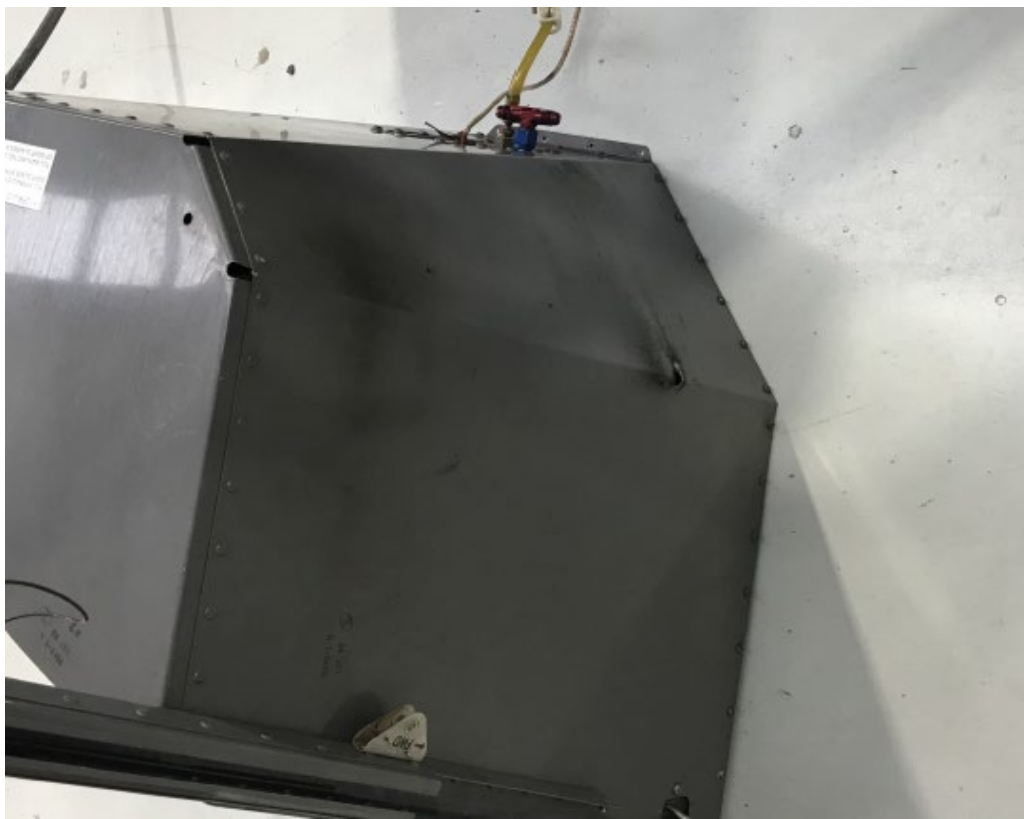
This CAN is prompted by a recent incident where an R44 engineer found evidence of chaffing between the aircraft fuel tank support structure and the stainless-steel braiding of the hydraulic pump suction hose. Refer to Figure 1 in this CAN for bladder fuel tank chaffing damage.

It appears that the hydraulic pump fittings, to which the hydraulic hoses attach, were incorrectly orientated on installation. This resulted in insufficient clearance between the hydraulic suction hose and the fuel tank.

The chaffing could have resulted in rupture of the bladder fuel tank if the insufficient clearance between the hydraulic suction hose and the fuel tank had remained undetected.

Figure 1 - Damaged fuel tank structure:

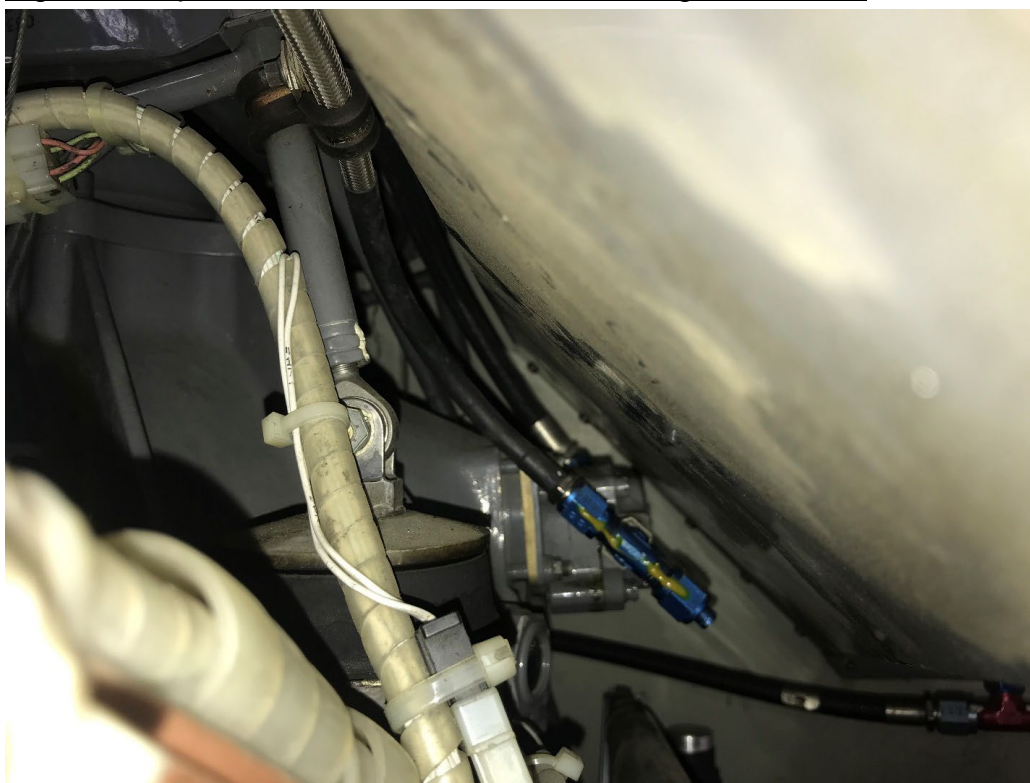
Fig 2. Example of correct orientation of the fittings and hoses

- The importance of correctly orientating the hydraulic fittings on the hydraulic pump. Refer to figure 2 in this CAN for hydraulic pump fitting orientation.
- The clearance requirements between the fuel tank structure and the adjacent hydraulic lines as detailed in the R44 maintenance manual.
- Ensure that appropriate clearances are maintained when installing fuel tanks. Refer to figure 3 for a pictorial of the R44 hydraulic flight control system.
