Airworthiness Directive Schedule

MD Helicopters 600N

23 December 2021

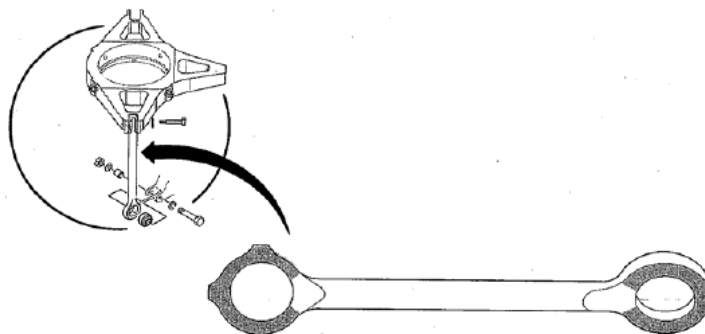
Figure 1

- Applicability:** All model MD600N aircraft fitted with a lateral mixer output link assembly (mixer link), P/N 600N7636-1, -3, -9 or -11.
- Requirement:** To prevent cracks in the mixer link, which could result in failure of the mixer link and subsequent loss of control of the aircraft, accomplish the following:
Remove each mixer link and visually inspect the shaded areas around the bearing bore for any crack as depicted in figure 1. Use a bright light and a 10x or higher magnifying glass.

Bearings have been removed for clarity.

Accomplish an eddy current inspection on each mixer link in the bearing end areas. Replace cracked mixer links, before further flight. Before installing mixer links held as spares, accomplish an eddy current inspection.

Accomplish these requirements per MDHI Service Bulletin No. SB600N-044, dated February 16, 2007.
(FAA AD 2007-05-51 refers)
