Airworthiness Directive Schedule

Helicopters

Bell 212 Series

24 November 2022

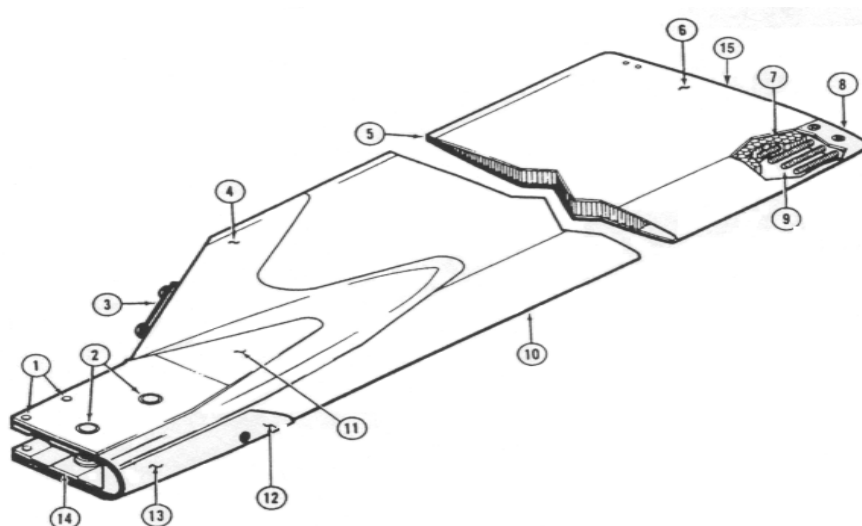
Figure 1 - T/R Blade Assembly

Visually inspect each T/R blade using a bright light and a 3X or higher magnifying glass. With reference to figure 1 in this AD, inspect the blade skins, leading edge spar, doublers, grip plates and trailing edge for cracks, corrosion and any other damage including nicks, scratches, and dents. Corrosion may be indicated by blistering, peeling, flaking, bubbling or cracked paint. Pay particular attention to both sides of each T/R blade in the area located 16 to 26 inches from the T/R blade tip (i.e. blade station 25 to 35 - the T/R blade tip is located at blade station 51), and inspect the inboard blade butt area near the attachment of the external balance weights and screws. Also pay particular attention where snags from the cloth are visible, as this may indicate a crack or paint chip that could lead to corrosion. If any blistering, peeling, flaking, bubbling, or cracked paint is found, remove the paint from the affected area and visually inspect the area for corrosion or a crack, using a 10X or higher magnifying glass. If any corrosion is found, measure the depth of the corrosion. A digital optical micrometer can be used for this measurement. If a nick, scratch, or dent is found, visually inspect for a crack using a 10X or higher magnifying glass and measure the depth of the damage. A digital optical micrometer can be used for this measurement. If a crack is found, replace the T/R blade before further flight. If any corrosion, nicks, scratches, dents, or other damage is within the maximum repair limits specified in the applicable maintenance manual, repair or replace the T/R blade before further flight. If any corrosion, nicks, scratches, dents, or any other damage exceeds the maximum specified repair limits specified in the applicable maintenance manual, replace the T/R blade before further flight.

Note 2: Blade repair procedures are specified in the applicable maintenance manual, component repair and overhaul manuals.
(FAA AD 2008-10-03 refers)
