Feedback

Canadian Aviation Service Difficulty Reports

The following content was published between 1 October 2022 and 31 December 2022. The full accessible version of each article is available on the Feedback [website](#).

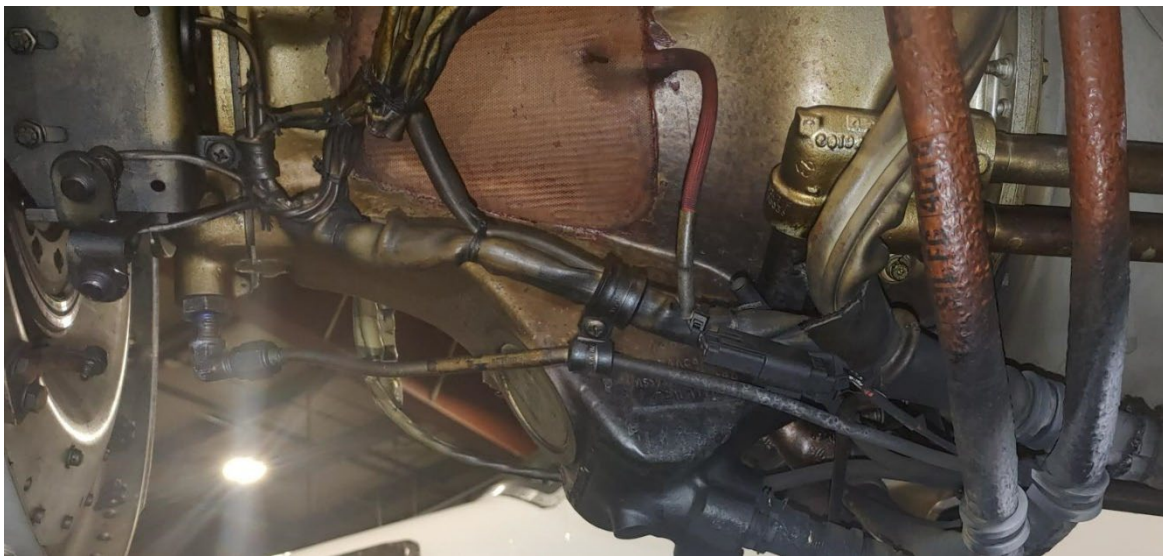
During regular maintenance, maintenance personnel noticed that the bottom of the engine was covered with soot. Further investigation revealed that the lower cowl inlet duct was completely broken, shooting hot bleed air directly on engine oil lines and engine wiring. Wiring was inspected, no damage was found, and the oil lines were replaced proactively. This Service Difficulty Report (SDR) is the result of investigation following a recent event. Refer to SDRs 20221019001 and 20221026010.

Similar failures have also been reported on other King Air models (not limited to King Air 300 Series aircraft) that utilize an inlet de-ice lip heated by exhaust gas from a collector in the exhaust stack. Failures include weld failure of the inlet/outlet tubes as depicted below, anti-ice flex hose failure, or connection points failure. Flight crews may be unaware that the air intake anti-ice lip heating function is degraded or completely unavailable as there are no shutoff, caution, or temperature indications for this system.

Picture 1 – Soot, signs of exhaust gas leakage

Operators and maintainers are reminded to remain vigilant when inspecting the surrounding areas. Soot is an obvious sign of exhaust gas leakage which should warrant a closer look to determine the exact cause. See [Feedback Issue 3/2003](#) for related information.

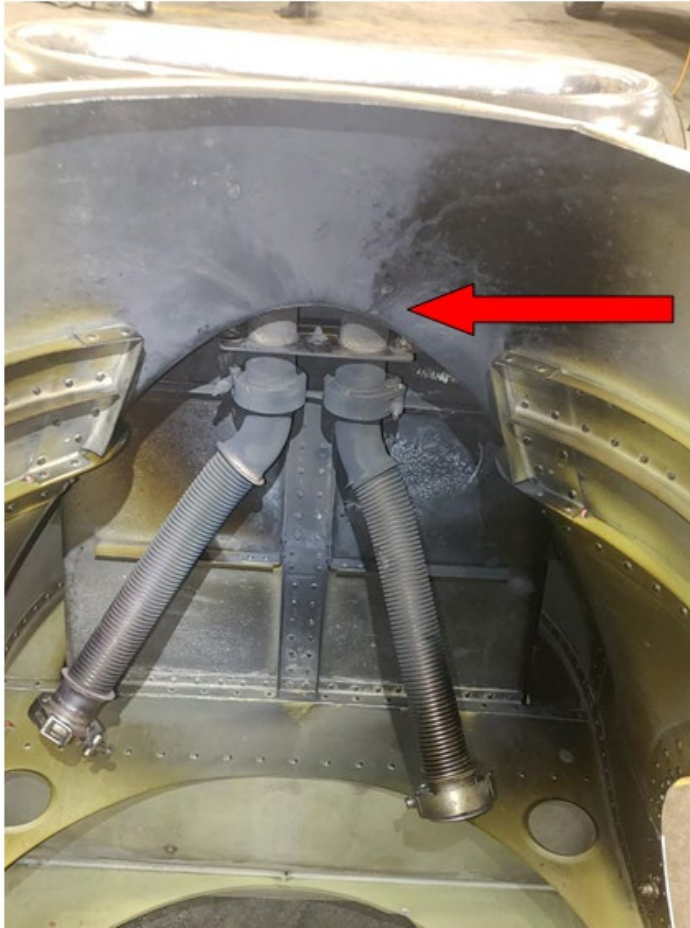
Picture 2 – Approximate location of weld failure

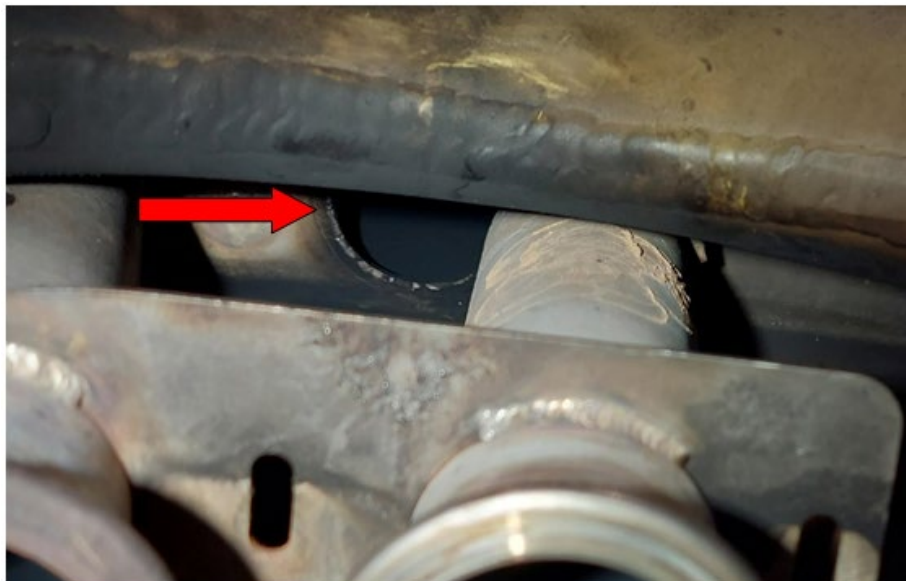
Picture 3 – Weld failure, source of exhaust gas leakage

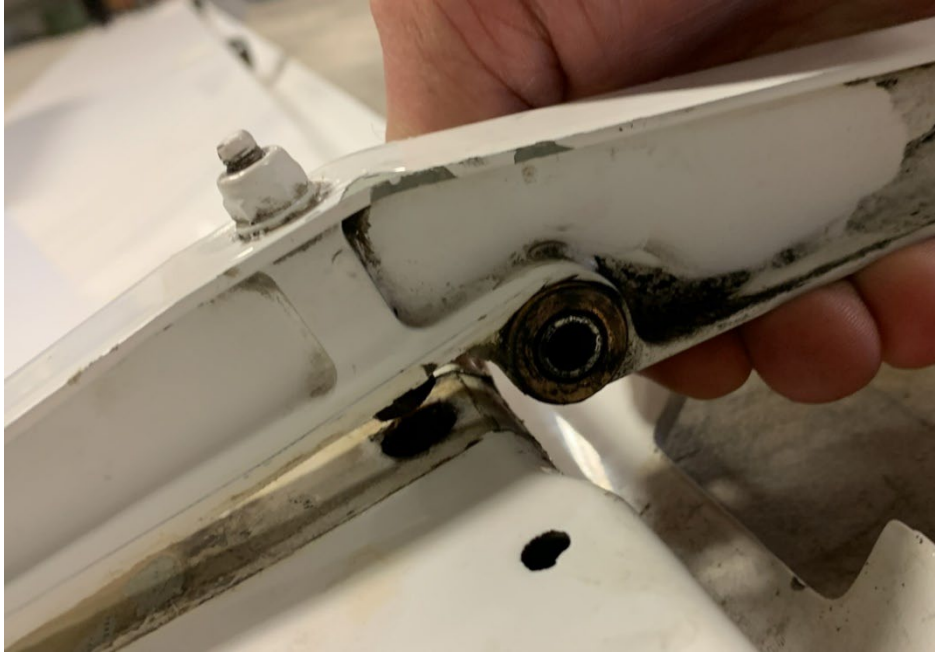
During the performance of a 300-hour inspection, the forward elevator control horn attachment bolt was found worn through the lower skin of the elevator.

The root cause of this failure is not entirely clear. Incorrect torque during the installation of the control horn bolt, and/or horizontal stabilizer water drain hole obstruction in combination with freeze/thaw cycles may have contributed to this failure. Maintainers are reminded to refer to the appropriate fastener installation torque values. In cases where specific torque values are not defined, standard torque values should be referenced.

Figure 2 – View of removed elevator (upside down). Forward attachment bolt worn through lower skin.

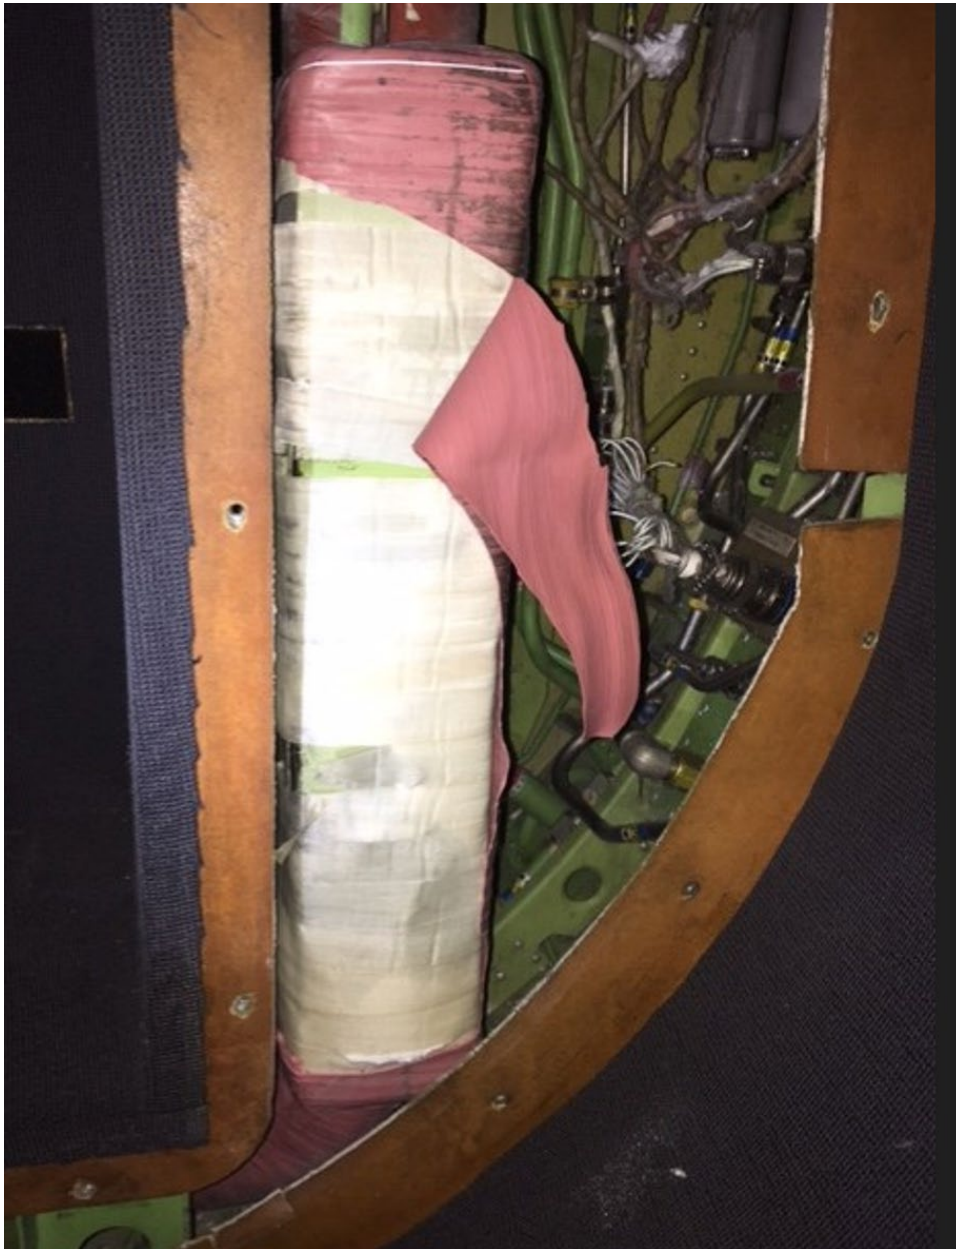
During routine maintenance, insulation was found blown into the hydraulic access panel and filter areas. Further investigation revealed that the cockpit ECS muffler assembly had cracked in two places (one crack was 2 1/8" long and the other was 3 1/8" long). No issues were noted in flight prior to the finding. This muffler was installed in 2000, in accordance with Service Bulletin 45-21-4 Modification of the Environmental Control System for Reduced Cabin Noise Levels and had accumulated 8178.0 hours since installation. The muffler was removed, inspected, and re-installed in 2020 due to other fleet muffler issues with no defects noted at that time.

This area is routinely accessed during a 300 hour hydraulic filter replacement. Damaged or loose outer insulation wrapping around the muffler or insulation material located near the hydraulic manifold is a good indication that the cockpit ECS muffler may be cracked.

Picture 1 – Muffler as installed, adjacent to the hydraulic filter manifold, outer insulation wrapping damage is evident

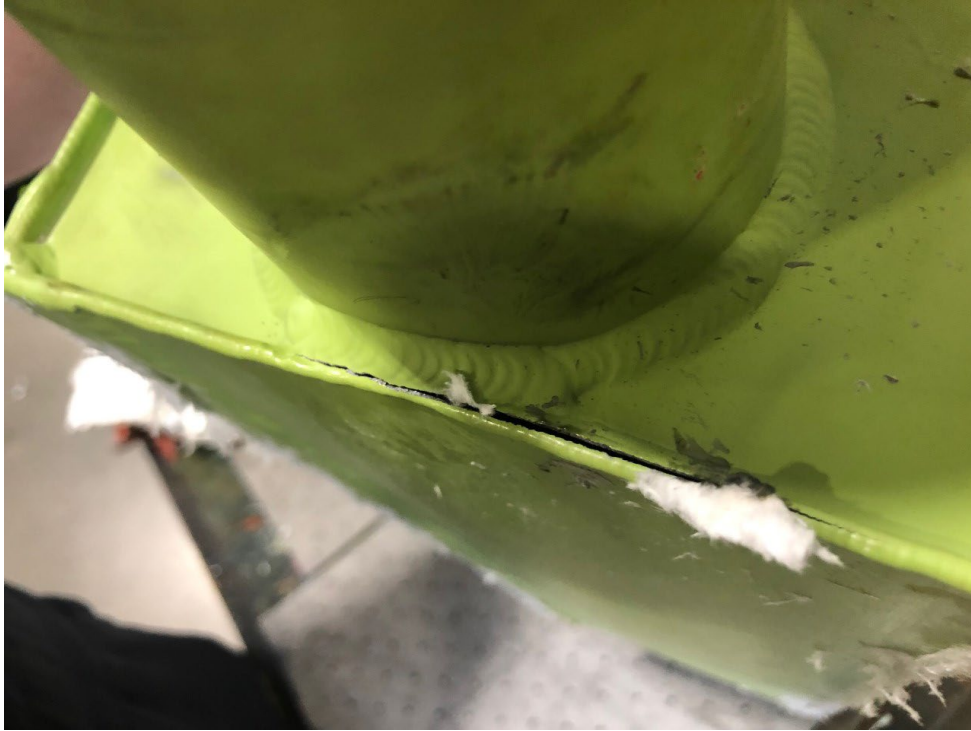
Picture 2 – Muffler outer wrapping removed, cracked at upper weld seam

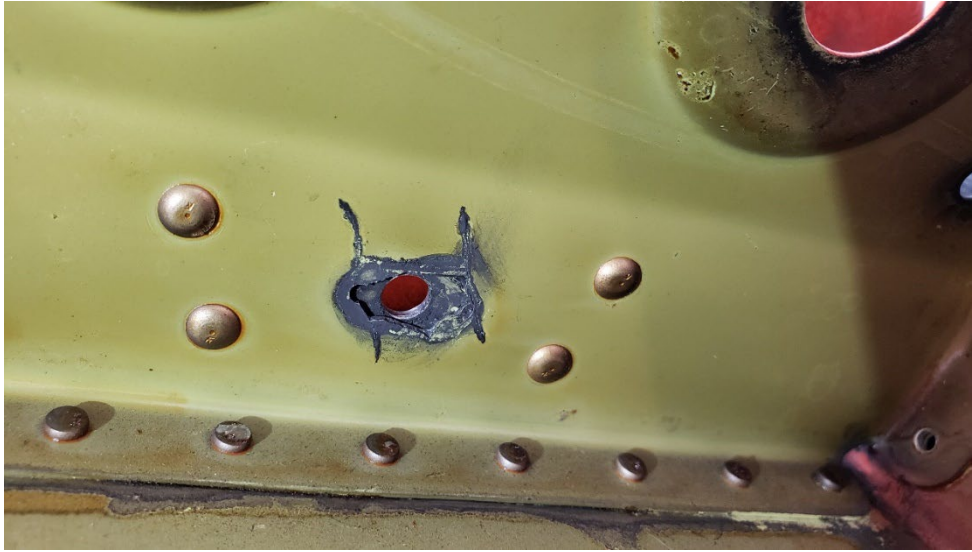
During a maintenance check, the rudder was removed to inspect for play at the hinge point, and a Structural Repair Manual (SRM) repair was carried out by installing a bushing. During the rudder re-installation, when mounting the top rudder attach point bolt, a rattling noise was heard of something that had dislodged and fallen inside the rudder. Upon further investigation, it was noted that the anchor nut to which the bolt must be attached had fallen inside the rudder. After the anchor nut was retrieved, it was noted that the anchor nut was still riveted to the broken piece of rudder rib 6.

Picture 2 – Underside of rudder rib 6 with missing anchor nut

The SRM repair mentioned by the submitter is Rudder Upper Hinge Fitting Repair RM06299 (Installation of an aluminum bushing). This repair has the operator increasing the top bolt hole to a larger size to accommodate a bushing, adding strength and preventing play-inducing wear.

Pilatus offers another repair, Rudder Upper Hinge Attachment Repair RM05387 (Replacement of the nutplate with a self-locking nut and washer). This repair replaces

the anchor nut with a self-locking nut and washer. This repair also adds an inspection panel to access the lower portion of rudder rib 6.

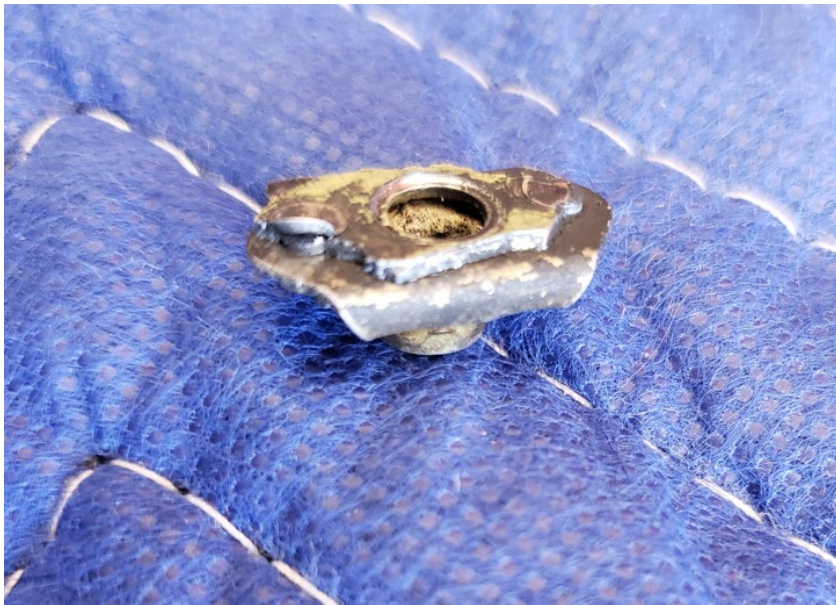
Picture 3 – Anchor nut with piece of rudder rib 6 still attached

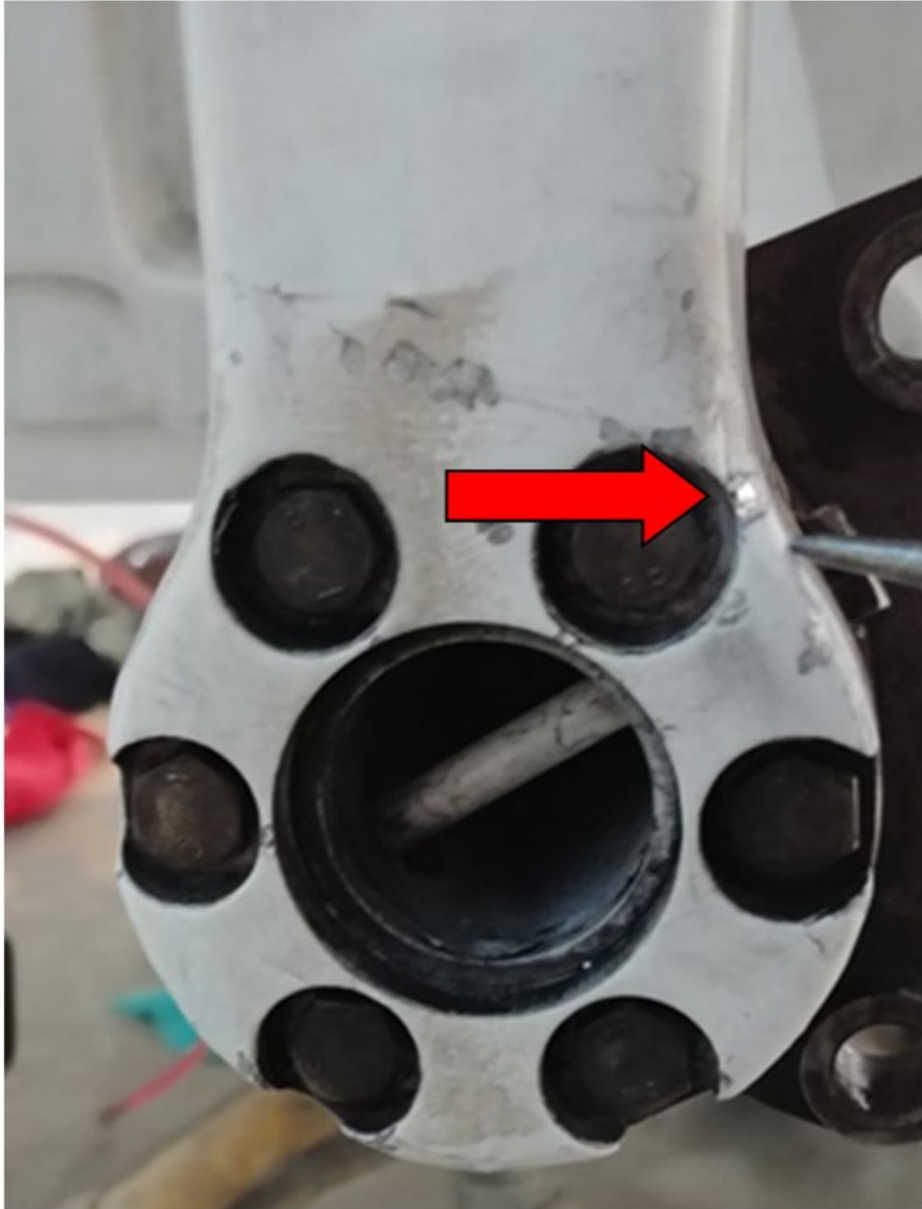
During an inspection of the gear down-lock switch on the right-hand (R/H) MLG, an aircraft maintenance engineer (AME) found, by chance, a crack on the lower strut assembly inboard of the axle, where the brake torque plate bolts attach. The crack is slightly above the bolt at the 1 o'clock position, and it is where the strut joins the axle. The location of the crack is in a significant load bearing area.

Piper Aircraft published service letter (SL) 1263 due to MLG piston tube fatigue cracking. Shortly thereafter, an accident (National Transport Safety Board report WPR21LA117) involving the separation of a R/H MLG occurred. The root cause was identified as failure of the landing gear strut piston tube due to fatigue cracking from corrosion pitting.

Figure 1 – Strut assembly fork – Crack location

Transport Canada Civil Aviation (TCCA) recommends compliance with SL 1263. Additionally, paying special attention to the area of the fork identified in this SDR is also recommended. High cycle aircraft, such as those used in a flight training role, may be particularly susceptible.

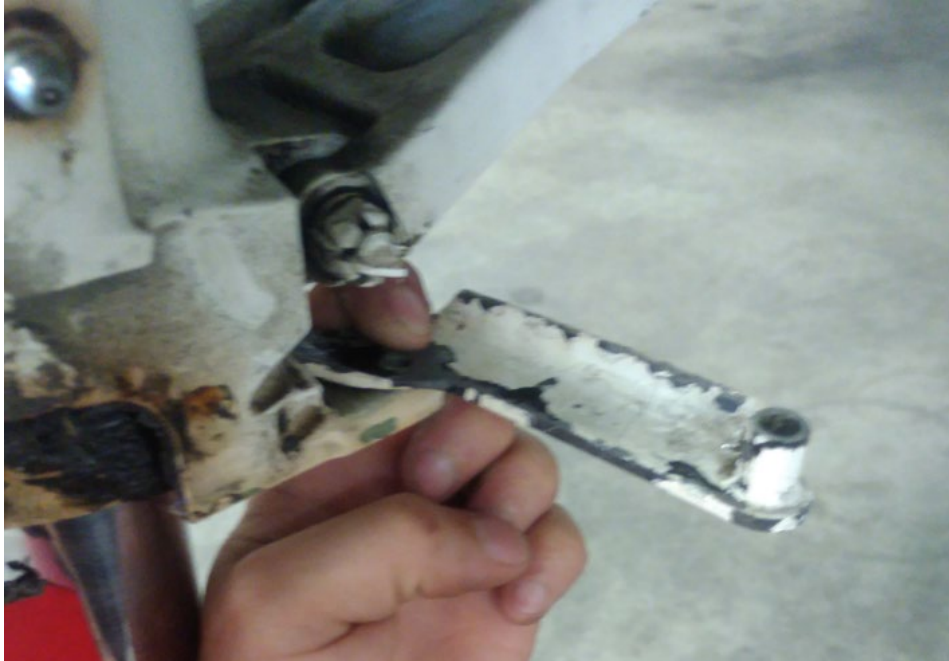
Upon inspection by maintenance, it was found that the centering spring (shimmy damper) bracket was installed incorrectly, which caused the nose gear to be turned off centre, and, consequently, the gear got stuck in the wheel well. Before this flight, there was a ground handling incident where the centering spring bracket had been bent. The bracket was removed, straightened, inspected, and reinstalled. It was at this time that the bracket was reinstalled upside down, causing the nose gear to spring off centre with weight off the wheel.

Figure 2 – Incorrect orientation of centering spring bracket

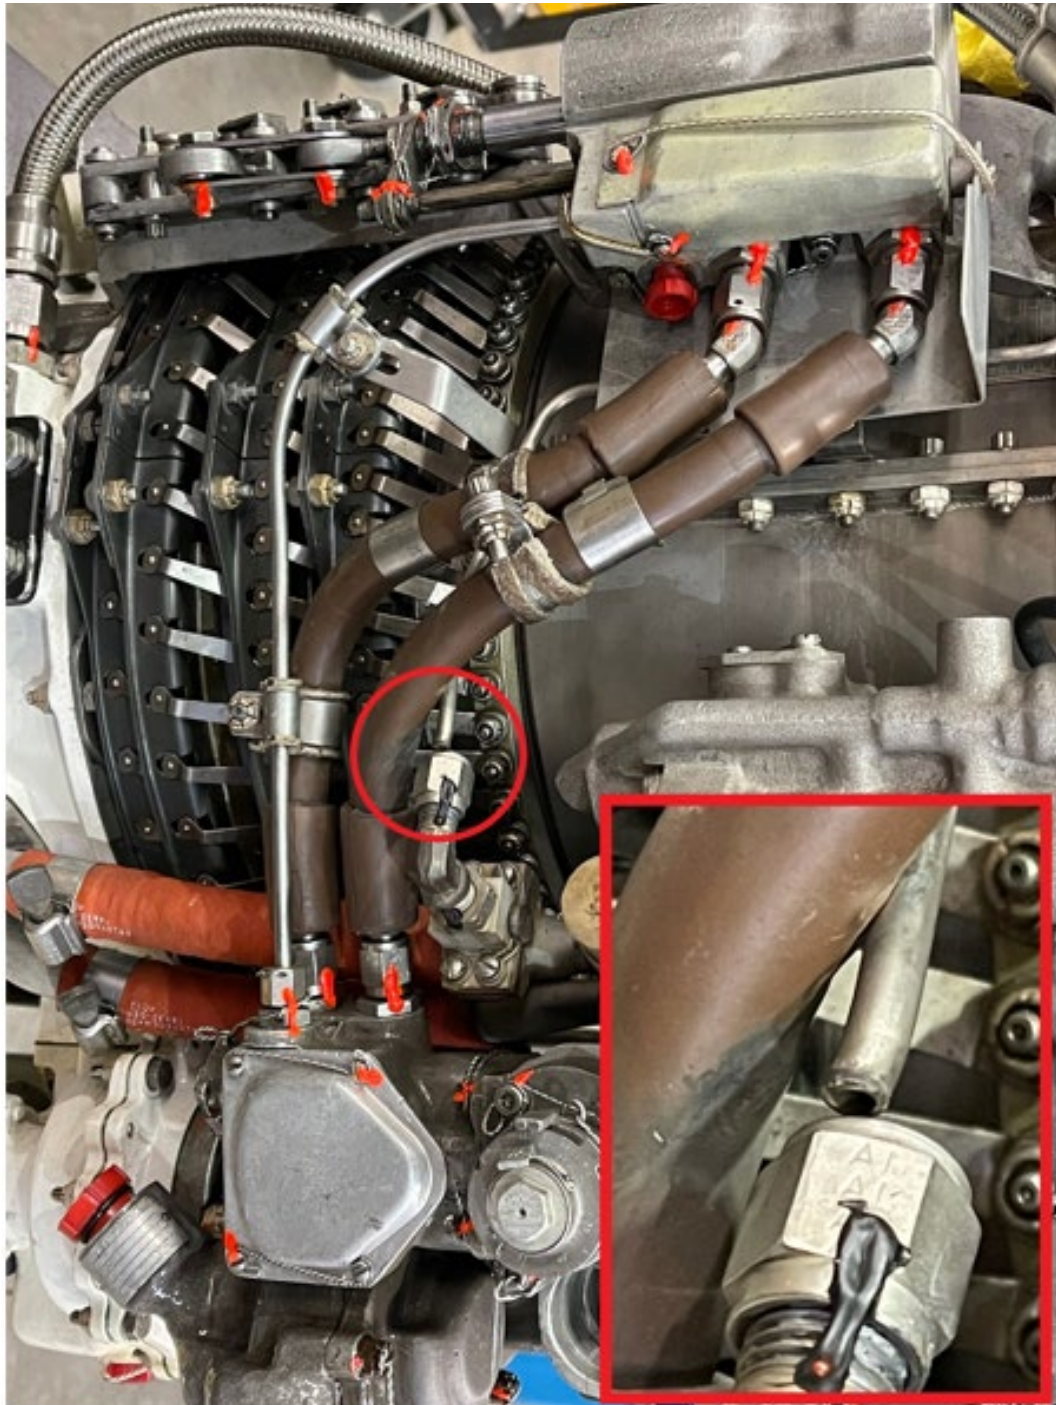
During forestry fire-fighting operations, after the load of water was picked-up and the climb was initiated, Engine Number 2 was not providing the required power. When compared with Engine Number 1, the torque was 40% lower and the T5 was 120 to 130 degrees Celsius below the Engine Number 1 T5 indication. The water load was released, the checklist for the low side governor failure was completed, and the helicopter returned safely to the base. An engine inspection revealed a broken P3 air line.

The root cause of the broken air line has yet to be determined, however, fatigue and stress may have played a role in this failure. The photo shows the broken air line offset from the B nut, which may suggest a side load from installation.

Due to congestion of lines and bundles on many engines, it is sometimes difficult to have proper alignment when connecting fluid lines. A slight bend of a line to achieve contact, may induce stress and lead to a failure. Another common error is securing and

torquing one end of the line before connecting the other end, instead of connecting both ends and then securing and torquing.

Broken P3 air line

Transport Canada Civil Aviation (TCCA) would like to make operators and maintainers of this model and similar models aware of this event. It is also recommended that close attention be paid to this line when inspecting in this area.

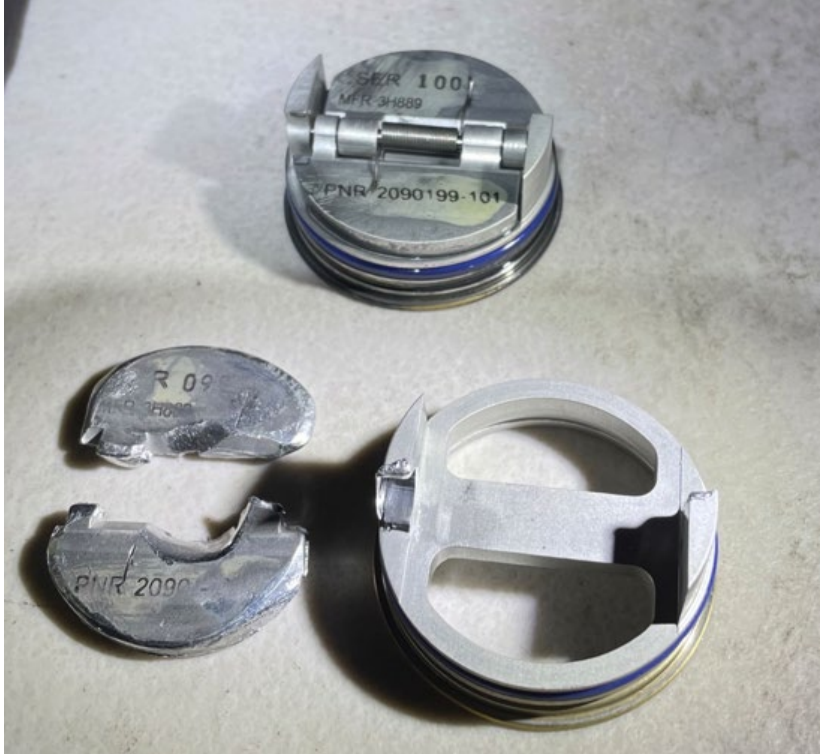
A fuel imbalance was experienced in flight. The following log entry was submitted by the aircrew: During the whole flight, we had fuel imbalance. The maximum was a 200kg difference. The low side was always on the right-hand side. The system balanced fuel three times within 45 minutes. On the ground, the fuel imbalance was still 160kg less on the right-hand side and the fuel flow was the same on both engines. The removal of the engine feed/isolation check valve revealed that the check valve was not properly installed.

Several Service Difficulty Reports (SDRs) have been received reporting "Fuel Imbalance" master caution messages during flight. Maintenance inspections found dislodged fuel check valves, which prevent backflow of fuel from wing tanks to centre tanks, as well as permit engine fuel cross-feeding when electrical boost pumps are in operation.

Photo 1 – Check valves

Transport Canada Civil Aviation would like to make operators and maintainers aware of Airbus Canada Service Letter CS-SL-28-20-004, which provides instructions for the replacement and installation of an improved retaining wire part number P/N 2183023-101.

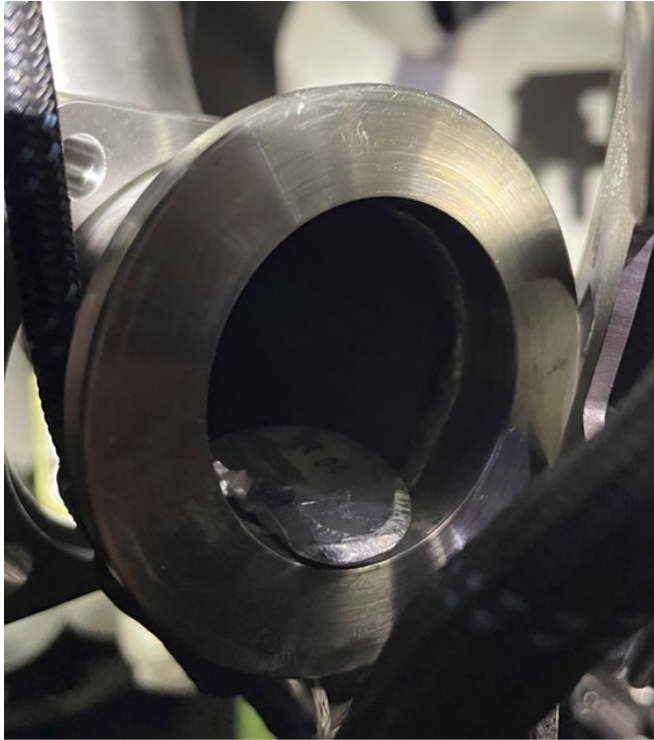
It was discovered that the retaining wire, which holds the check valve in its correct position, is of an insufficient diameter allowing the check valve to become dislodged and, consequently, allowing fuel to bypass the check valve.

Photo 2 – Dislodged piece of check valve

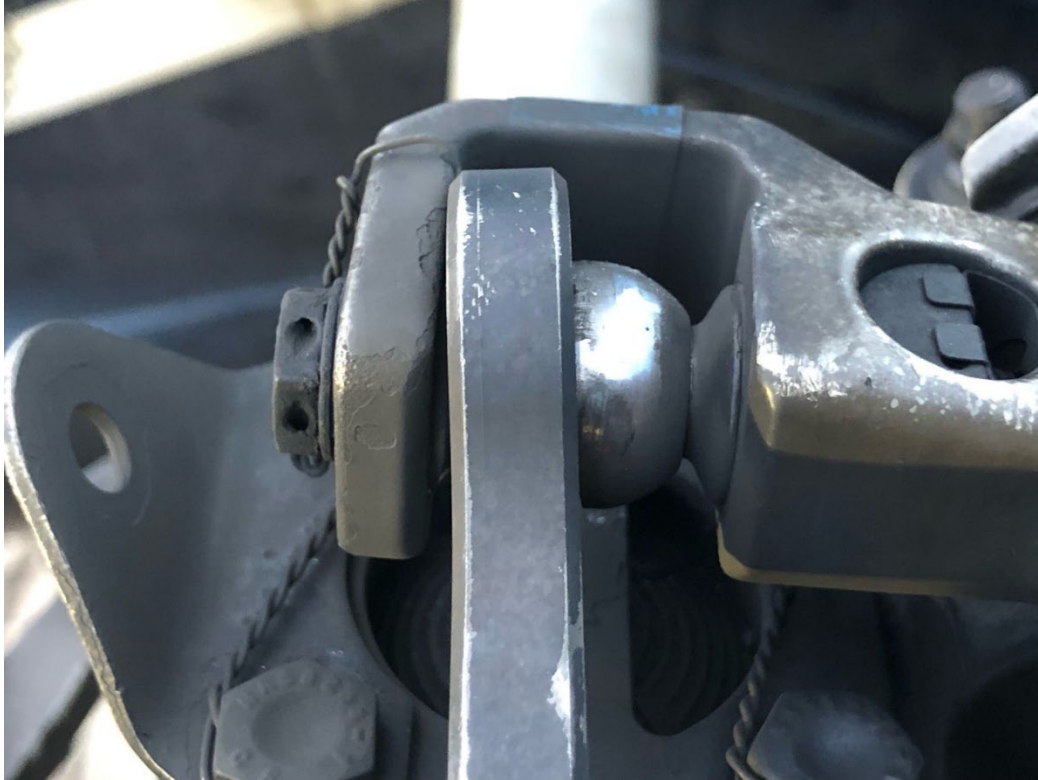
During the preflight walk-around, the pilot noticed that the tail rotor pitch link at the pitch horn did not look correct. Upon further investigation, it was found that the inner bearing had been separated from the housing. The bearing did not show excessive signs of wear at the last progressive inspection event #1, which was completed 150 hours prior to the incident. It is noted that the effected part is not an original equipment manufacturer (OEM) part however, it is a PMA part.

Transport Canada Civil Aviation (TCCA) has received service difficulty reports (SDRs) of excessively worn bearings on PMA part number (P/N) 4AA-312-103-101 tail rotor pitch link assembly. The SDRs are limited to the Bell model 407 helicopter, however, this PMA tail rotor pitch link assembly is also eligible for installation on model 206L4 and 427 helicopters. Supplemental instructions for continued airworthiness (ICA) are not published for these PMA tail rotor pitch links, the current ICA from Bell helicopter are applicable for each model. The PMA holder, Able Aerospace Services, has been made aware of the recent SDRs. To raise awareness, TCCA reminds operators and maintainers of the PMA P/N 4AA-312-103-101 tail rotor pitch links to remain vigilant when inspecting, and to report any service difficulties for this product.

Tail rotor pitch link housing found dislodged from the bearing during preflight inspection.

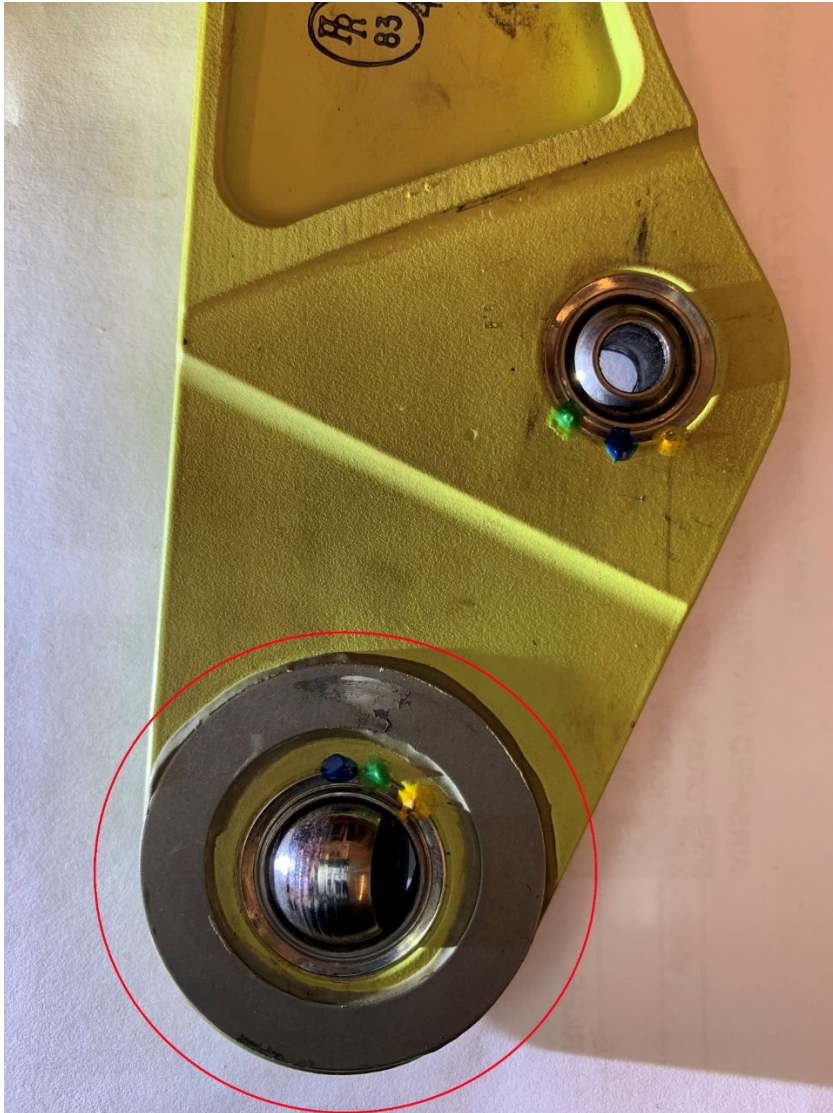
The following was reported to Bell upon the 800-hour inspection. Excessive wear was found on the bearing of the directional control idler.

The worn bearing, part number (P/N) MS14101-5A, is a component of the tail rotor directional control idler assembly, P/N 429-001-721-105. Several Service Difficulty Reports (SDRs) were received describing a worn bearing, P/N MS14101-5A, in the idler assembly. Bell investigated these reports and published Operation Safety Notice (OSN) 429-19-04 to highlight the importance of completing the scheduled detailed inspection of the bearing. In addition to publishing the OSN, Bell has indicated the possibility of a future design change to replace the existing bearing. Transport Canada Civil Aviation (TCCA) will monitor this service difficulty and reminds operators and maintainers to continue submitting a report for each reportable service difficulty.

Bearing, MS14101-5A, installed in the tail rotor directional control idler assembly, P/N 429-001-721-105

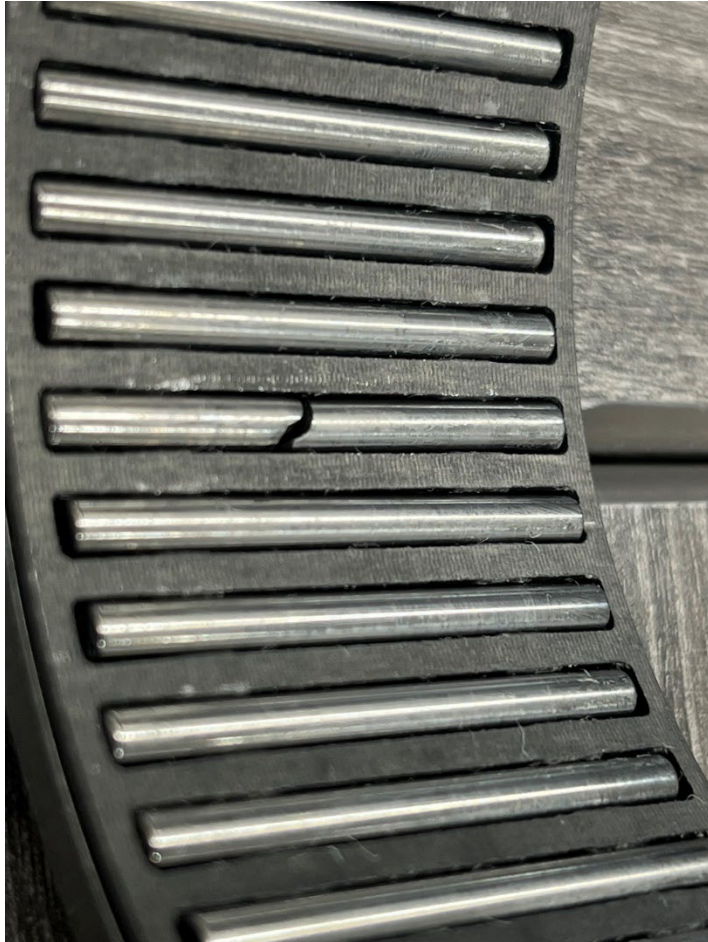
Feathering bearing, part number (P/N) 206-011-118-001, was removed from a main rotor hub of a Bell model 505 helicopter. The main rotor hub has not been disassembled since new. Total time is 197.2 hours since new. The feathering bearing was found damaged upon removal. Bell Helicopter has been notified.

Bell investigated this service difficulty and indicated that it may have been possible for the bearing to have been inadvertently damaged during the assembly of the main rotor hub. Although the roller was found fractured, an inspection of the rollers mating surface on the main rotor yoke showed no damage. Transport Canada Civil Aviation encourages owners, operators, and maintainers to submit a Service Difficulty Report if a fractured bearing roller is discovered during inspection of any helicopter model with a similar designed main rotor hub.

Fractured roller in bearing P/N 206-011-118-001
