SAFETY INVESTIGATION REPORT
CAA OCCURRENCE 18/6476
ALPI AVIATION SRL PIONEER 300
ZK-TNB
CONTROLLED FLIGHT INTO TERRAIN
TARINGATURA HILLS, SOUTHLAND
08 SEPTEMBER 2018

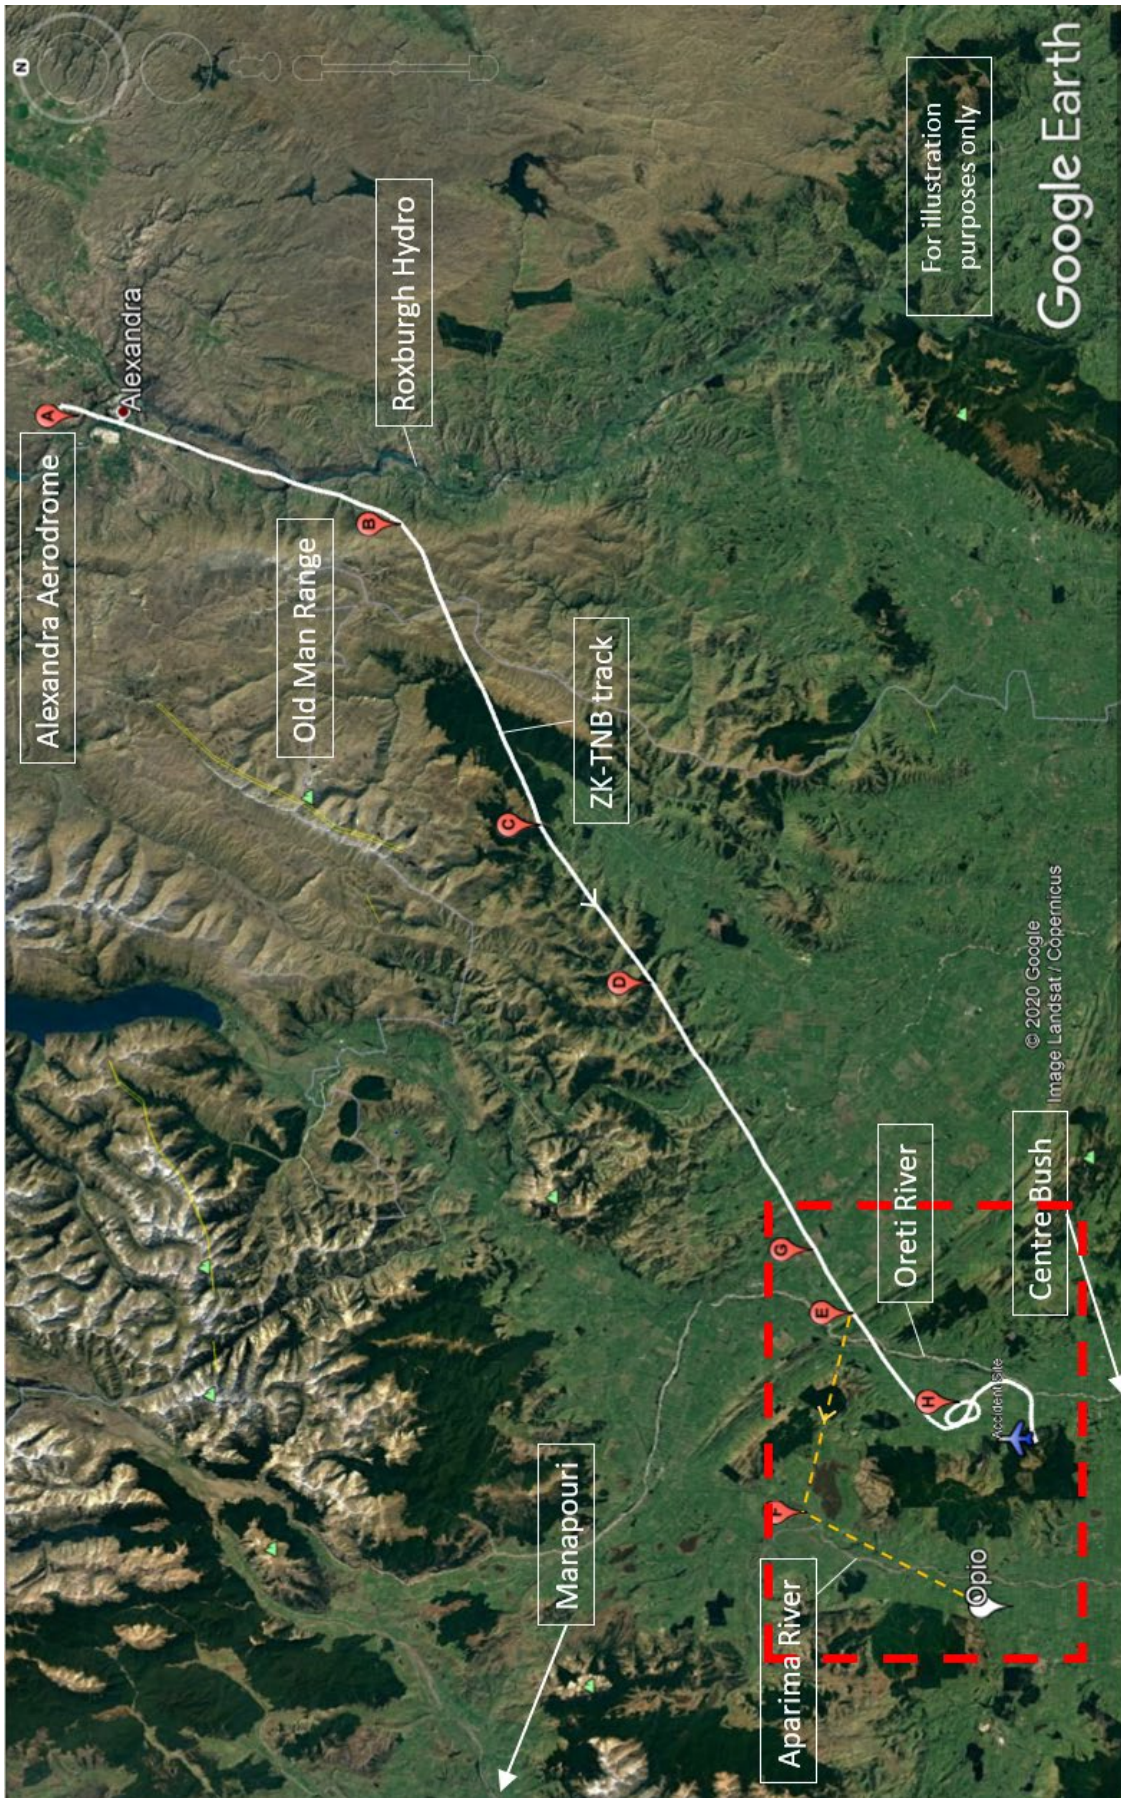
Figure 1: ZK-TNB flight track from AvPlan EFB application flight data

- 1.1.5 Both aircraft departed Alexandra aerodrome at approximately 0836 hours (refer point A on Figure 1).

- 1.1.10 When the lead aircraft was approximately 36 NM from Opio (refer point D on Figure 1) the pilot contacted the lead pilot via VHF radio asking for the location of Opio.

- 1.1.12 Flight data shows ZK-TNB's track changes slightly onto a more direct track toward Opio at point C on Figure 1. Then, the flight data shows that the pilot initiated a gradual descent just after point C on Figure 1.

- 1.1.13 The lead pilot stated that during the time between points C and D on Figure 1 the two pilots also discussed a "bank of cloud" and "hazy" conditions visible to the south, in the direction of their destination. The lead pilot stated that the pilot commented that, "It looks worse because we're looking at it from a distance".

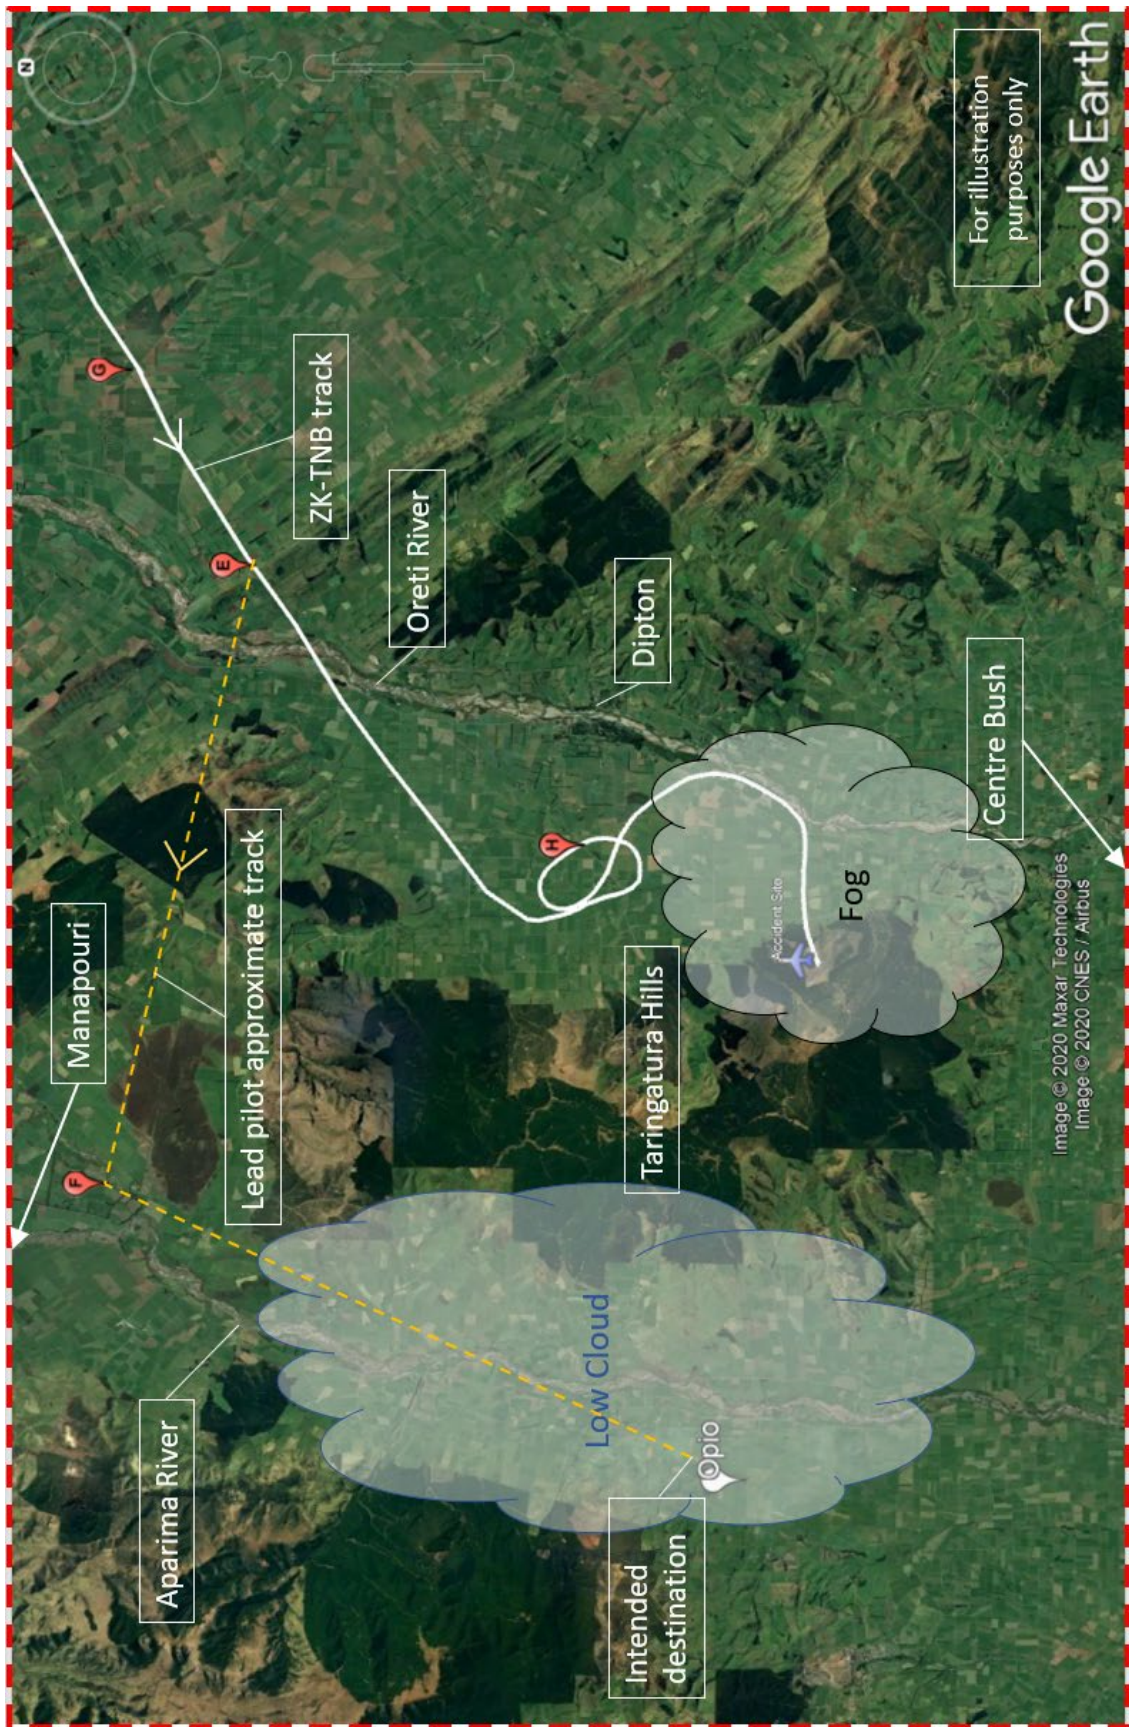
Figure 2: Inset from Figure 1
 (For an accurate representation of the fog/low cloud refer Figure 4 on page 14)

- 1.1.14 Approximately 15 NM from Opio (refer point E on Figure 2) the lead pilot stated that he initiated a descent to 3500 ft; simultaneously altering his track in a westerly direction to 'skirt' around the northern side of the Taringatura Hills. The lead pilot stated that he assumed that ZK-TNB was still following.

- 1.1.15 At approximately point F on Figure 2, the lead pilot contacted a pilot who was on the ground at the airstrip. The lead pilot stated that the suggestion given was to "fly downstream on the right-hand bank of the Aparima River". He descended to 500 ft above ground level (AGL) to get under the bank of cloud and follow the river.

- 1.1.19 At point E on Figure 2 the flight data shows ZK-TNB had descended to approximately 2300 ft AMSL. It then shows ZK-TNB crossed the Oreti River while remaining on track toward Opio, on the eastern side of the Taringatura Hills.

- 1.1.22 Corresponding flight data position points, at the time of the call, show ZK-TNB east of the Taringatura Hills, abeam Dipton, performing an orbit (refer point H on Figure 2). Once the call ended, ZK-TNB continued turning to the south, descending towards the Oreti River.

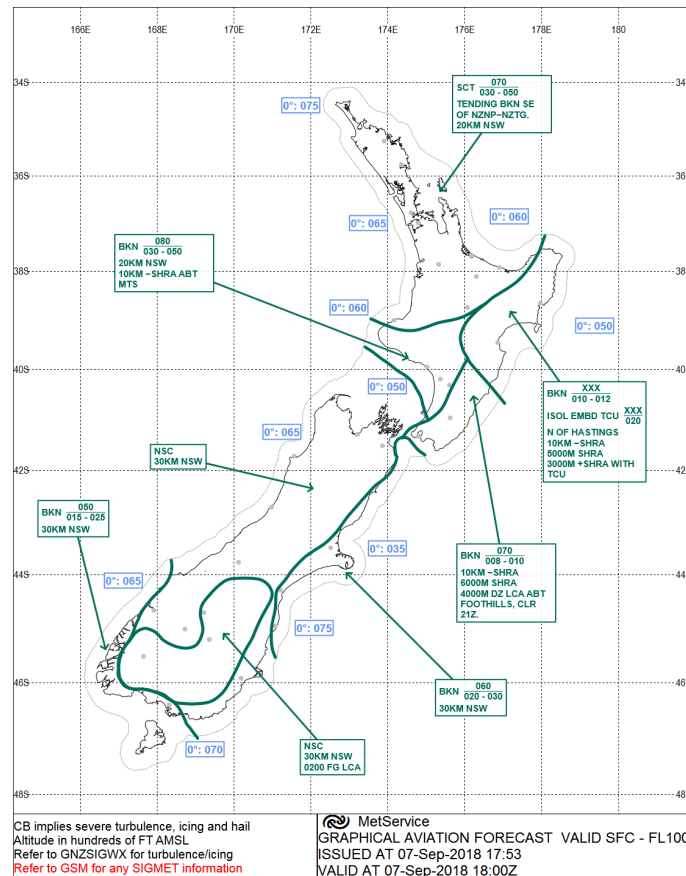
Figure 3: Graphical aviation forecast for New Zealand, valid at 1800Z 7 September 2018 (0600 hours 8 September 2018 NZST) and issued at 1753Z 7 September 2018 (0553 hours 8 September 2018 NZST)

- 1.7.7 This forecast was reissued shortly before 0600 hours on the morning of the accident, with no significant change made (refer to Figure 3).
- 1.7.8 The elevation at Opio is approximately 600 ft AMSL and the area east of the Taringatura Hills is approximately 350 ft AMSL.

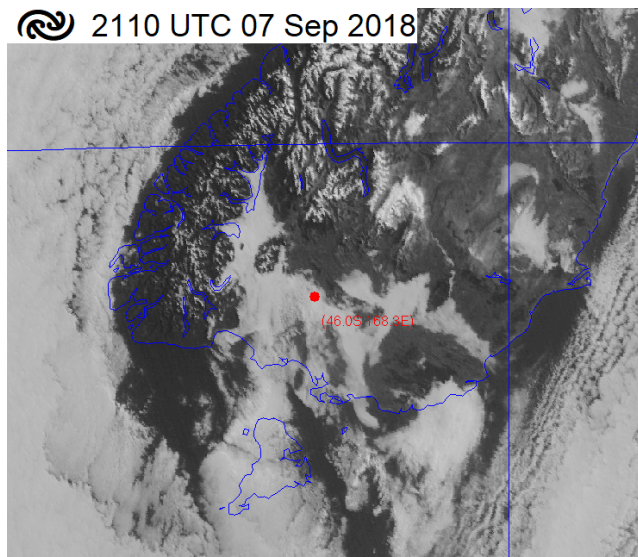
Figure 4: Himawari-8 visible satellite imagery at 21:10Z 7 September 2018 (0910 hours 8 September 2018 NZST), with the accident location marked by the red dot.

- 1.7.10 Satellite imagery for the same day and time showed extensive areas of fog over the lower South Island, particularly in the valleys and basins. The location of the accident site is coincident with a large area of fog or low cloud depicted in the satellite image (refer to Figure 4).
