Safety investigation brief

Paramotor accident, Poerua River, West Coast, 12 November 2020

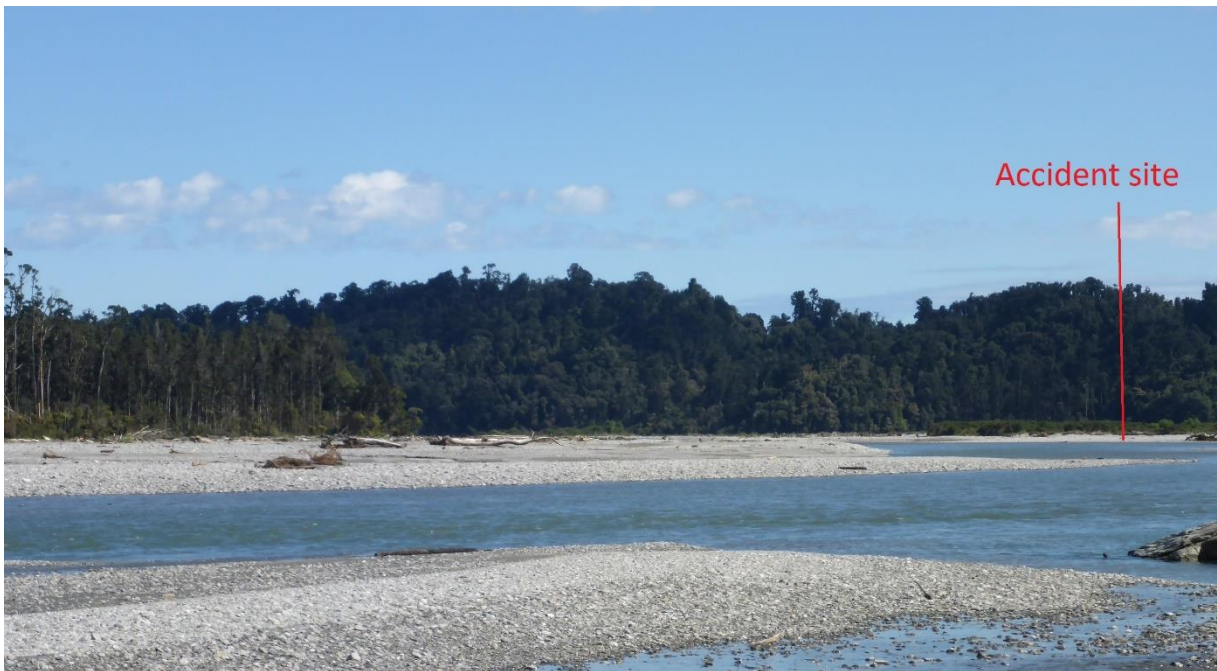
Figure 2. View looking down the Poerua River towards accident site.

An eyewitness at the river mouth watched the pilot take off and then fly downwind up the river, but lost sight of him when he flew behind trees in a bend in the river about two kilometres away. This indicated the pilot was near tree-top height while flying up the river, and that was consistent with the height he flew over the same part of the river on his way to the river mouth. The trees were approximately 80-100 feet high.
