**AIRCRAFT ACCIDENT REPORT**  
**CAA OCCURRENCE NUMBER 11/5349**  
**Eurocopter AS350BA ZK-IMB**  
**Loss of control due to spatial disorientation**  
**Karikari Moana, Karikari Peninsula, Northland**  
**30 November 2011**

## **Executive summary**

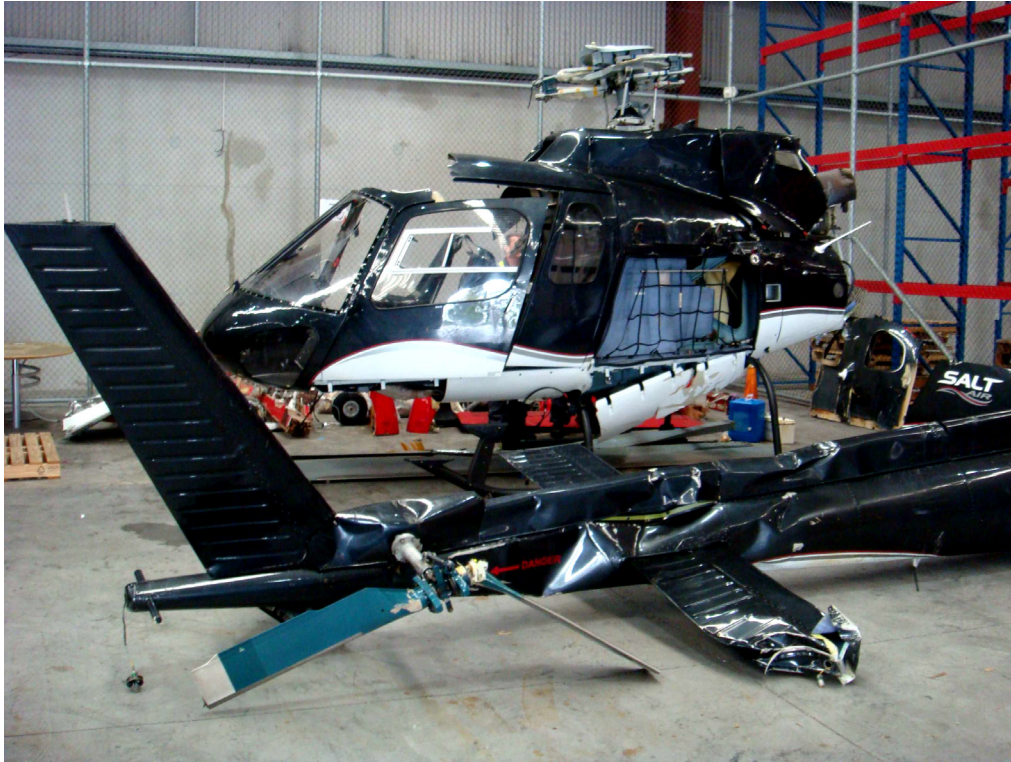
Figure 2. Helicopter at CAA facility prior to inspection.

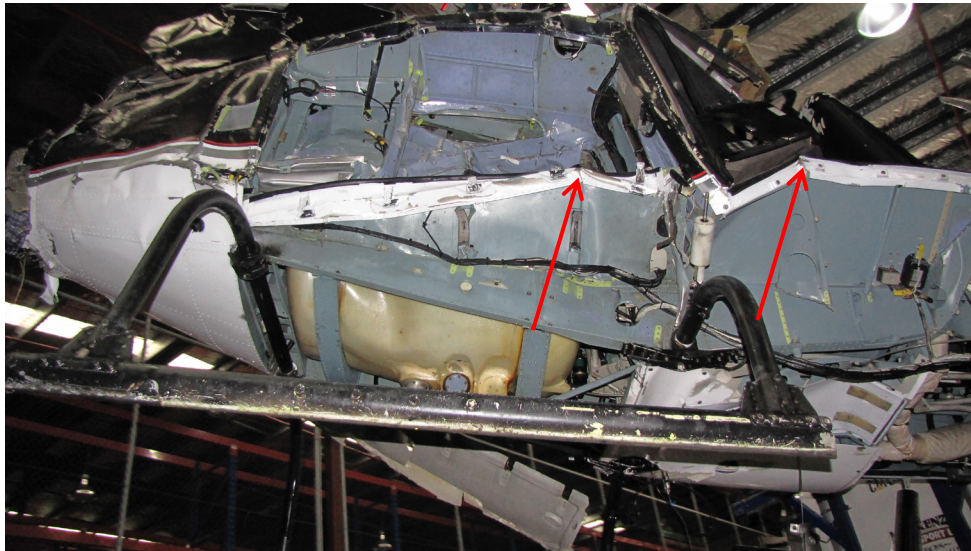
- 1.12.2 Significant impact damage was notable on the starboard side of the helicopter. Water impact “wave length signature” was evident on the subframe, causing buckling to the floor (Figure 3). The roof and forward section of the cockpit had separated compromising the rigidity of the cockpit area. The Pilot’s door was not installed during the fire-fighting to allow the Pilot to observe the monsoon bucket. The door was located near the monsoon bucket at the loading site.

Figure 3. Underneath of fuselage showing wave action and deformation.

- 1.15.1 The extensive damage to the fuselage indicated that the helicopter had impacted the sea, predominately on the starboard side, with sufficient force to partially separate the forward section of the cockpit from the fuselage.
