AIRCRAFT ACCIDENT REPORT
CAA OCCURRENCE NUMBER 15/1102
ROBINSON R44 RAVEN II
ZK-IWL
COLLISION WITH POWER LINES
FRENCH PASS, MARLBOROUGH SOUNDS
13 MARCH 2015

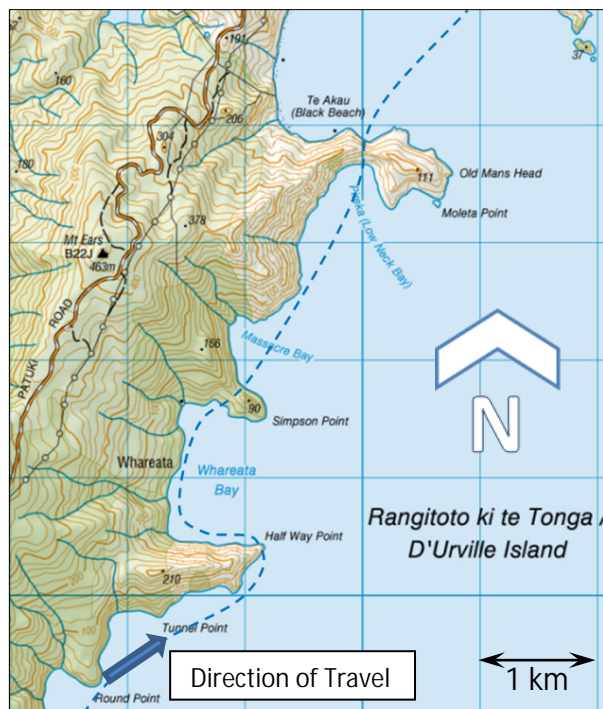
1.1.2 Residents of Whareatea Bay observed the helicopter flying along the northeast coast of D'Urville Island between Half Way Point and the Rangitoto Islands. The witnesses stated that helicopters transition through the area 'regularly', and the small white helicopter they observed that afternoon was 'flying very low... close to the land... inland of two boats moored at the northern end of Whareatea Bay'. They were 'worried that it would hit the mast of a yacht' moored in the bay, due to the altitude at which it was flying. Figure 2 depicts the helicopter's estimated flight path, based on witness accounts.

Figure 2: Estimated flight path along northeast coast from witness statement. Sourced from NZTopo50-BP28 Te Aumiti/French Pass. Crown Copyright Reserved

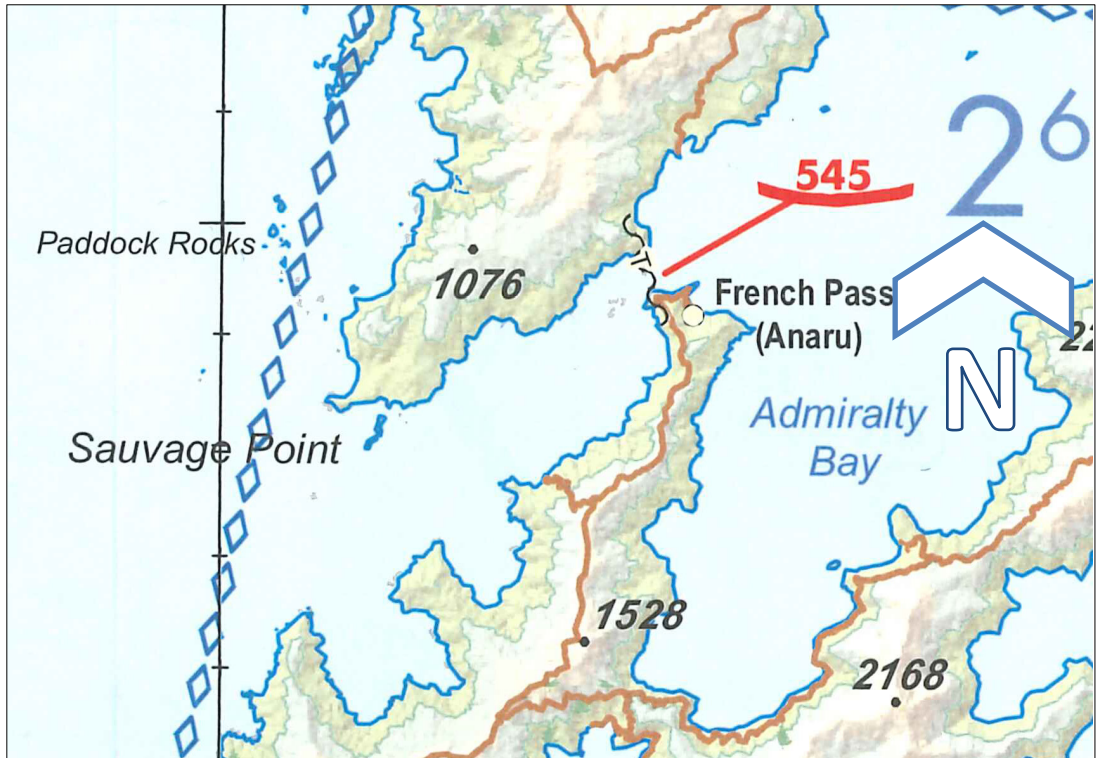
The wires that span French Pass are marked on the AIP New Zealand Visual Navigation Chart 1:250 000 scale: Chart C7. The highest point of the span is indicated as 545 feet AMSL (see Figure 4 and Figure 5).

Figure 4: French Pass Wire Hazard marking on AIP New Zealand Visual Navigation Chart 1 :250 000 scale: Chart number C7.

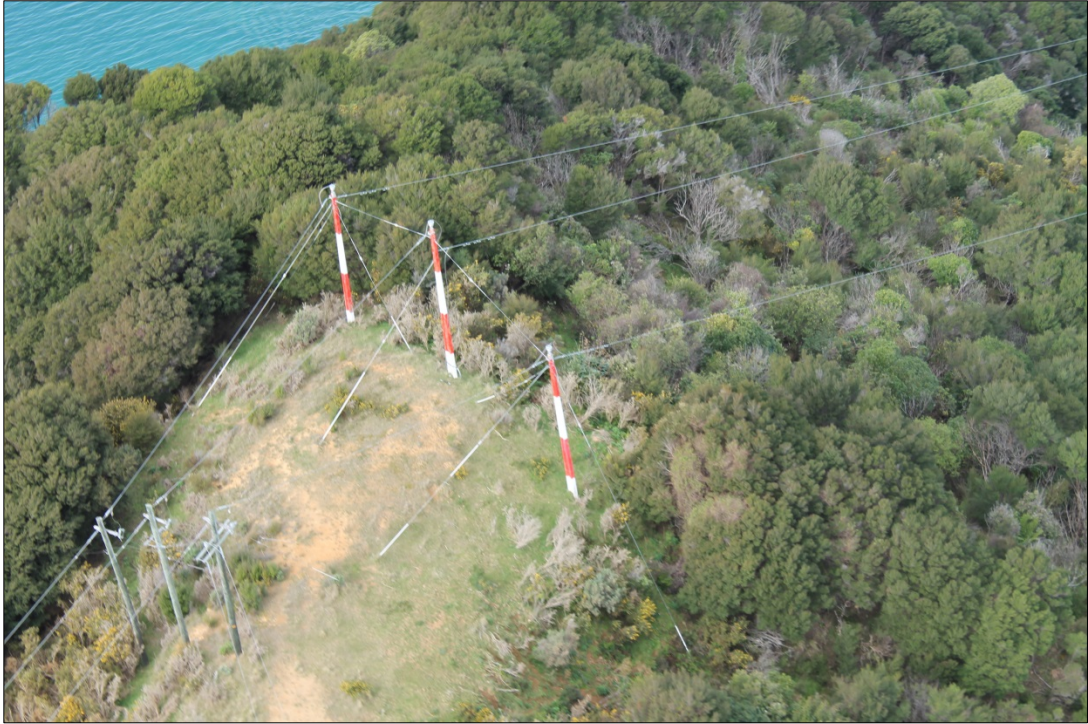
No marking devices were installed on the wires that span French Pass at the time of the accident. The supporting structures on each end of the span are painted white and red for contrast against foliage and sky.

Civil Aviation Rules, Part 77 *Objects and Activities Affecting Navigable Airspace* do not require this span to be marked due to the height of the structures supporting the wires on each side of the span, and the fact that the wires across the span are considered shielded.⁸

Figure 6: The structures supporting the wires on each end of the span are painted white and red for contrast against the foliage and sky. These are the structures on the north end of the French Pass span.

The CAA should consider an assessment of the adequacy of current markings on hazards to navigable airspace through the policy issue assessment process. The assessment should ensure that the shielding principles do not prevent hazardous wires and other hazards on low-level transit routes, like those in the Marlborough Sounds, from being marked to provide pilots with a visual warning that they are approaching a hazard.
