AIRCRAFT ACCIDENT REPORT
OCCURRENCE NUMBER 08/2220
ZENITH CH601-XL
ZK-ZXL
WAIROA AERODROME
25 MAY 2008

AIRCRAFT ACCIDENT REPORT

OCCURRENCE No 08/2220

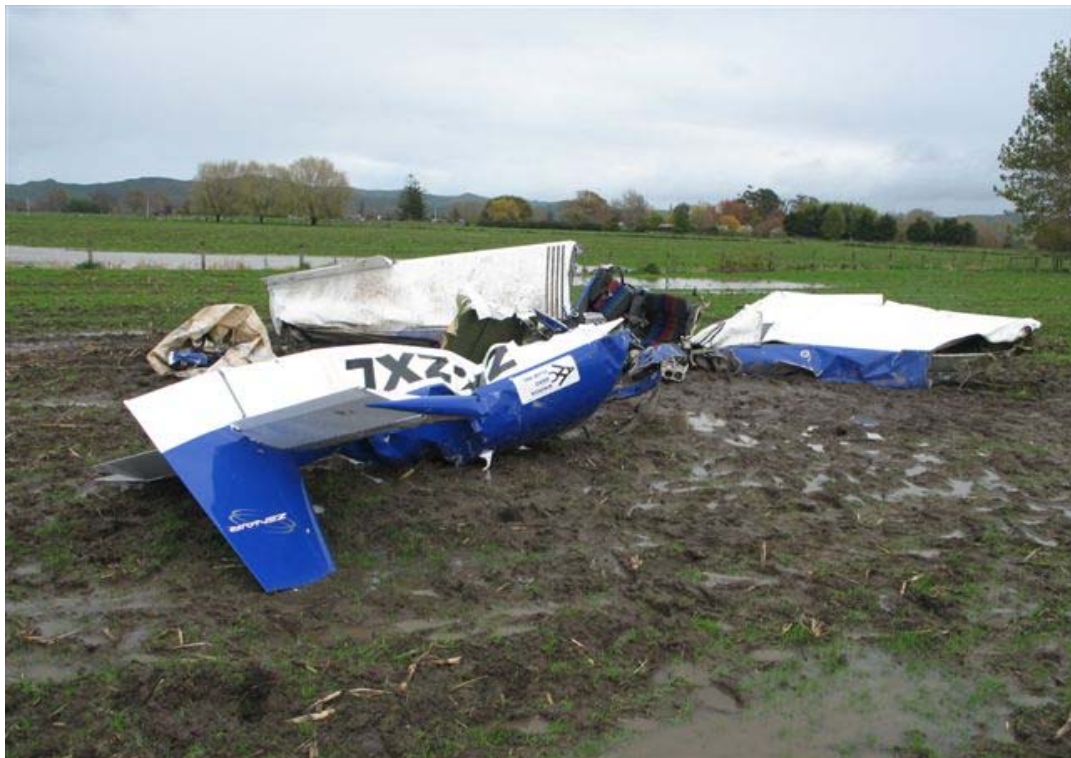
- 1.12.1 The aircraft was located 150 metres north-west of the extended centre line of Runway 34, in a heavily water-logged flat pasture paddock. The aircraft had impacted the ground from a near vertical attitude. The left wing had struck the ground first and the rear fuselage had fractured behind the cabin area causing the rear fuselage to come to rest inverted over the cabin.
- 1.12.2 The wreckage was contained within a small impact area, with the exception of the propeller and cabin Perspex which was scattered over a 15 metre area.

Figure 1: General distribution of wreckage.

Note – the rear fuselage has been moved to allow access to the aircraft cockpit area.

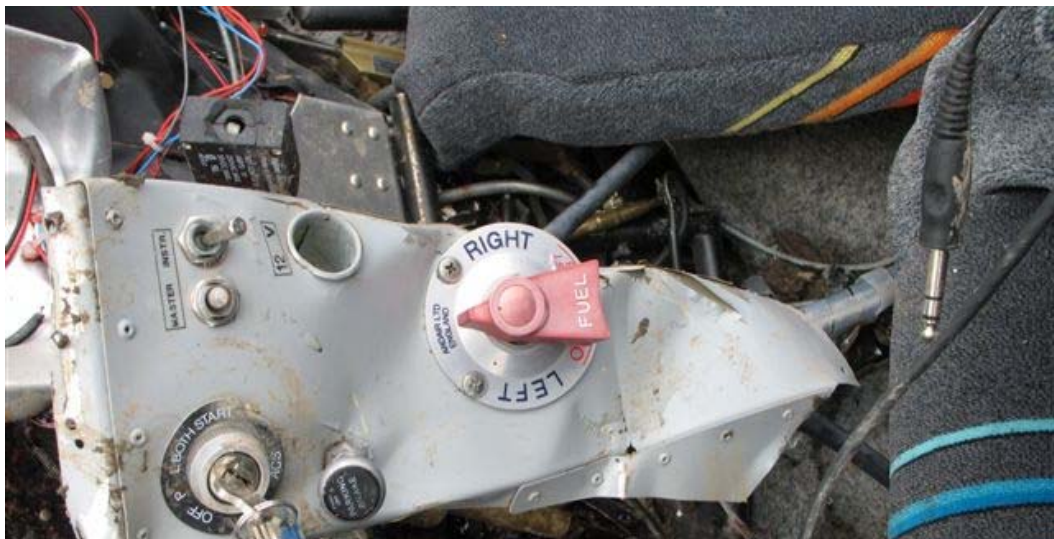
- 1.12.4 Fuel spillage was mixed in with the waterlogged ground, as evidenced by a large number of worms being killed by fuel seepage into the ground.
- 1.12.5 The fuel selector was found positioned fore and aft midway between the 'LEFT' and 'RIGHT' tank selection positions.
- 1.12.6 A personal locator beacon was found in its pouch secured in the cabin. It had not been activated. No aircraft-mounted ELT was fitted, nor was it required to be under the provision of CAR 91.529(e)(2), *Emergency locator transmitter*.
- 1.12.7 The aircraft was recovered to a secure facility for more detailed inspection, during which the integrity of the flight controls was established. It was discovered that the two flaps had a slight asymmetry problem due to the rigging of the controls and stops.

- 1.16.1 The fuel selector was removed from the aircraft and tested because it had been found in the mid-travel position without any obvious interference. This position may have resulted in fuel starvation to the engine. The unit was flow tested and dismantled, confirming continued fuel flow in this position.
- 1.16.2 Practical testing was carried out on an identical fuel selector installed in an RV-6 aircraft. The mid-travel position was selected and the engine ran for at least one minute on the ground at full engine power with the auxiliary fuel pump off.

- 1.16.3 Flight testing with the fuel selector in mid-travel position was also carried out in an RV-6 aircraft with a Lycoming O-320D1A rated at 160HP at 2700 rpm. This involved two minutes at climb power with the auxiliary pump off. A normal fuel delivery of 55 litres per hour was attained, then 30 minutes in the cruise running between 36 litres per hour down to 28.5 litres per hour. Exhaust gas temperatures and cylinder head temperatures were recorded as normal.
- 1.16.4 Research in to the fuel selector revealed that although this model has a ‘LEFT’ and ‘RIGHT’ (tank) selection position, when it is installed in the Zenith 701XL aircraft, fuel can still flow to the engine when the selector is moved to a mid-travel position.

Figure 2: Fuel Selector at mid travel position

- 2.14 The fuel selector position caused some concern early in the investigation, because there was no cabin lighting near the fuel selector and it was possible that inadvertent selection of the mid-travel position had cut off the fuel supply to the engine. This possibility was eliminated by subsequent testing and research.
