# Continuing Airworthiness Notice 27-022

## Cessna 208 Elevator and Rudder Torque Tubes

15 June 2022

Cessna 208 and 208B Elevator and Rudder Torque Tubes – Corrosion and Cracks.

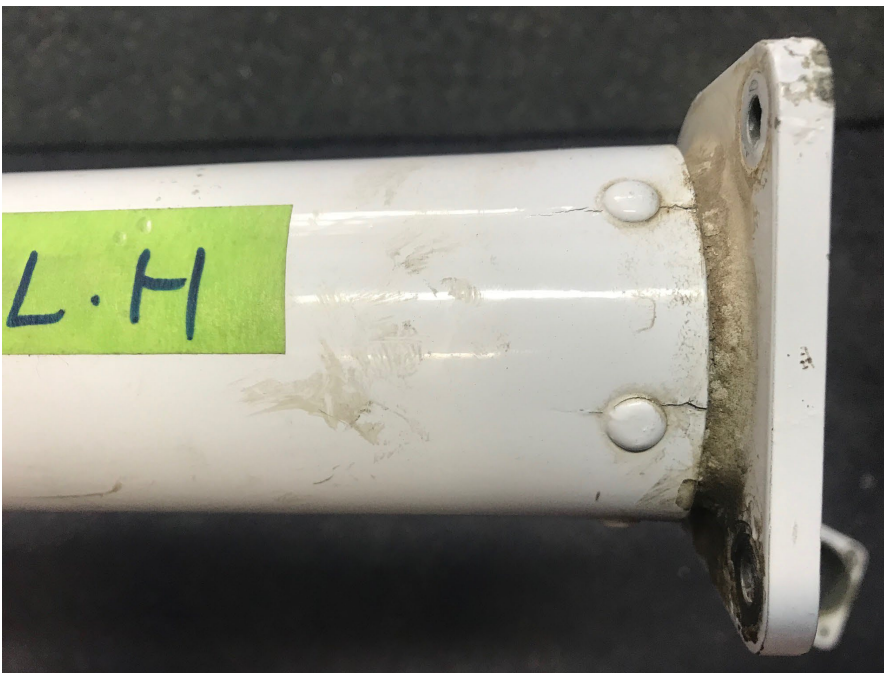
Photo 1 – LH Elevator Torque Tube:

With the aircraft on 200-hour inspection a detailed inspection was required of the horizontal and vertical stabiliser area. With the tail cone removed the RH and LH elevator torque tube support flanges were found cracked. The aircraft was grounded until replacement parts arrived.

Location of cracks found in the LH elevator torque tube at a 200-hour inspection on an aircraft at 5864 hours TTSN.

The flange fitting that fits inside the torque tube was significantly corroded with exfoliation corrosion causing the tube to burst. Replacement parts were ordered and fitted. A detailed inspection including removal of the rudder was undertaken to confirm structural integrity. All pivot bearings also renewed. Some hardware replacements were changed due to visual corrosion.

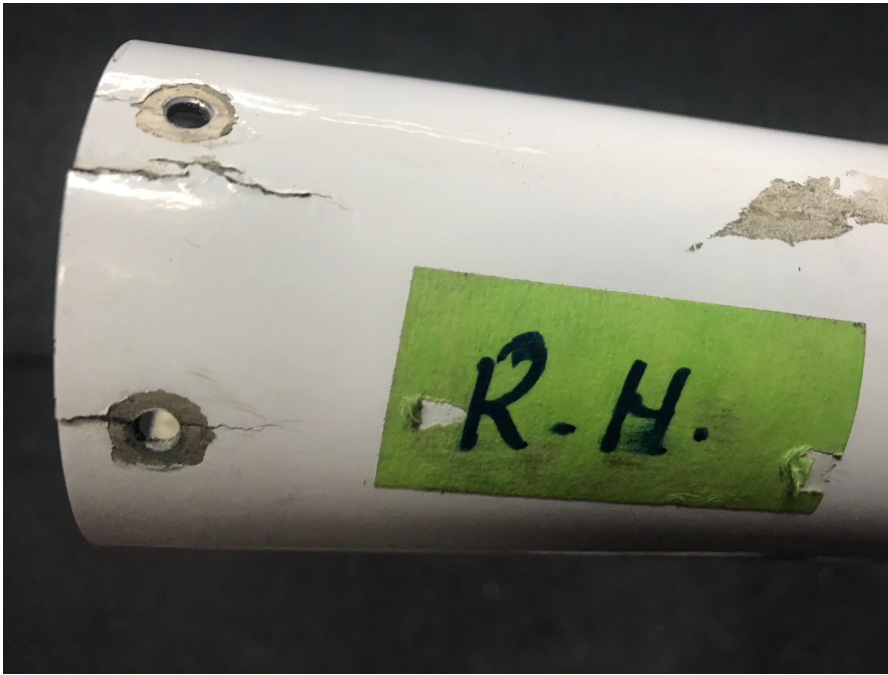
Photo 2 – RH Elevator Torque Tube:

Location of cracks found in the RH elevator torque tube at a 200-hour inspection on aircraft at 5864 hours TTSN.

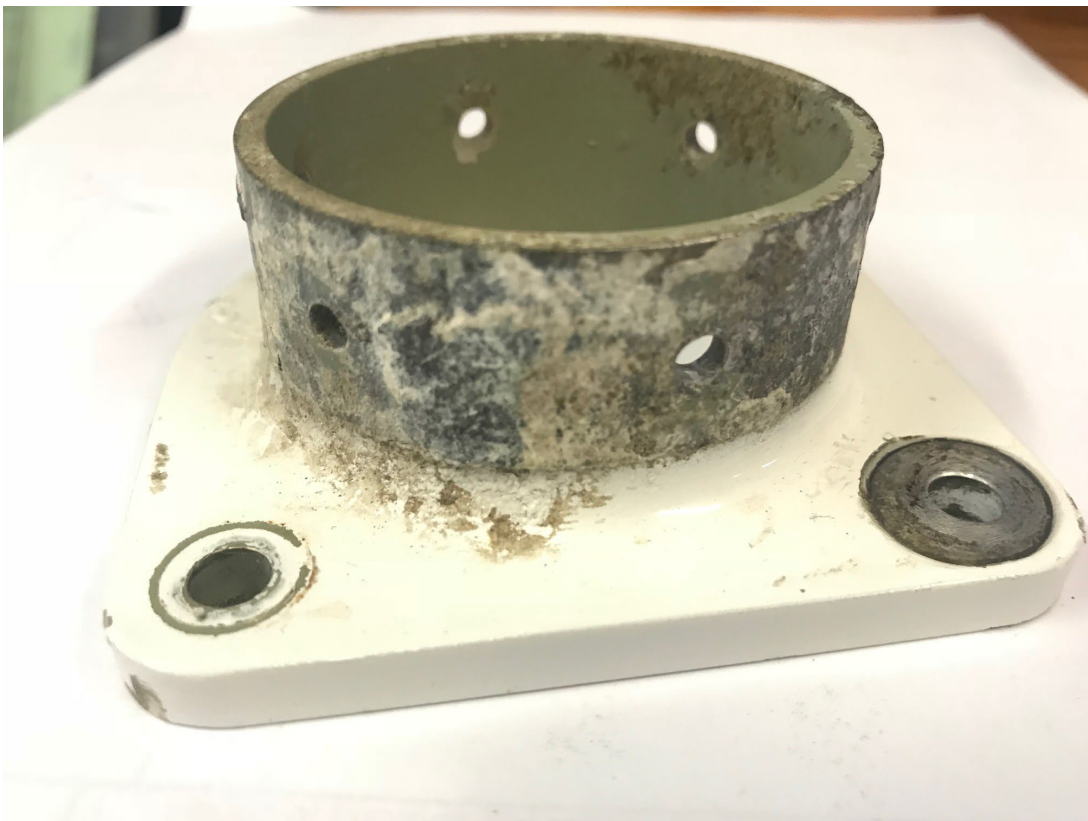
Photo 3 - Elevator Torque Tube:

The flange fitting that fits inside the torque tube found significantly corroded on aircraft at 5864 hours TTSN.

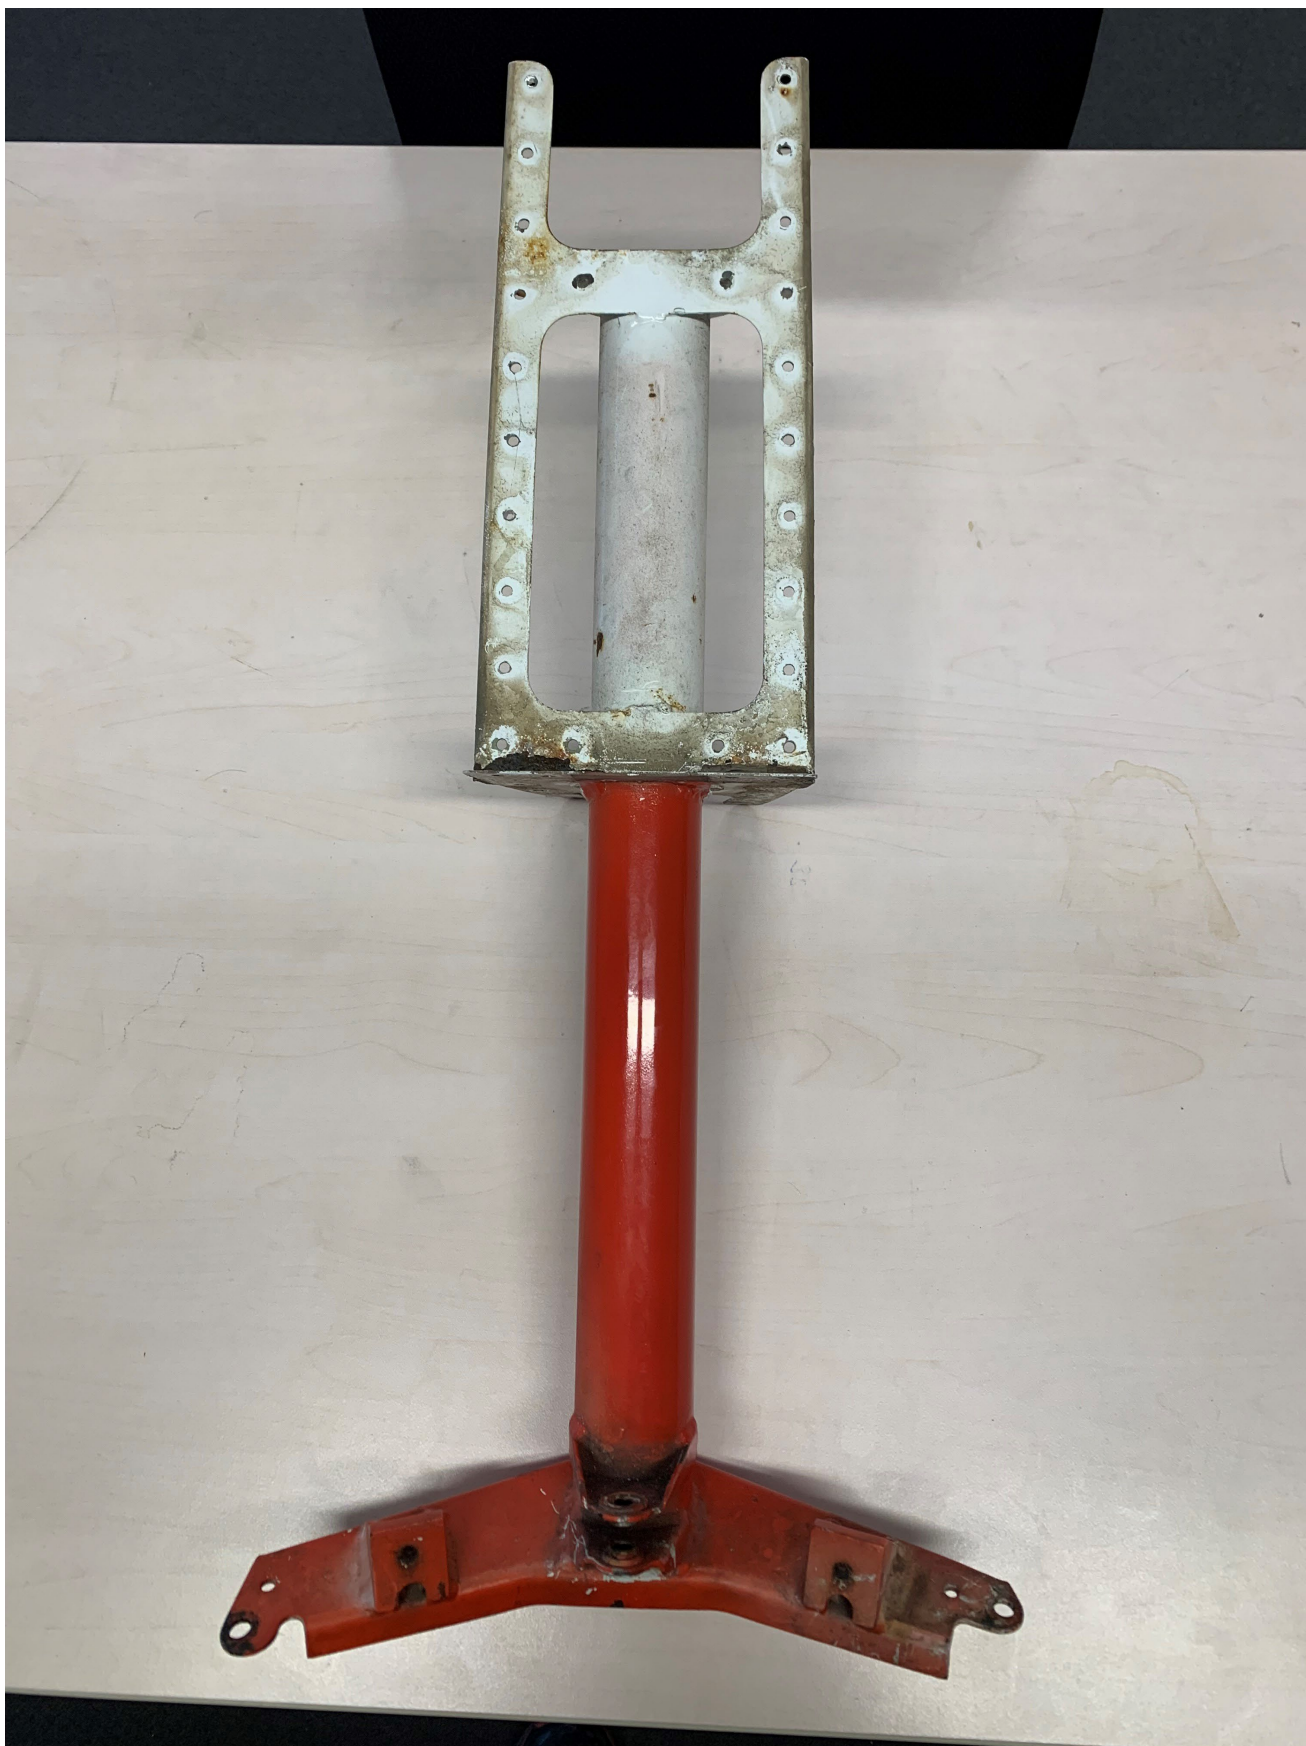
Photo 4 - Rudder Torque Tube:

The rudder torque tube assembly was being replaced due to finding the rudder cable attachment holes worn beyond repair. The rudder was removed and de-riveted to enable torque tube replacement. On removal, severe corrosion was found in the welded corners of torque tube assembly.

A review of the aircraft records determined that the original rudder torque tube assembly was installed since aircraft manufacture (2003). Corrosion possibly initiated due to deterioration of the paint and/or the corrosion protection. Of significance is the fact that the area where the corrosion was found is internal structure in the rudder, the only way to examine this area would be to remove the rudder and access with borescope through the leading-edge skin of the rudder. The maintenance provider noted that the corrosion was found before corrosion set in surrounding aluminium structure. No further defects were found. The rudder torque tube assembly was replaced.

Location of corrosion found in the rudder torque tube on a second aircraft at 6607 hours TTSN.

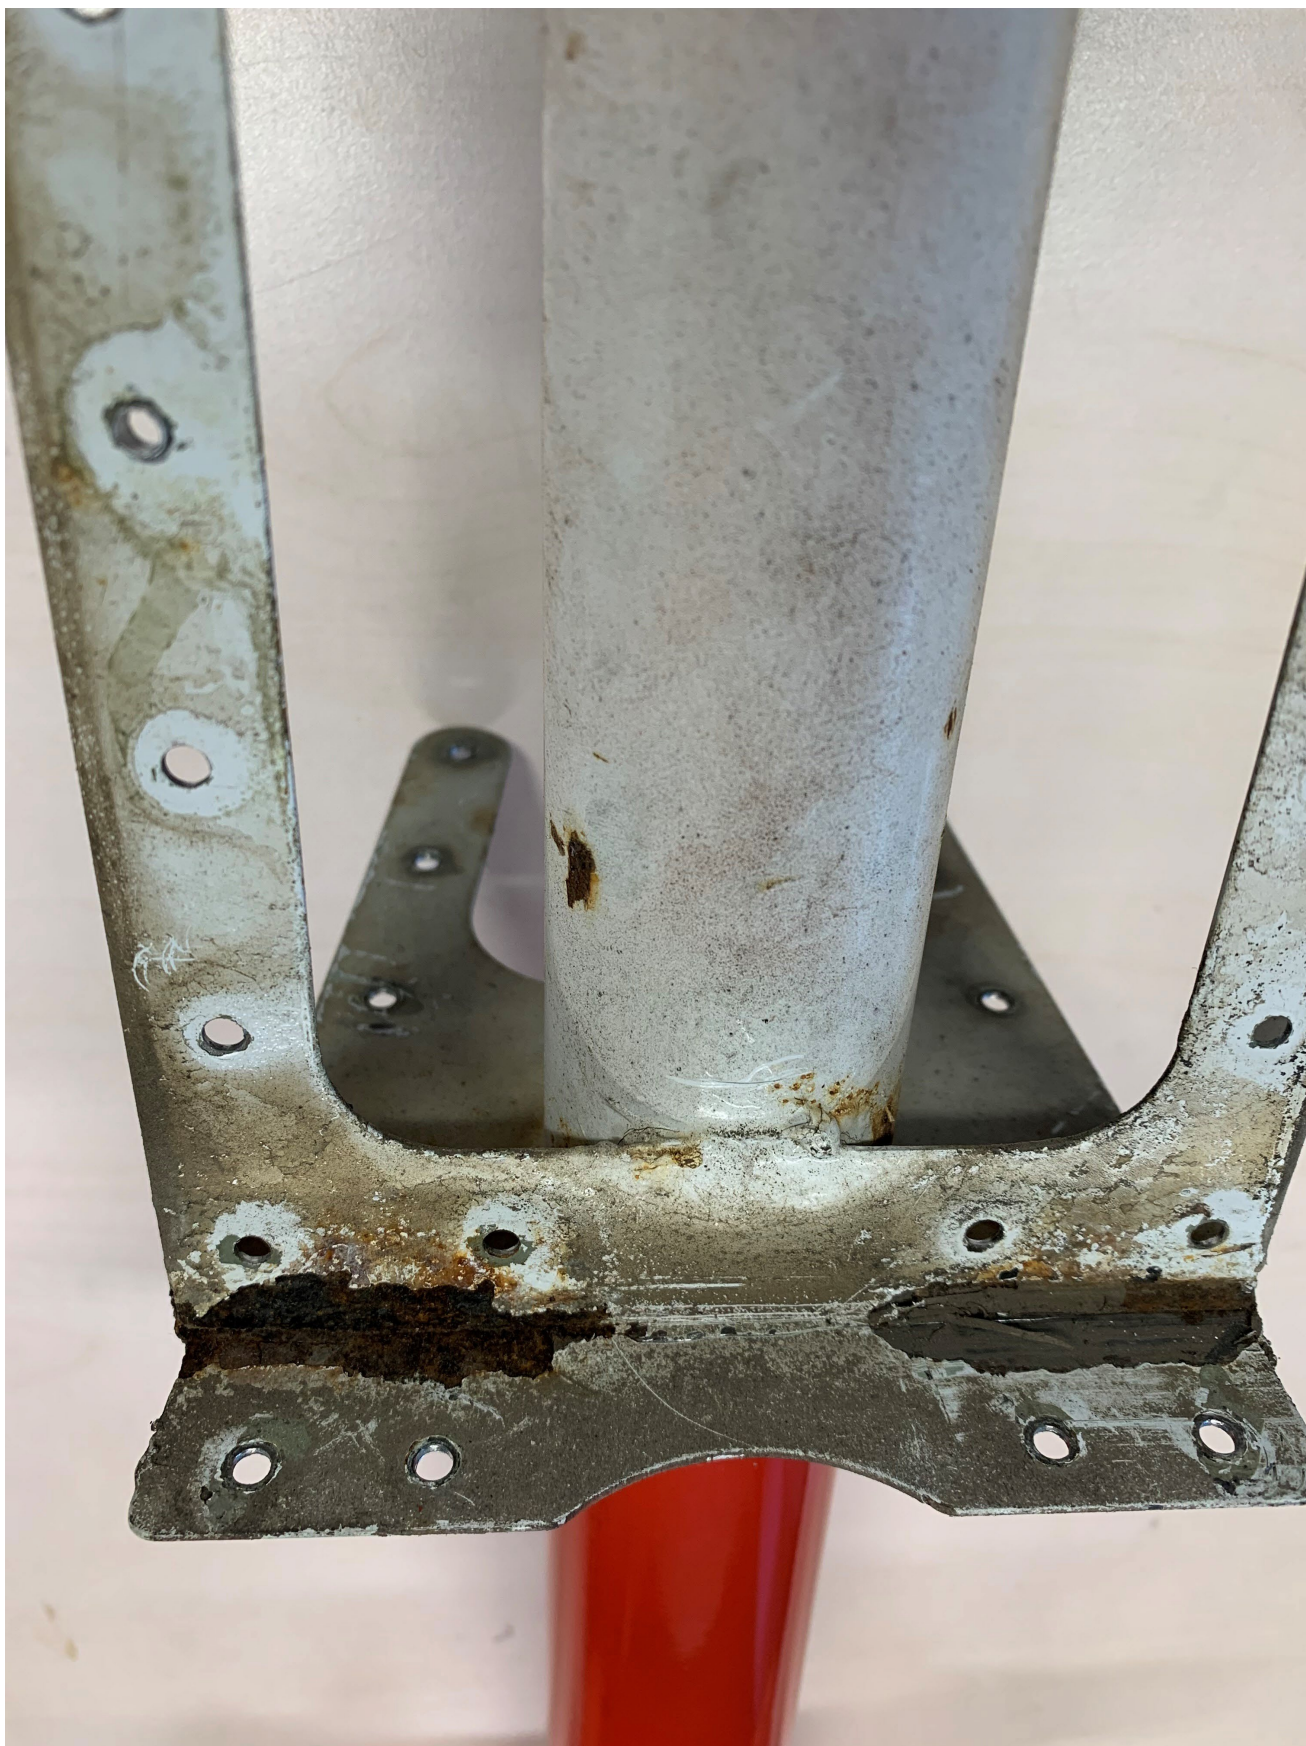
Photo 5 - Rudder Torque Tube:

Location of corrosion found in the rudder torque tube on a second aircraft at 6607 hours TTSN.

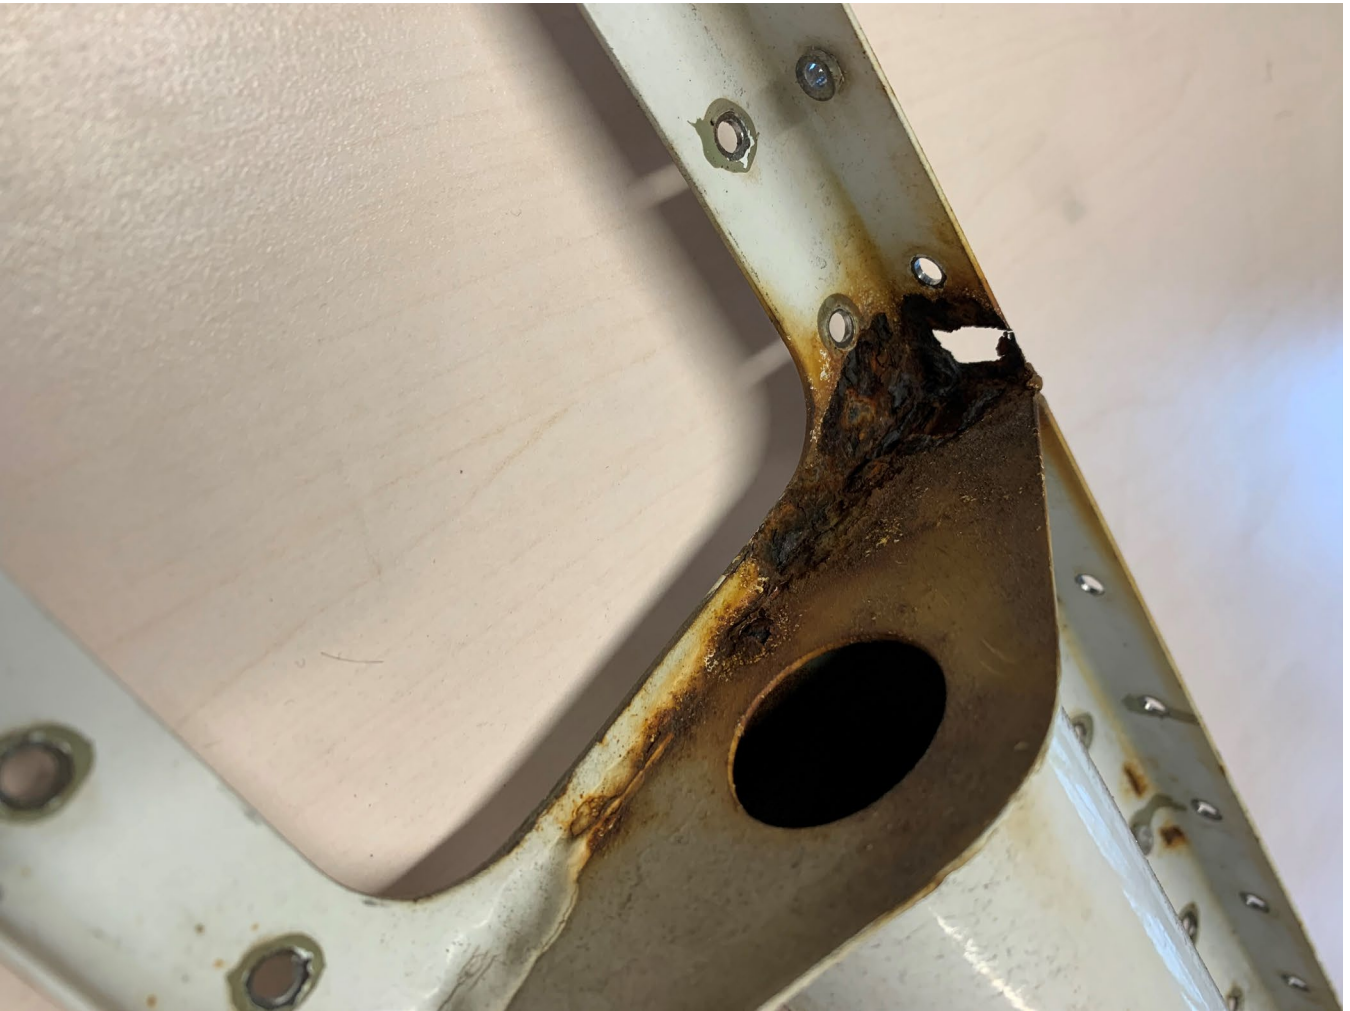
Photo 6 - Rudder Torque Tube:

Location of corrosion found in the rudder torque tube on a second aircraft at 6607 hours TTSN.
