Airworthiness Directive Schedule

Helicopters

Airbus Helicopters AS 350 Series

18 January 2024

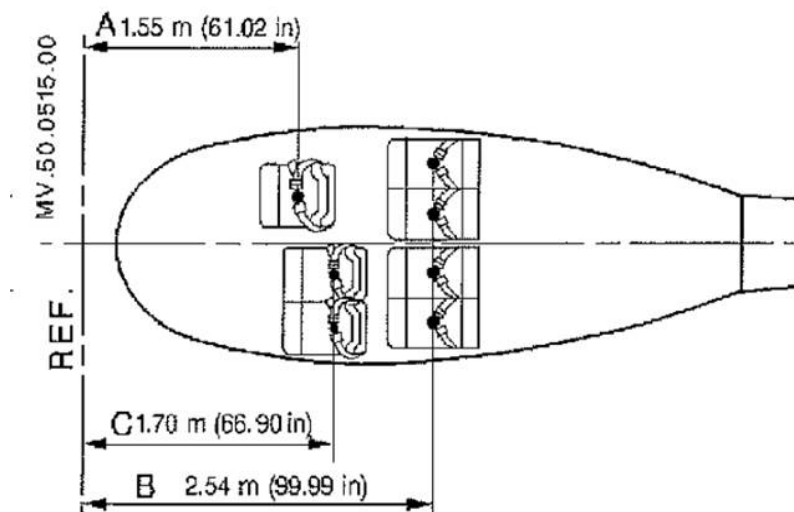
1. Determine the longitudinal moment arm of the forward two-place seat using the center of the seat pan cushion as a measurement reference point.
Complete and issue a new form CAA 2173 Weight and Balance Data.
The weight of the seat components must be included in the CG calculations. If a seat adaptor plate is fitted the moment (position and weight) of the plate must also be considered for the CG calculation.
The lateral CG arm of the helicopter must not be assumed to be zero. The lateral CG must be recorded and be within the limits specified in the AFM.
Annotate the CAA2173 to include the value of the longitudinal moment arm of the forward two-place seat used.
2. Remove CAA Limitations Section, (1 page), dated 14 December 2015 and insert 1 page dated 30 June 2016.

Figure: Airbus Helicopters recommended CG position of forward two-place seat
