Feedback

Canadian Aviation Service Difficulty Reports

The following content was published between 1 January 2023 and 31 July 2023. The full accessible version of each article is available on the Feedback [website](#).

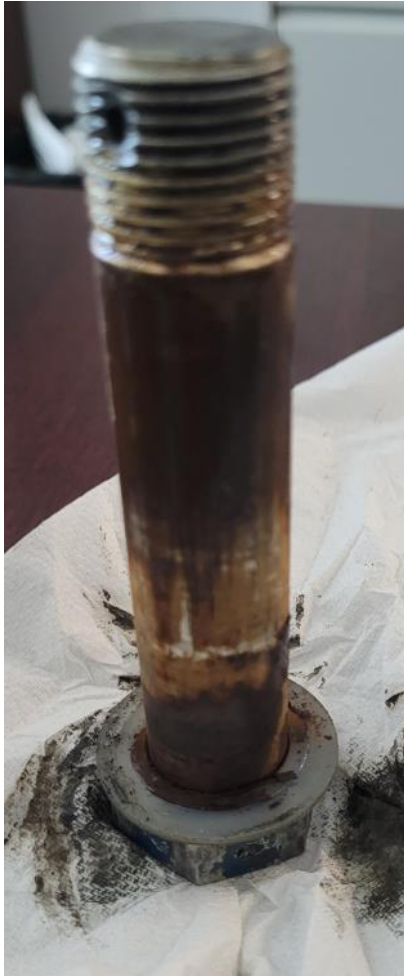
During an inspection of a lower forward wing attach bolt carried out every 60 months in accordance with Beechcraft Special Inspection 57-18-03, the bolt was found to be seized and unable to be removed in accordance with Beechcraft instructions. When communicating with Beech, we were informed that this is unusual and the bolt should not be seized.

A Textron technician assisted the operator in the removal and replacement of the lower forward wing attachment bolt which was seized due to corrosion. The technician mentioned that a possible cause of corrosion may be due to the use of anti-ice solution used in northern climates.

Figure 1 – Forward lower wing attachment bolt – Corrosion evident

Corrosion discovered in the case of this Service Difficulty Report (SDR) has not been determined to be the result of a lack of corrosion preventative compound (CPC), although Transport Canada Civil Aviation (TCCA) would like to remind maintainers of the importance to follow recommended practices outlined in the appropriate instructions for continued airworthiness (ICA). Current mandatory replacement of the lower forward wing attachment bolts every five (5) years and annual servicing recommendations both require the correct application of specified CPC. TCCA would appreciate receiving any additional SDRs of wing attachment bolt corrosion, particularly where recommended servicing has been followed.

MP-TP-0033 includes recommended removal techniques to complement existing ICA maintenance practices.

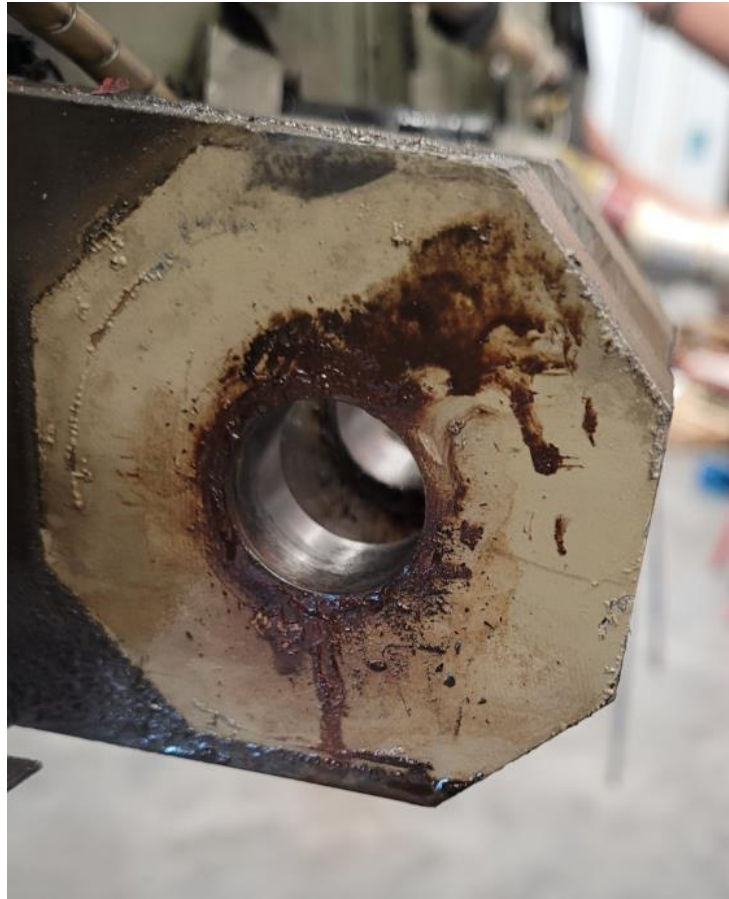
Figure 2 – Forward lower wing attachment fitting

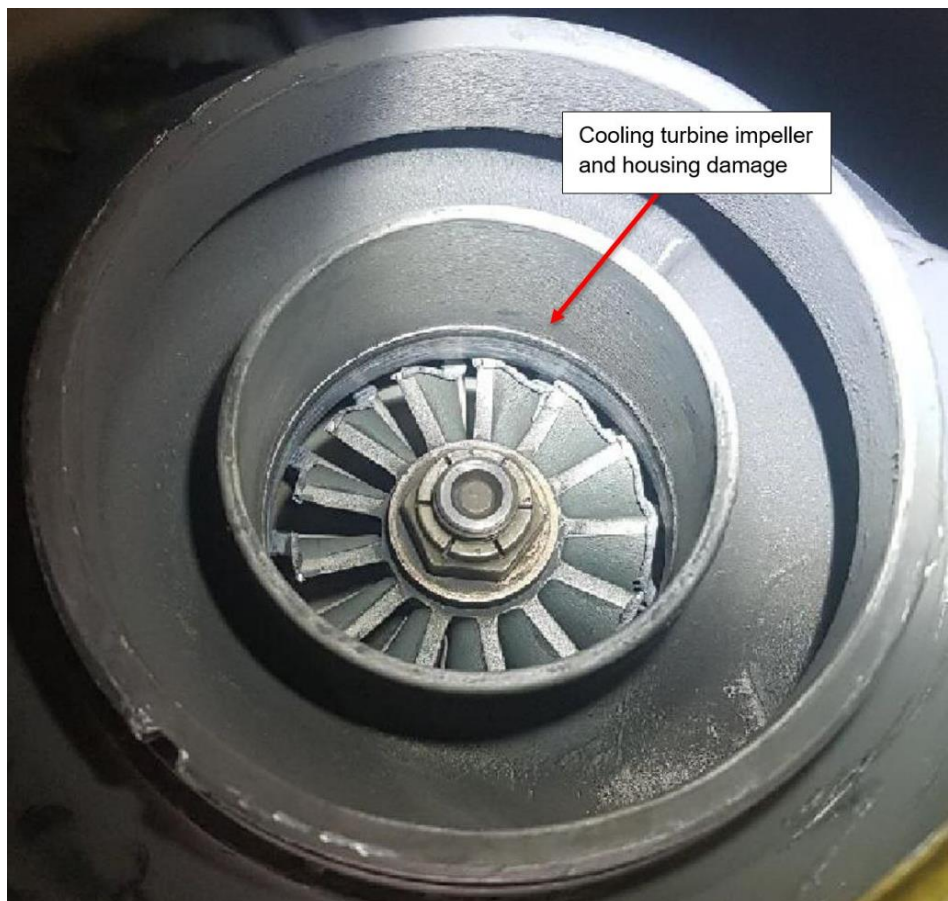
Cooling turbine bearing failure often results in seizure, and multiple service difficulty reports (SDRs) suggest that this is accompanied by smoke/oil mist in the cabin. Other indications of failure have been described as: smoky haze, white smoke, or acrid smell in the cabin/cockpit. Cabin temperature rising, while not responding to temperature controller or manual temperature control, has also been reported.

It is important to reiterate that inspection and servicing outlined by the manufacturer should be completed correctly and during the suggested interval. In addition, SDR data suggests that high oil level, or a blockage in the air delivery system may contribute to cooling turbine failure.

Picture 1 – Cooling turbine bearing failure

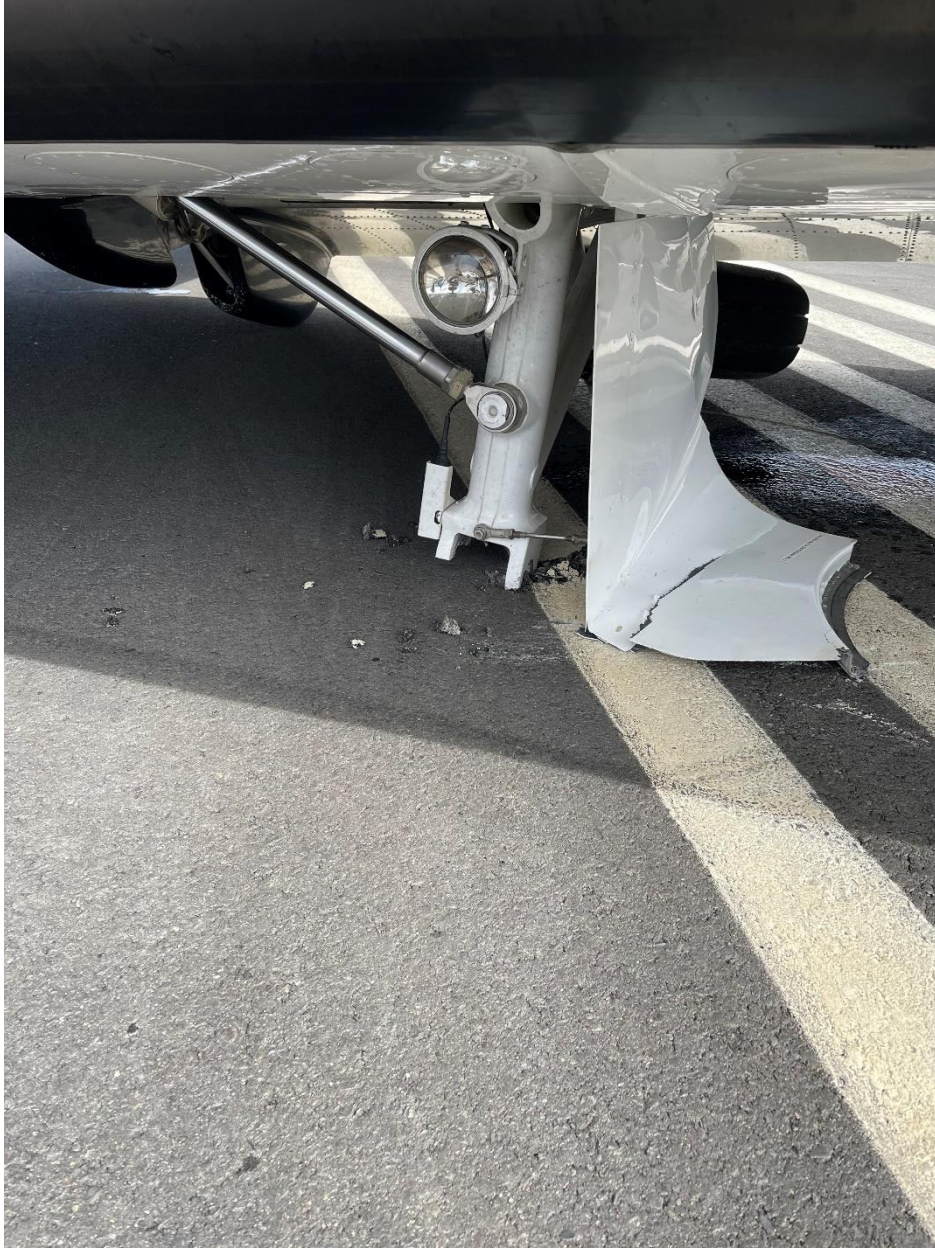
The MLG lower trailing link broke away from the upper yoke fitting. The pivot pin attach lug on the yoke fitting, inboard side, broke in half, allowing the lower trailing link bushing and pin to separate from the upper gear leg.

Picture 1 – Fractured gear impacting the runway

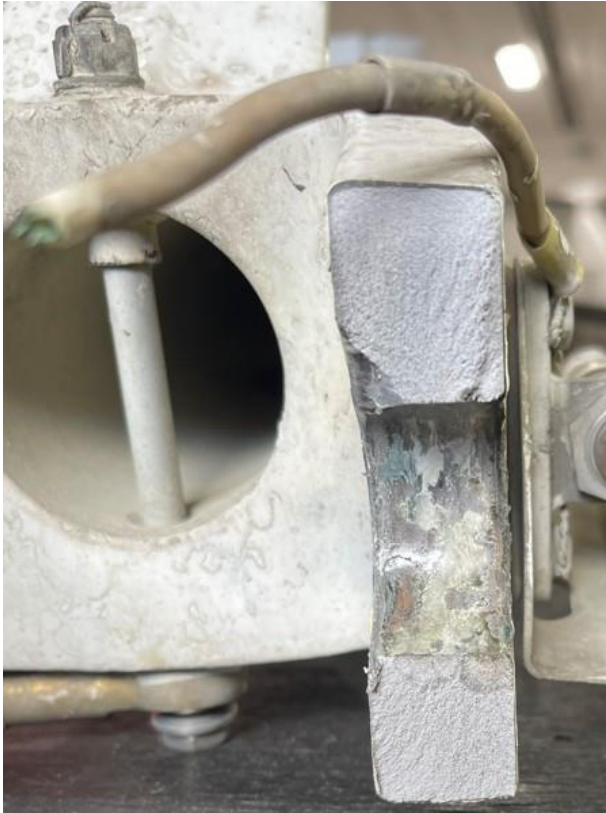
This Feedback Article aims to raise awareness in the PC 12 community of potential undetected corrosion being present under specific bushings of the yoke fitting assembly. It is suspected that this corrosion weakens the bore in the yoke fitting which can cause the separation of the lug from the rest of the yoke assembly. This specific aircraft was positioning for takeoff at the end of the runway when the lower trailing link broke away. The gear assembly is presently with Pilatus in a Swiss lab for investigation.

Picture 2 – Close-up of the lug with corrosion present in the bore

Transport Canada Civil Aviation recommends that operators pay extra attention to these bushings during all routine maintenance checks for signs of corrosion. The Pilatus MLG CMM provides specific instructions for the subject bushings' removal, inspection, repair and reinstallation.

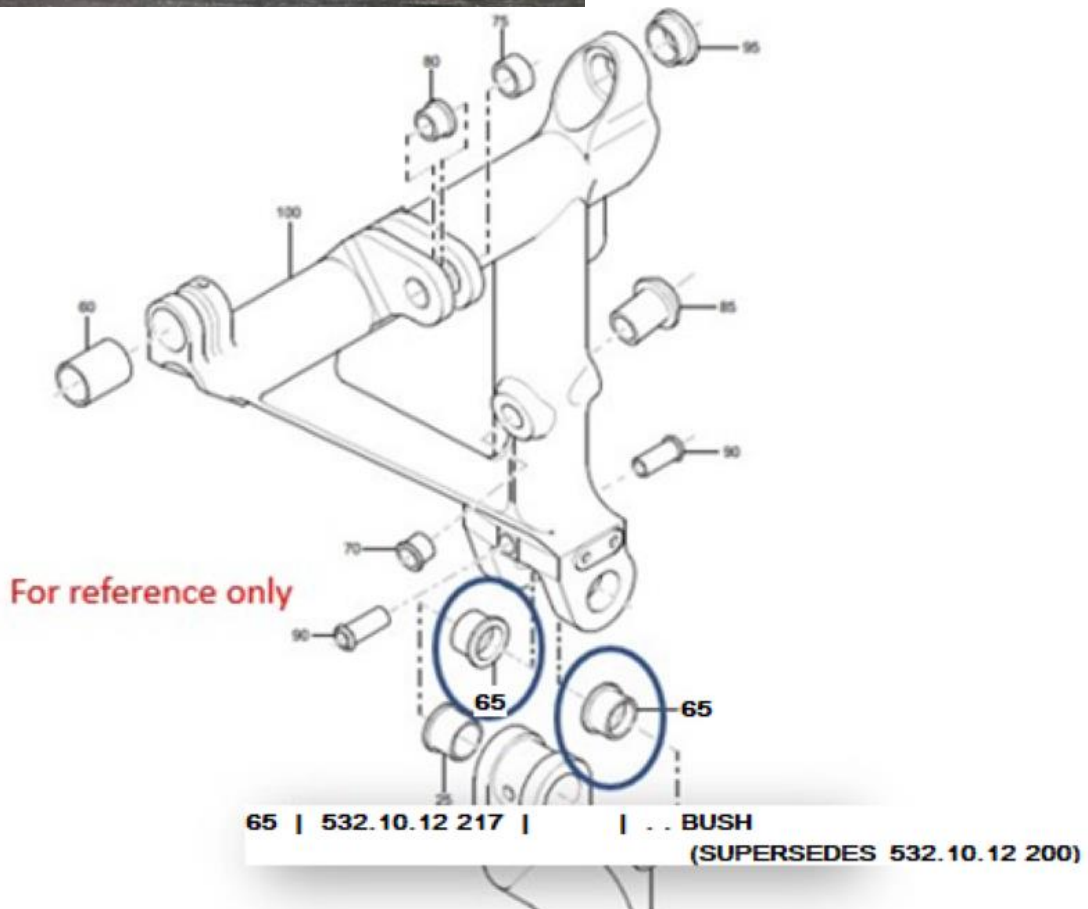
Picture 3 – CMM reference

Pilatus specifies in their MLG Component Maintenance Manual (CMM) that up to “25,000 flying hours or 30,000 landings (whichever comes first), the overhaul of the MLG is done 'on condition' and requires the disassembly, cleaning, check, repair (if necessary) and assembly of the component”. The overhaul consists of an examination and dimensional check of the bushings, but removal is optional.

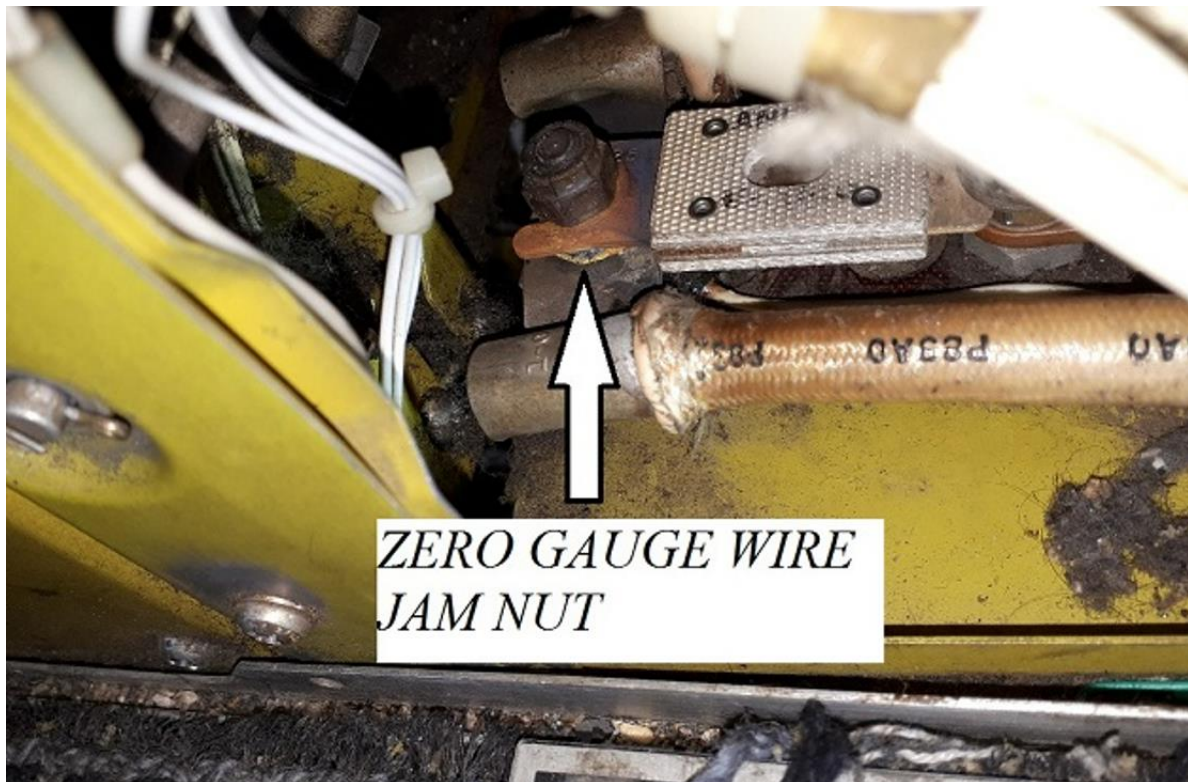
Figure 1 – Isolation limiter terminal stud location

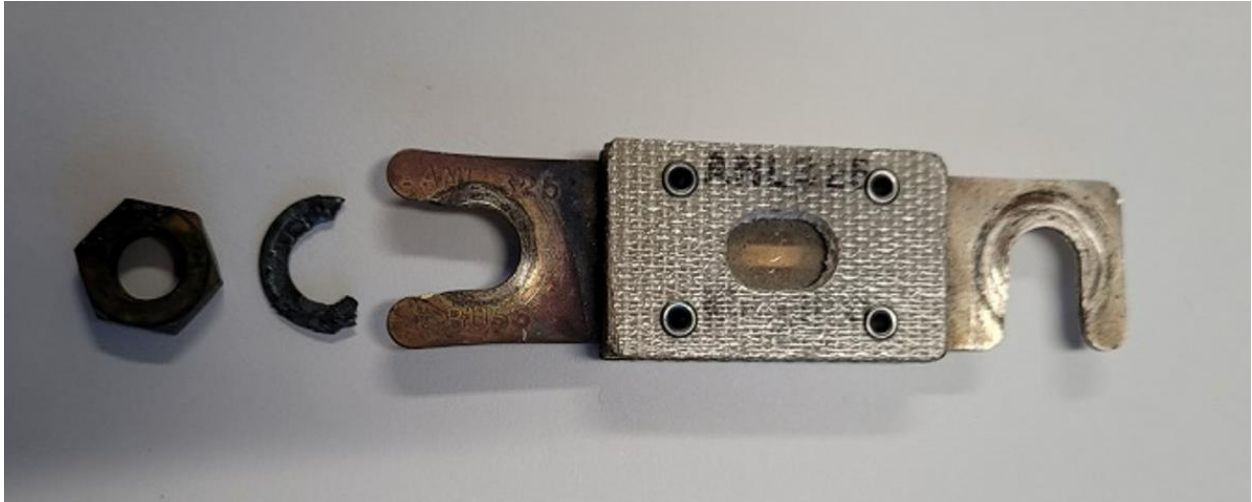
During a training flight, the crew selected the landing gear handle to the up position. The landing gear did not retract. Upon checking the circuit breakers, it was found that the right-hand no1 and no2 subpanel feeder 50-amp circuit breakers were out, which caused loss of power to the no2 dual fed subpanel bus. During an inspection, it was found that the zero-gauge wires, connected to the terminal studs of the isolation limiters on the isolation limiter bus, were loose and had arced. The system was repaired and the aircraft returned to service with no subsequent issues.

Figure 2 – Unserviceable hardware evident

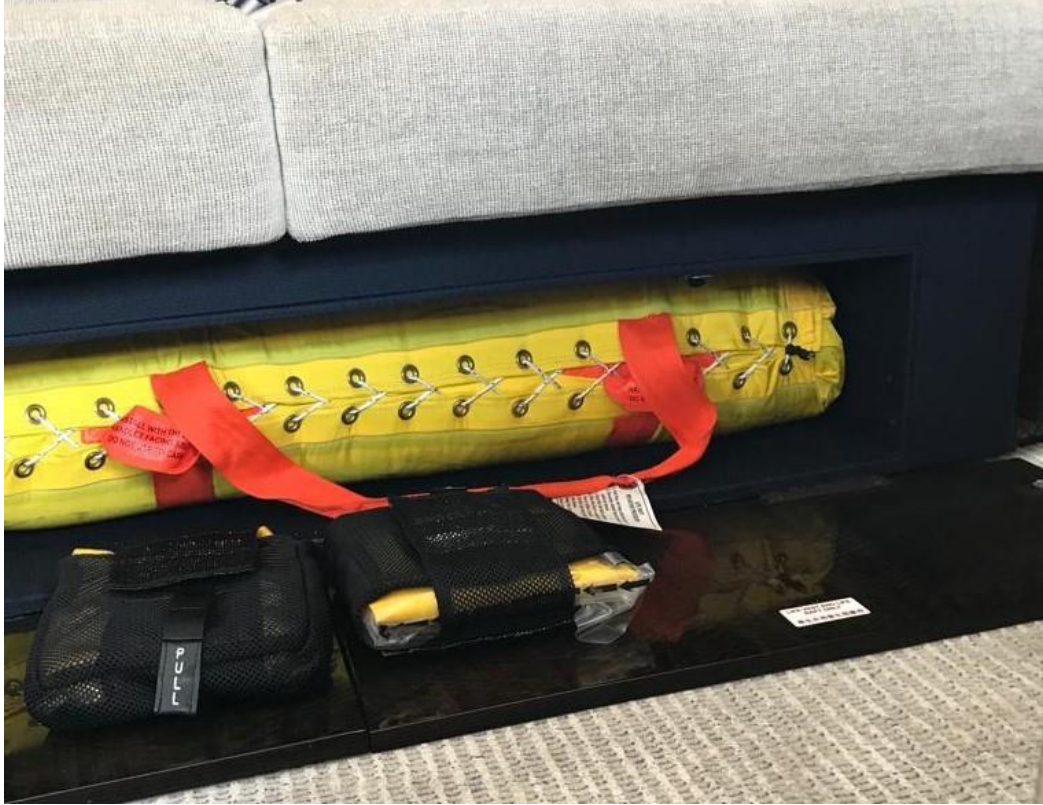
During cabin inspection the pilot observed that the life raft that is stored under the aft cabin divan appeared to be swollen and he was unable to move or remove the raft. The mooring line and ripcord are both on the inside of the compartment and were inaccessible. The ripcord/mooring line were not pulled. Something had failed and caused it to inflate. A procedure was supplied by Winslow where after trying to remove the raft by following the first steps in the procedure it was unsuccessful. The procedure for drilling the raft in the location was followed and it was found that the raft was inflated; the pressure was released and the raft was successfully removed from the aircraft. It was found to have self-inflated with both the inflation pull handle and mooring line still intact and not pulled.

Figure 1 – Image of the inflated life raft

It is important to inspect all safety equipment before flight to ensure that they are in proper working order. In this case, the life raft would have been unusable in an emergency situation.

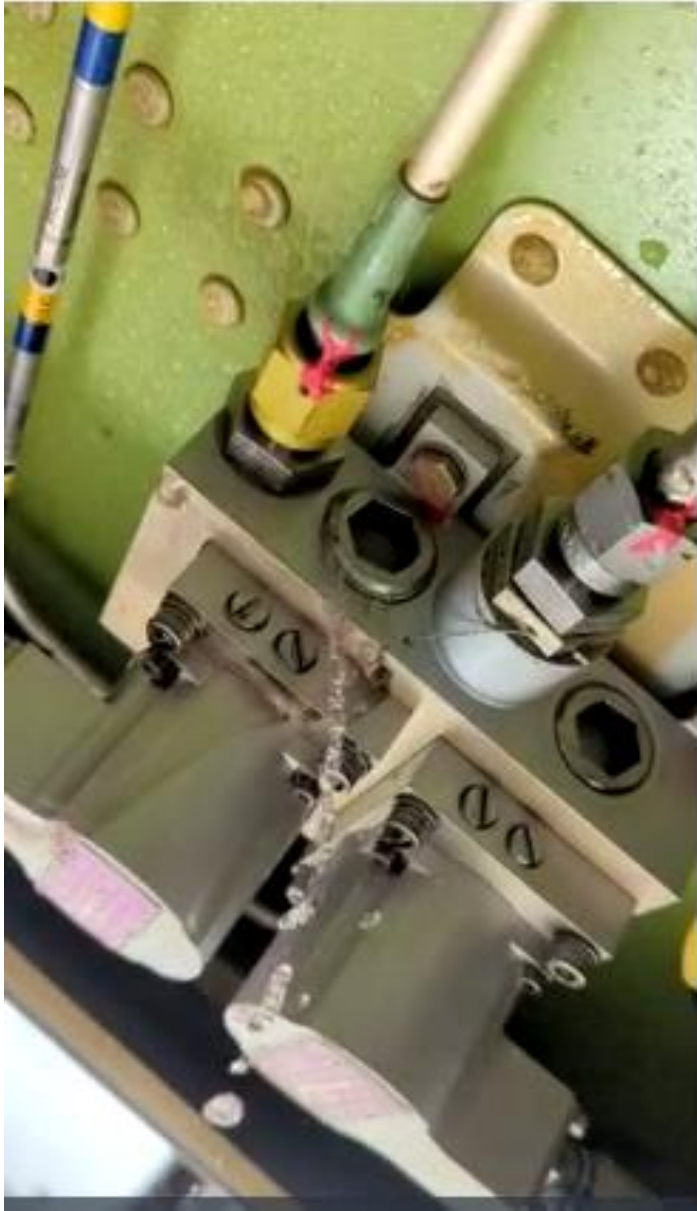
The crew contacted maintenance for a (blue advisory) hydraulic #1 low quantity crew alerting system (CAS) in flight. The decision was made to divert the aircraft and land. No caution CAS message appeared during the event. Hydraulic system #1 quantity started at about 51% and dropped to 16% after touchdown. The attached picture shows the brake control valve, part number 90007135-2, with an Allen key bolt backed out and leaking hydraulic fluid. A picture of the correctly installed Allen key bolts on a serviceable brake control valve is attached for reference.

This interesting event shows how a component can fail for many reasons. Control valves will typically fail mechanically or electrically. The backing out of a set screw shows a possible assembly error at overhaul or manufacture.

Picture 1 – Leaking Brake Control Valve

Maintainers and operators are asked to watch for even the less apparent faults.

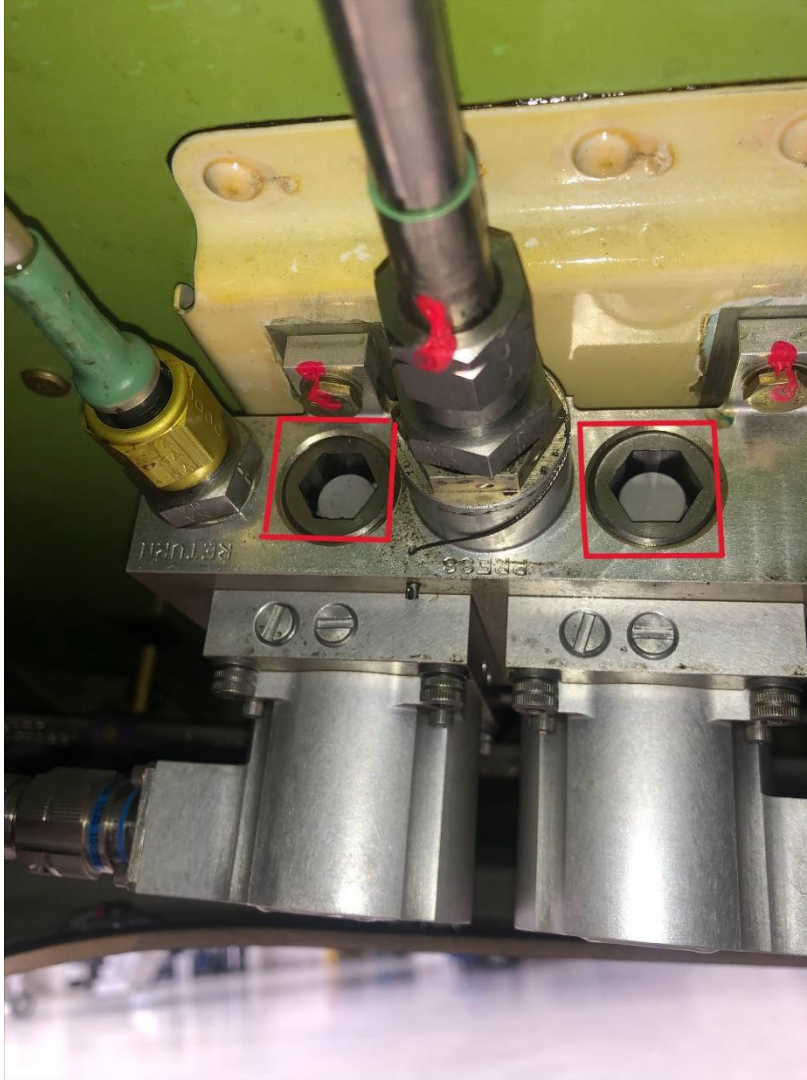
Picture 2 – New Brake Control Valve with flush set screws

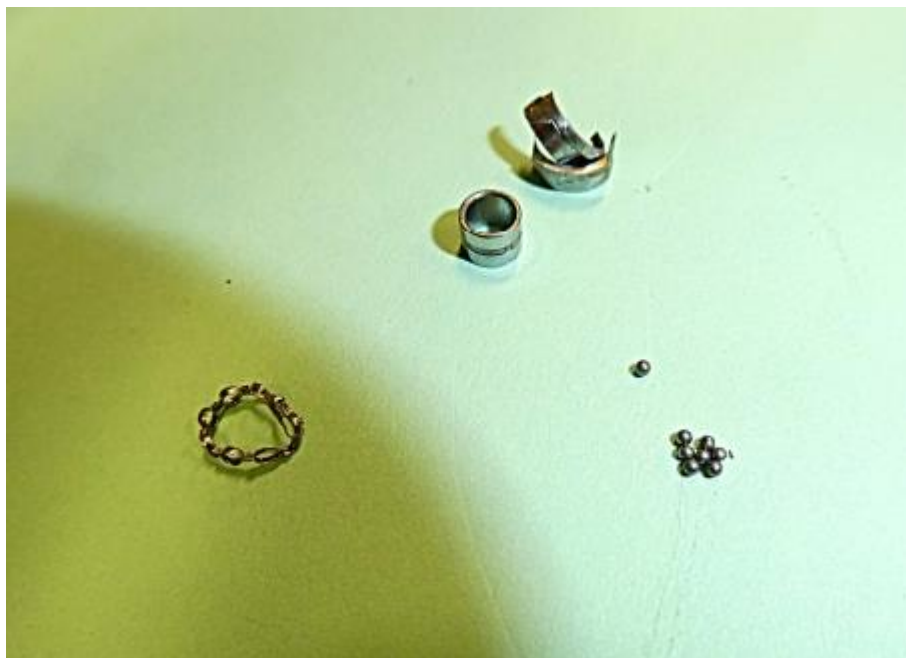
propeller governor was removed and sent to the overhaul facility who confirmed that one of the four internal flyweight bearings failed. All eight (8) balls and race were missing. On our side, no other metal part has been found so far into the oil filter, on the aft Accessory Gear Box (AGB) pump inlet screen or around the forward AGB magnetic chip opening.

Woodward, the propeller governor manufacturer, issued Service Bulletin (SB) 83053-61-027 in 2012. The SB provides instructions for replacing bearings that were assembled with lightly crimped bearing retainers. Engineering analysis, conducted cooperatively by the engine, governor and bearing manufacturers, concluded that the failure was likely caused by a vigorous oscillatory motion of the two-piece, loosely crimped, bearing retainer resulting in fretting wear of the retainer assembly.

Figure 1 – Damaged flyweight bearing

Further to their investigation into this Service Difficulty Report (SDR), Pratt & Whitney Canada continues to promote compliance with Woodward SB 83053-61-027. Transport Canada Civil Aviation (TCCA) concurs with this position and would like to highlight the value in assessing and following manufacturers' recommendations, including those at the component or vendor level.

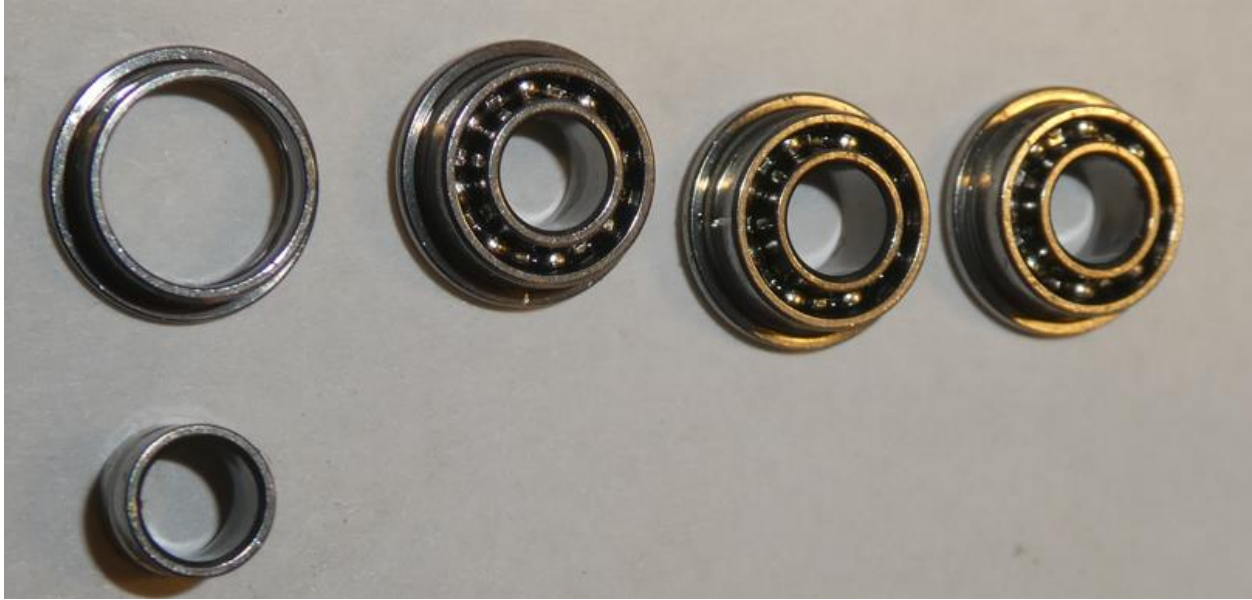
Figure 2 – Damaged and serviceable flyweight bearings

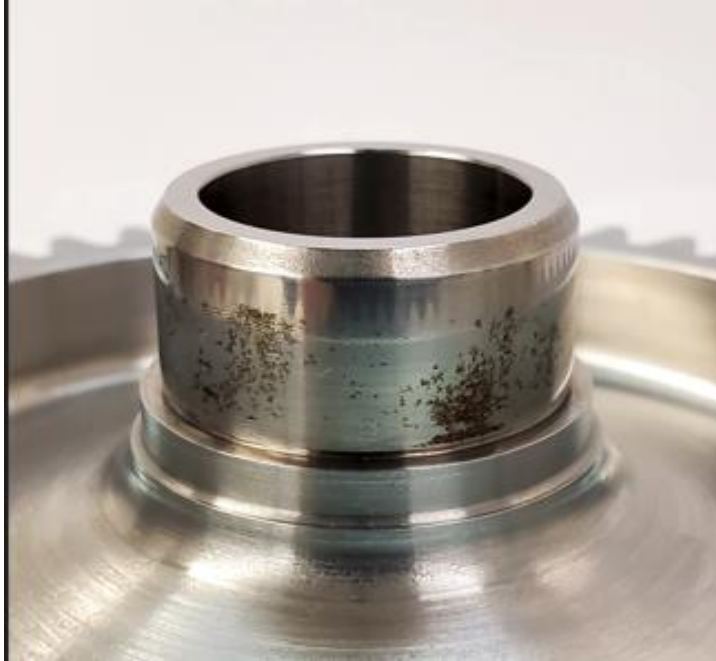
The bearing surface of the gear shaft had numerous pit marks from corrosion, which may have been caused by improper preservation for storage. This corrosion was not detected until the protective cap was removed from the gear shaft assembly.

Picture 1 – Corroded gear shaft

Transport Canada Civil Aviation reminds maintainers and operators to carry out receiving inspections to ensure serviceability of incoming components. Do not assume parts are serviceable because of the documentation attached. Well done to this operator who caught this issue prior to the gear shaft being installed in an accessory gearbox.

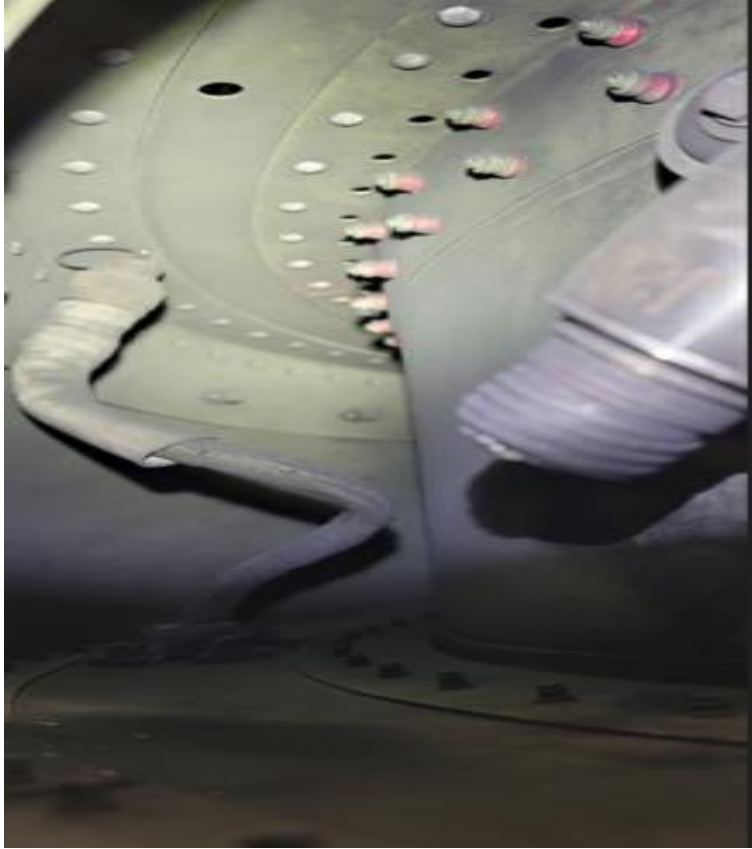
The photos attached show the extent of several failed components of the power turbine temperature sensor system. The electrical connector plug P20 may have disconnected because of the damaged threaded bezel fracturing therefore not being secured to the receptacle J20, however why it fractured could be the result of the sensor itself which appears to have overheated and distorted its shape. This distortion may also have caused the mounting bolt and grommet to pull out of the mounting bracket.

Picture 1 - Disconnected P20 electrical connector

TC would like to remind operators and maintainers to pay particular attention to this sensor and connector when inspecting in this area and note of any findings by reporting them through their SDR reporting system.

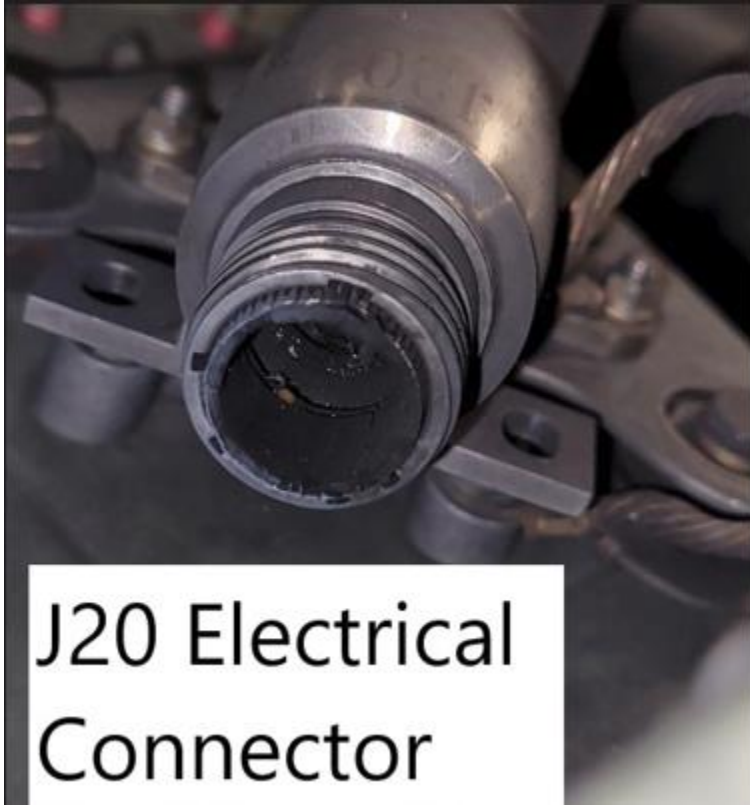
**J20 Electrical
Connector**

Picture 2 - Damaged J20 electrical connector

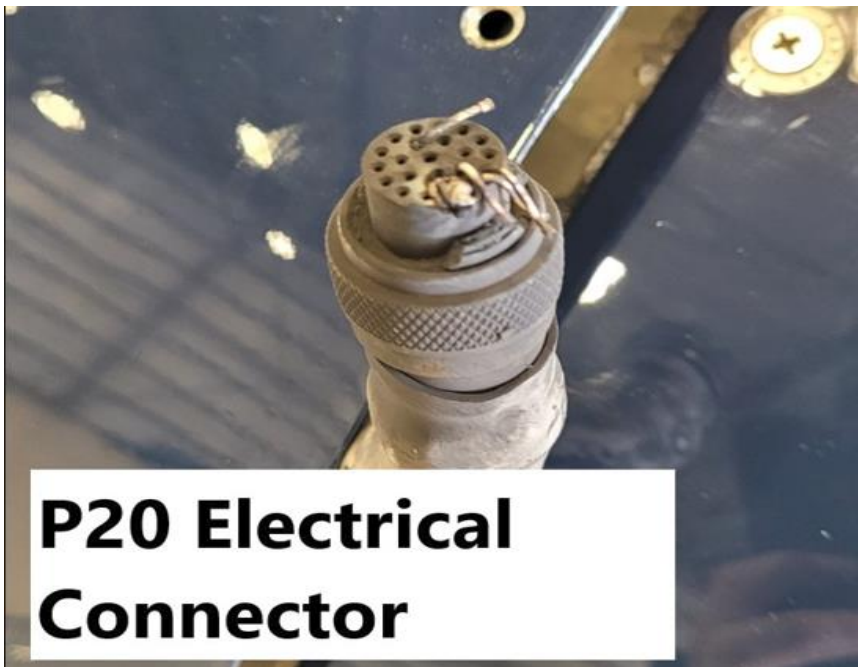
**P20 Electrical
Connector**

Picture 3 - Damaged P20 electrical connector

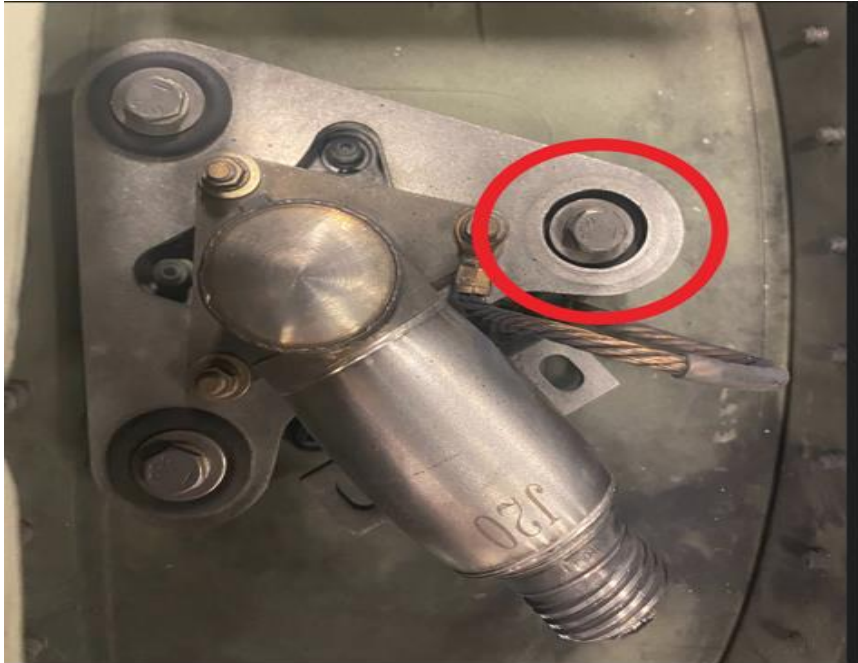
Picture 4 - Missing mounting grommet

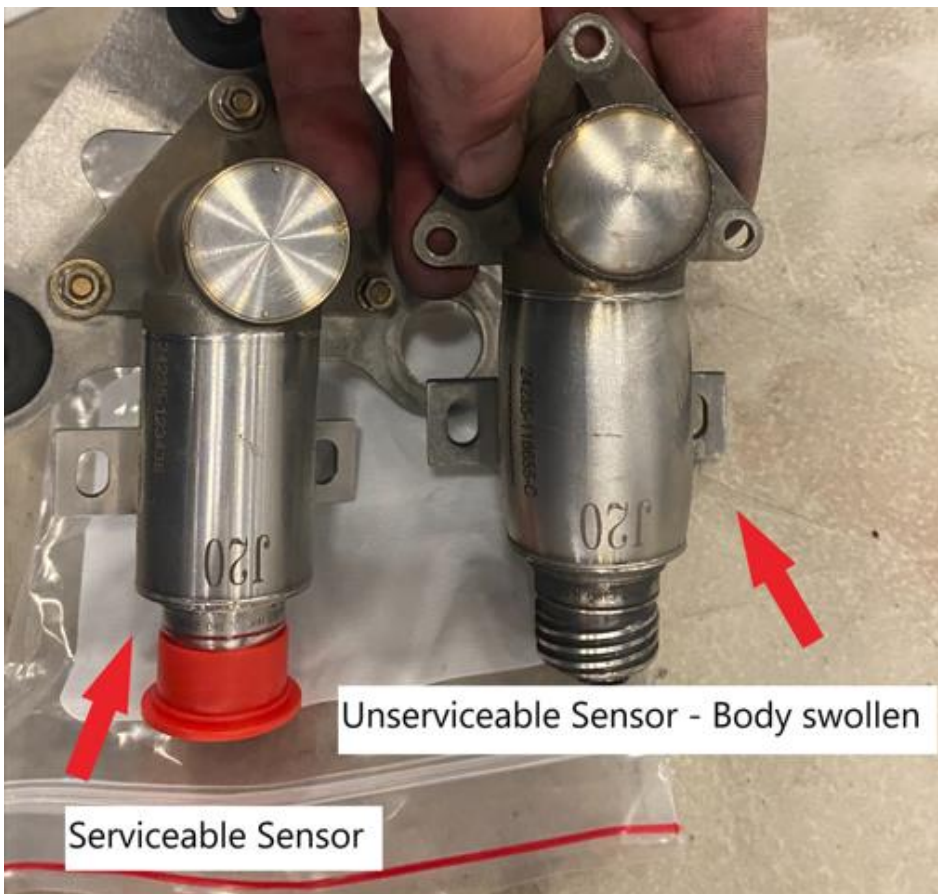
Picture 5 - Serviceable and Unserviceable Sensor
