## **C404 VH-ANV accident and CASA changes**

*May 2018*

# C404 VH-ANV accident

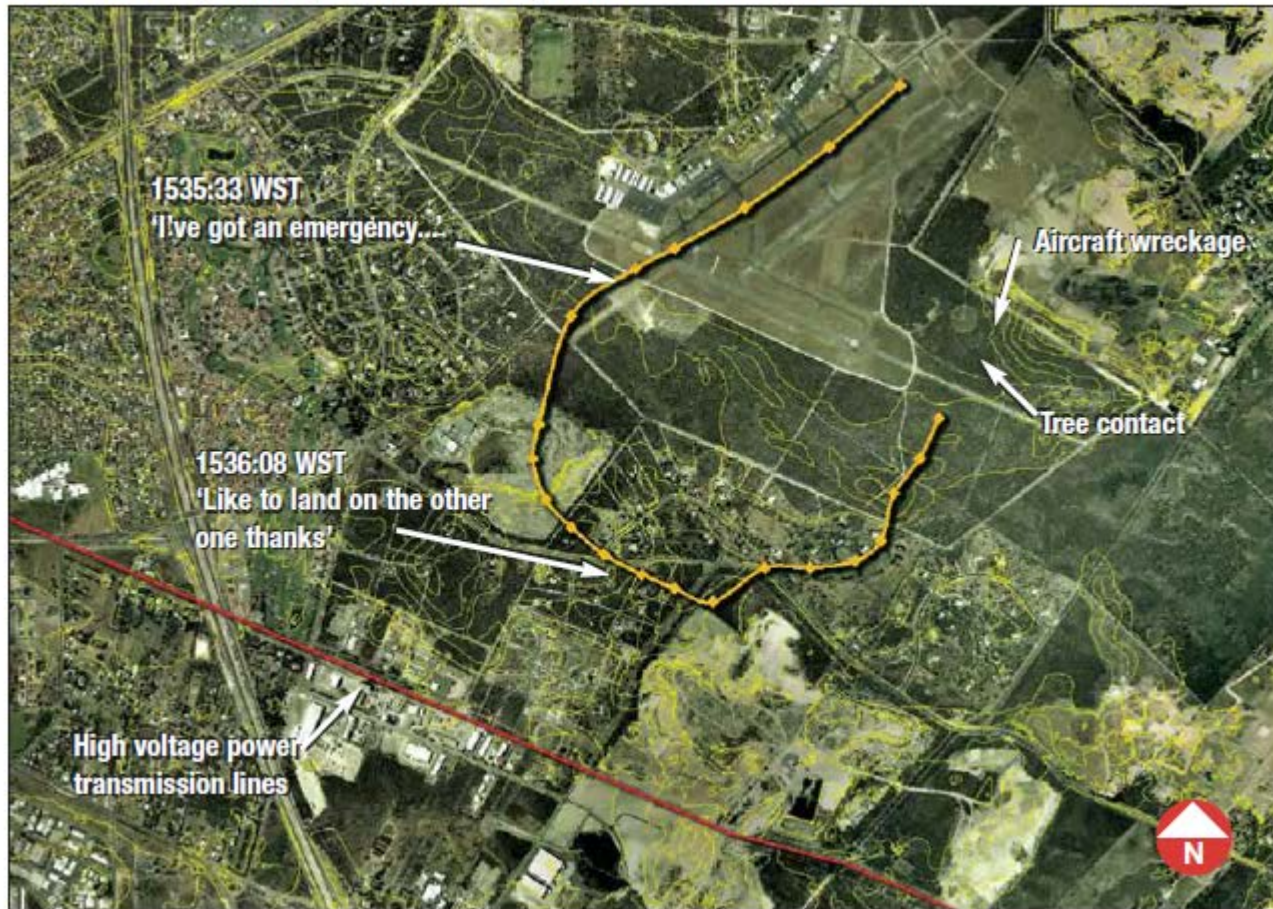
FIGURE 1: Aerial photograph<sup>4</sup> of Jandakot Airport with ATS radar data overlaid

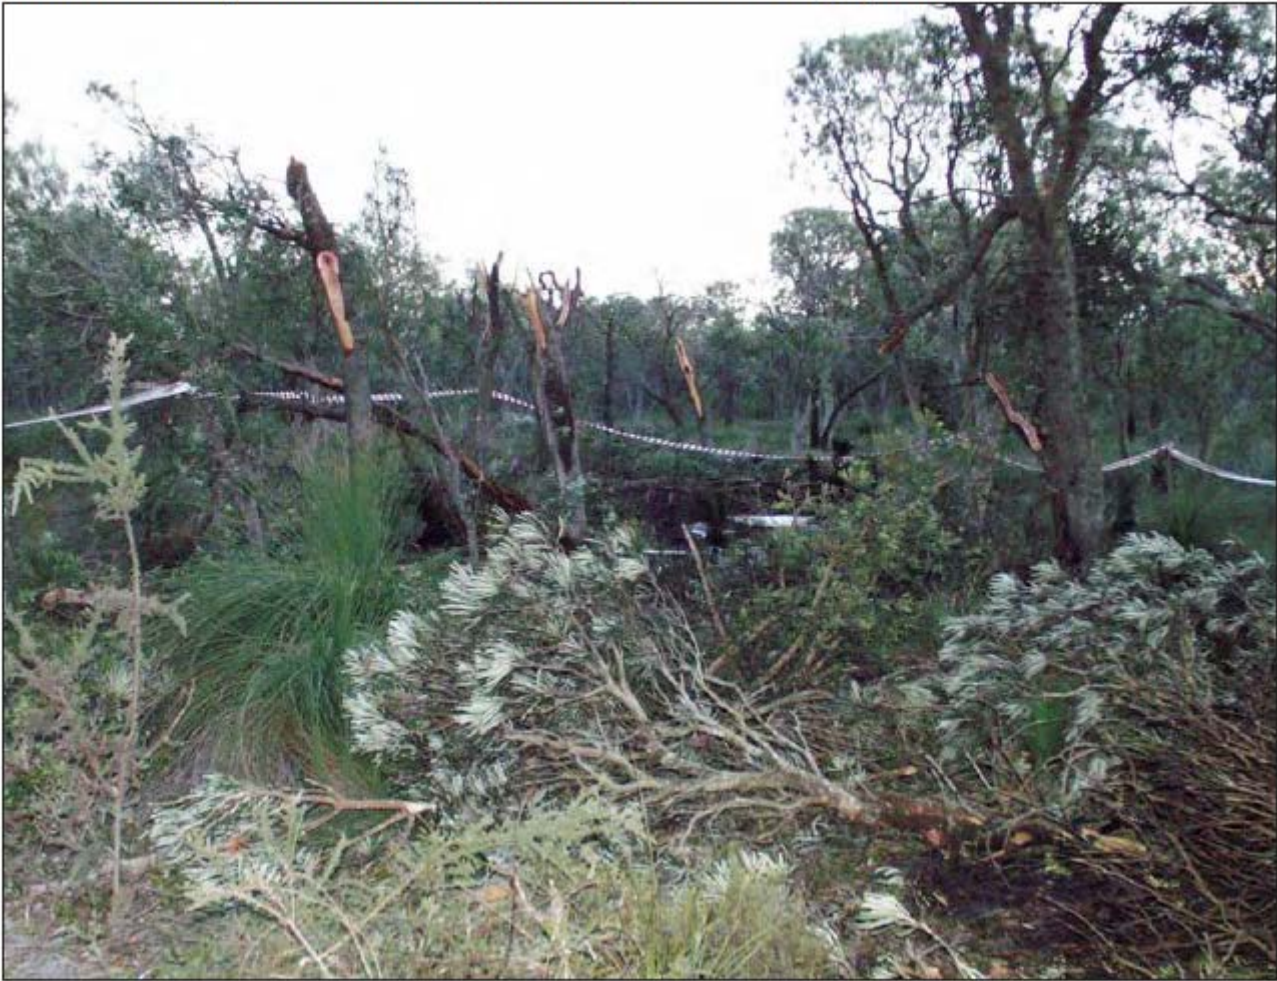
- Failure of right hand engine on takeoff
- Aircraft crash landed in lightly wooded terrain, rupturing the fuel tanks resulting in post crash fire
- 1 pax fatally injured in crash and fire
- Pilot and remaining pax sustained serious burns
- 1 pax died of injuries 85 days later

**FIGURE 2: Initial impact with trees, looking back along the aircraft's flight path**

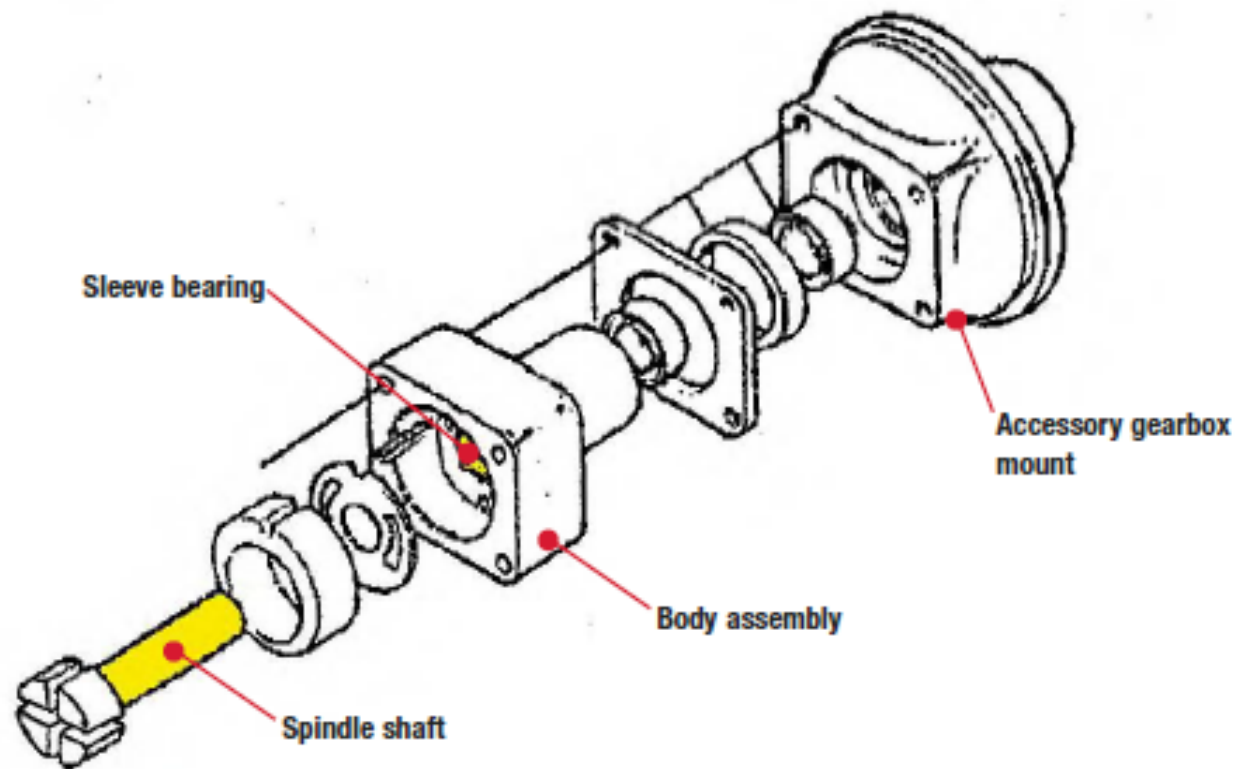
“Examination of the right engine revealed a material anomaly with the sleeve bearing from the engine-driven fuel pump. That bearing exhibited evidence of localised adhesive wear (galling) that had restricted the rotation of the pump spindle shaft. The bearing had previously been replaced during the last engine overhaul. Analysis of the bearing revealed that it had been manufactured from material that possessed inferior galling resistance when compared with bearings from similar pumps. The investigation concluded that the specified material for the replacement sleeve bearing was inadequate with respect to its galling resistance. High torsional loads between the spindle shaft and the sleeve bearing had caused the pump’s drive shaft to shear at a critical phase of flight. Associated with a loss of drive to the pump shaft was a reduction in fuel pressure, which was insufficient to sustain operation of the engine at take-off power.”

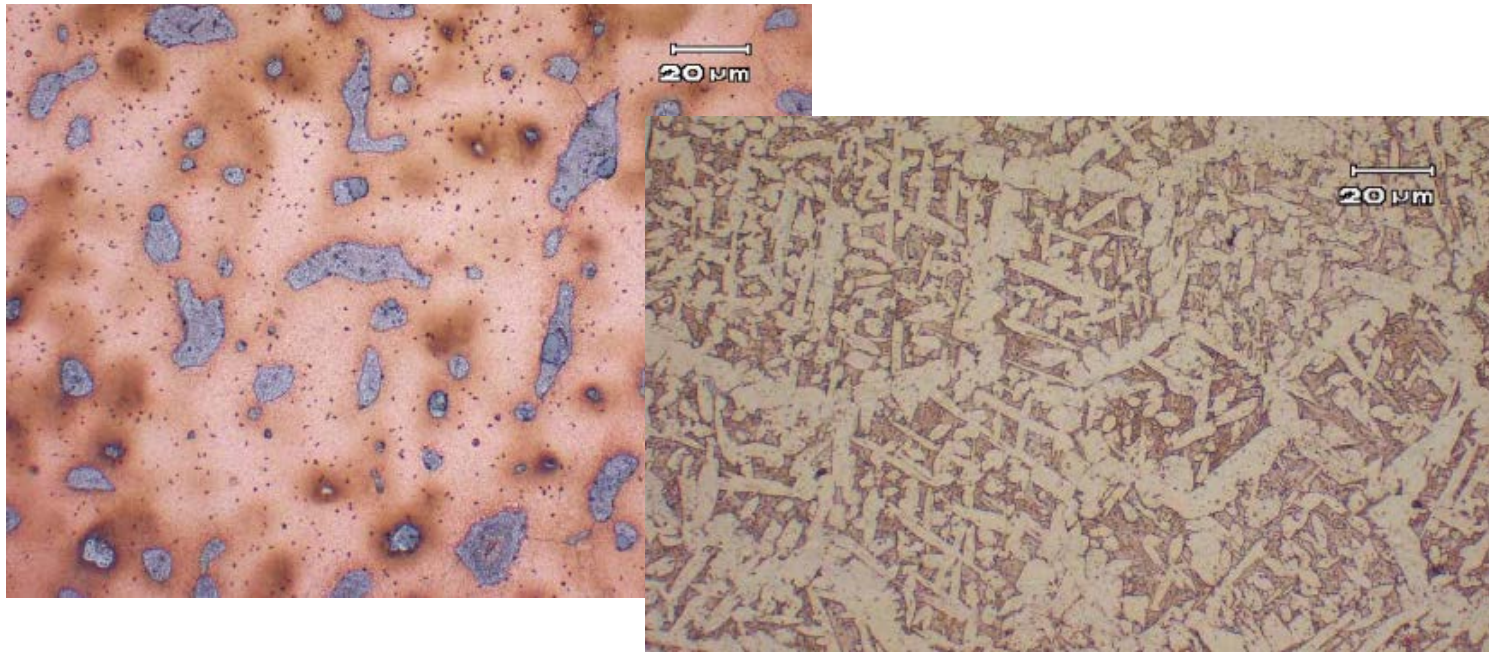
“The process of producing the engineering order did not identify that the original equipment manufacturer (OEM) specification was for the use of high leaded bronze in bearing manufacture.”
