Feedback

Canadian Aviation Service Difficulty Reports

The following content was published between 1 October 2022 and 31 December 2022. The full accessible version of each article is available on the Feedback [website](#).

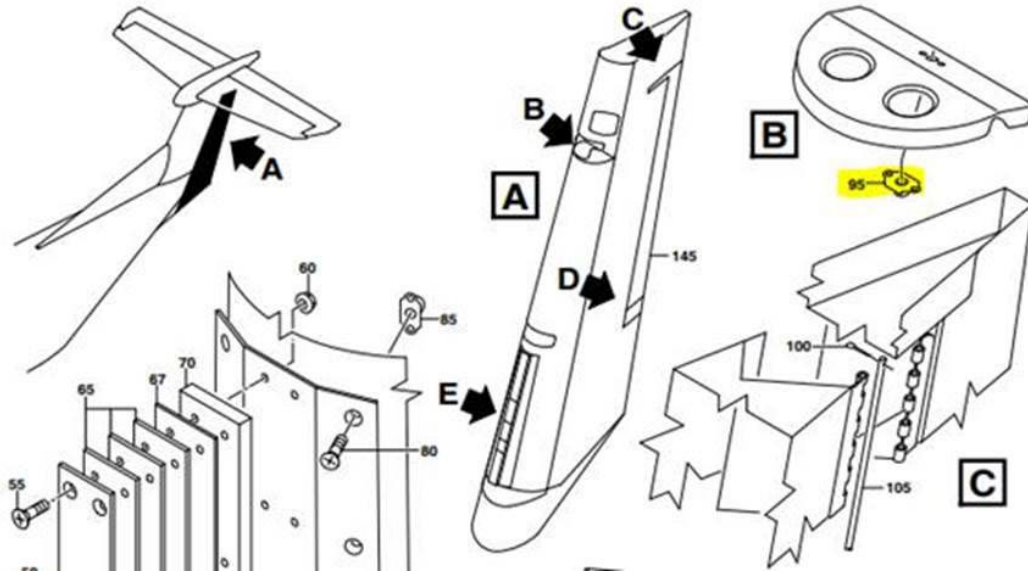
During a maintenance check, the rudder was removed to inspect for play at the hinge point, and a Structural Repair Manual (SRM) repair was carried out by installing a bushing. During the rudder re-installation, when mounting the top rudder attach point bolt, a rattling noise was heard of something that had dislodged and fallen inside the rudder. Upon further investigation, it was noted that the anchor nut to which the bolt must be attached had fallen inside the rudder. After the anchor nut was retrieved, it was noted that the anchor nut was still riveted to the broken piece of rudder rib 6.

Picture 1 – Illustrated Parts Catalogue (IPC) reference of rudder rib 6 and anchor

The SRM repair mentioned by the submitter is Rudder Upper Hinge Fitting Repair RM06299 (Installation of an aluminum bushing). This repair has the operator increasing the top bolt hole to a larger size to accommodate a bushing, adding strength and preventing play-inducing wear.

Pilatus offers another repair, Rudder Upper Hinge Attachment Repair RM05387 (Replacement of the nutplate with a self-locking nut and washer). This repair replaces

the anchor nut with a self-locking nut and washer. This repair also adds an inspection panel to access the lower portion of rudder rib 6.

Play in the rudder attachment fittings is checked while performing Pilatus Task: Rudder Inspection Check - 12-B-55-40-00-00A-313A-A. Operators are asked to keep this defect discovery in mind when finding play in the rudder upper hinge fittings of PC-12 aircraft.
