AIRCRAFT ACCIDENT REPORT
CAA OCCURRENCE NUMBER 15/1102
ROBINSON R44 RAVEN II
ZK-IWL
COLLISION WITH POWER LINES
FRENCH PASS, MARLBOROUGH SOUNDS
13 MARCH 2015

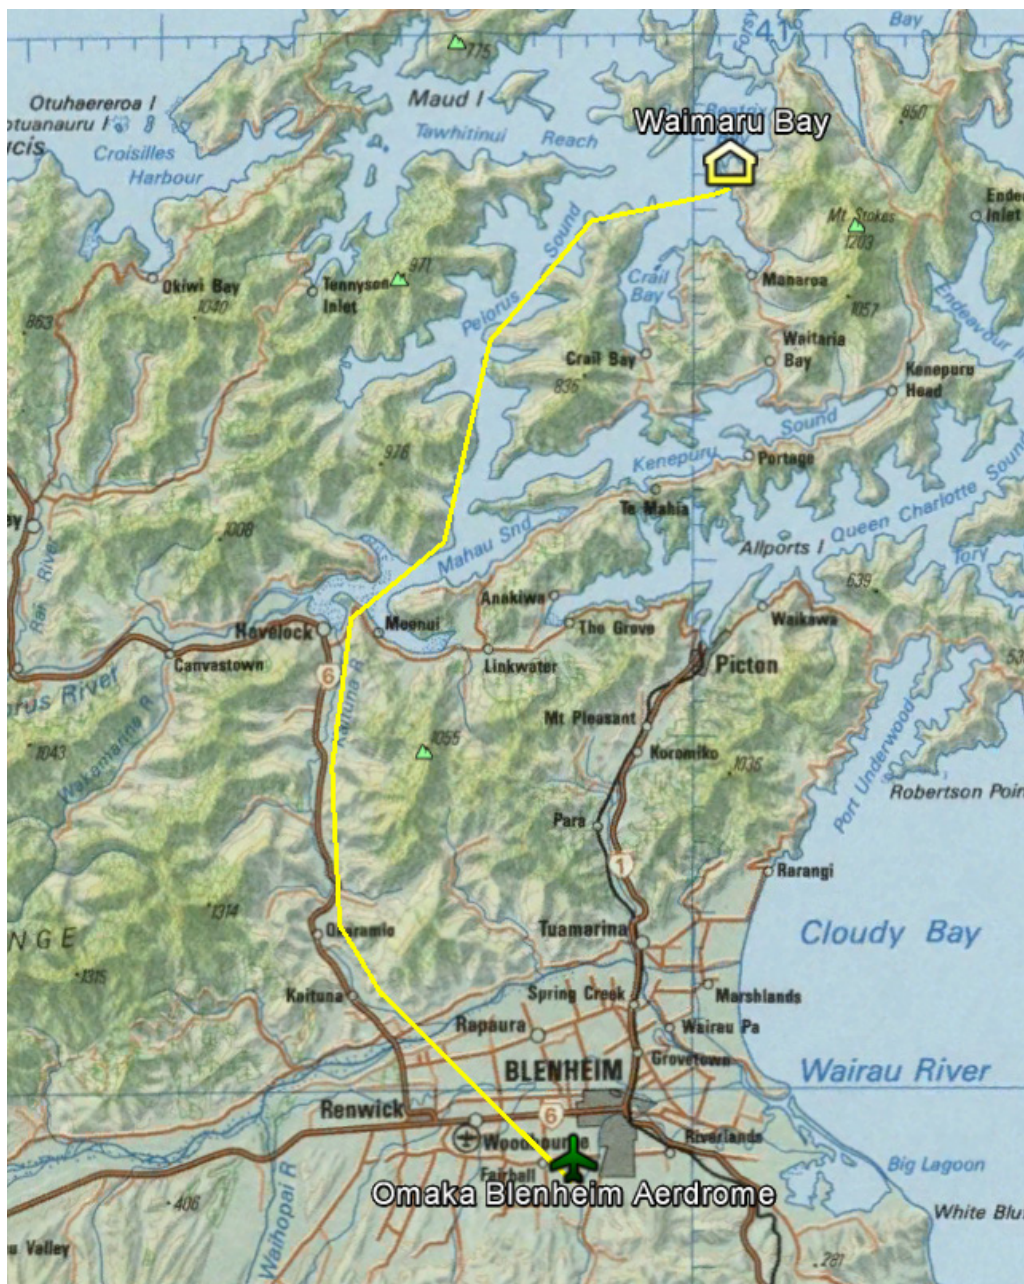
1.1.1 On 13 March 2015 at 1300 hours, the pilot of the Robinson R44 Raven II (Reg. No. ZK-IWL) departed Omaka Aerodrome on a private flight to a holiday home at Waimaru Bay via Havelock and Pelorus Sound. The expected time of arrival at the holiday home was approximately 1400 hours, and the pilot departed the holiday home sometime prior to 1700 hours.

Figure 1: Pilot's route from Omaka Aerodrome to his holiday home at Waimaru Bay. Sourced from Topographic Map 242-3 North Meets South. Crown Copyright Reserved

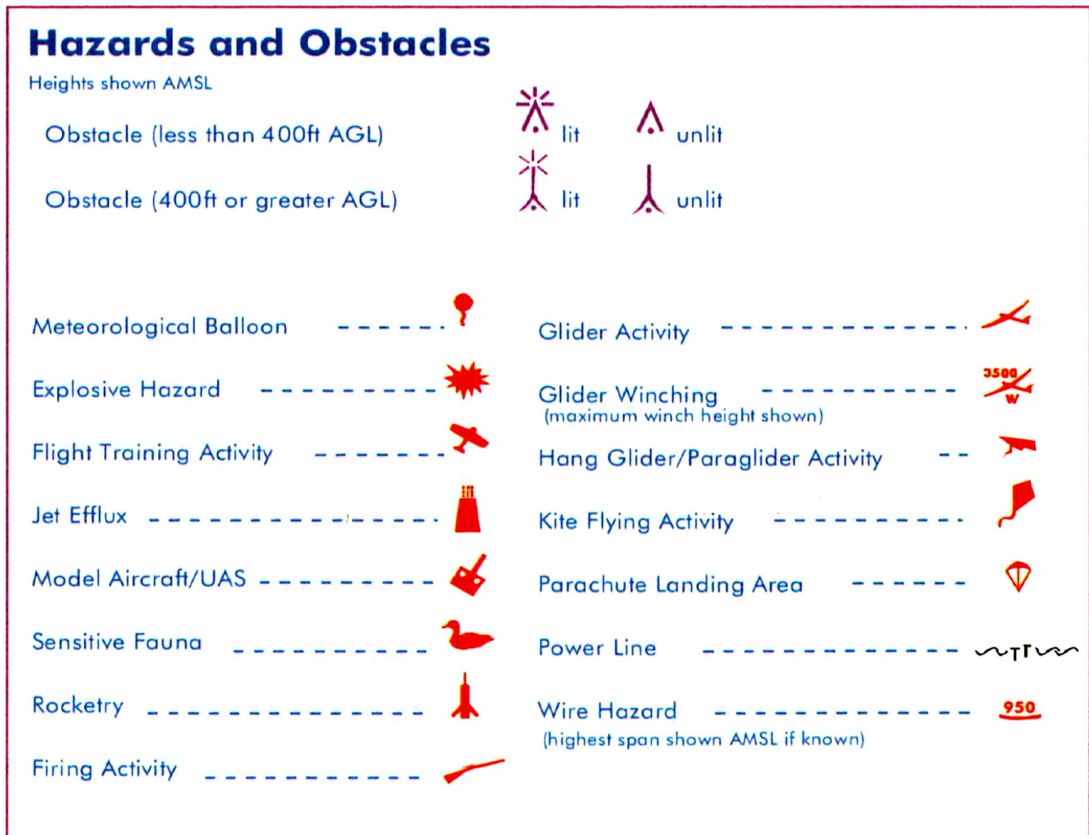
The wires that span French Pass are marked on the AIP New Zealand Visual Navigation Chart 1:250 000 scale: Chart C7. The highest point of the span is indicated as 545 feet AMSL (see Figure 4 and Figure 5).

Figure 5: Information on the AIP NZ Visual Navigation Chart 1:250 000 scale. Wire Hazards are marked with the "highest span shown AMSL if known".
