## **C404 VH-ANV accident and CASA changes**

*May 2018*

# C404 VH-ANV accident

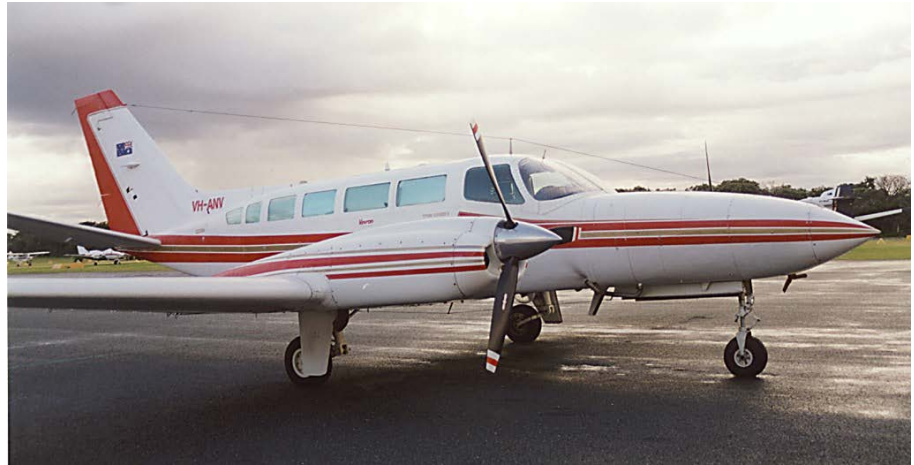
- Cessna 404, VH-ANV
- 1 Pilot plus 5 pax
- Aerial work

- Failure of right hand engine on takeoff
- Aircraft crash landed in lightly wooded terrain, rupturing the fuel tanks resulting in post crash fire
- 1 pax fatally injured in crash and fire
- Pilot and remaining pax sustained serious burns
- 1 pax died of injuries 85 days later
