# Reducing accident and incidents – Communication with operators and maintenance providers

May 2018

***Flight Structures Ltd***

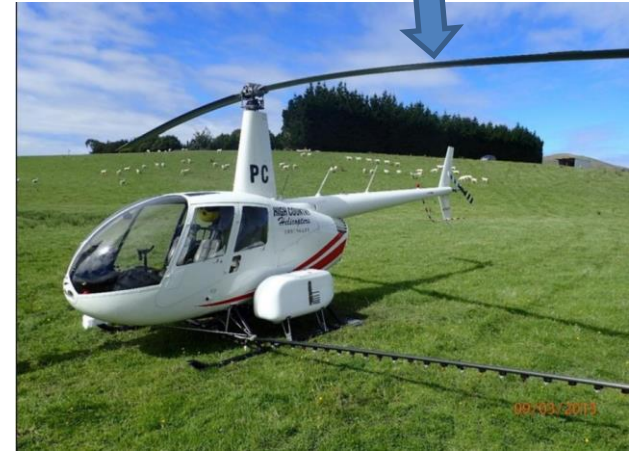
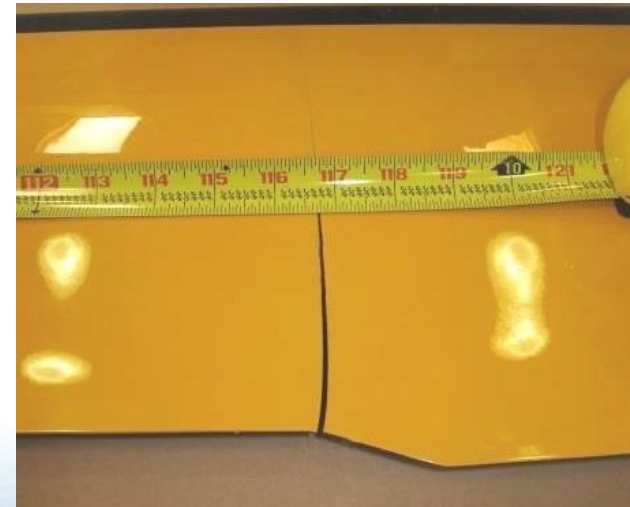
TAIC Report AO-2015-003

- While spraying gorse near Waikaia on 23 January 2015, the pilot of a Robinson R44 helicopter felt an unusual and significant vibration. He landed immediately and discovered a large crack in the lower skin of one of the main rotor blades.

The crack's origin contained features characteristic of metal fatigue. The crack had started in a radius in the blade trailing edge, known as the 'chord length transition'. Flight testing by the manufacturer found that the stress in this area was higher than had been thought.

- As a result of this incident, the manufacturer developed a modification for main rotor blades in service, and made design changes to new main rotor blades for R44 (and R66) helicopters.

The helicopter had been operated primarily for agricultural flying, usually at or over the maximum power settings. The use of a 'flick turn' while operating the helicopter close to the maximum all up weight very likely subjected the main rotor blades to additional high stresses not envisaged by the manufacturer.

The helicopter was not designed specifically for agricultural flying. The manufacturer had therefore not been required to consider the increased loads and cycles of agricultural flying when calculating the service life of the rotor blades.

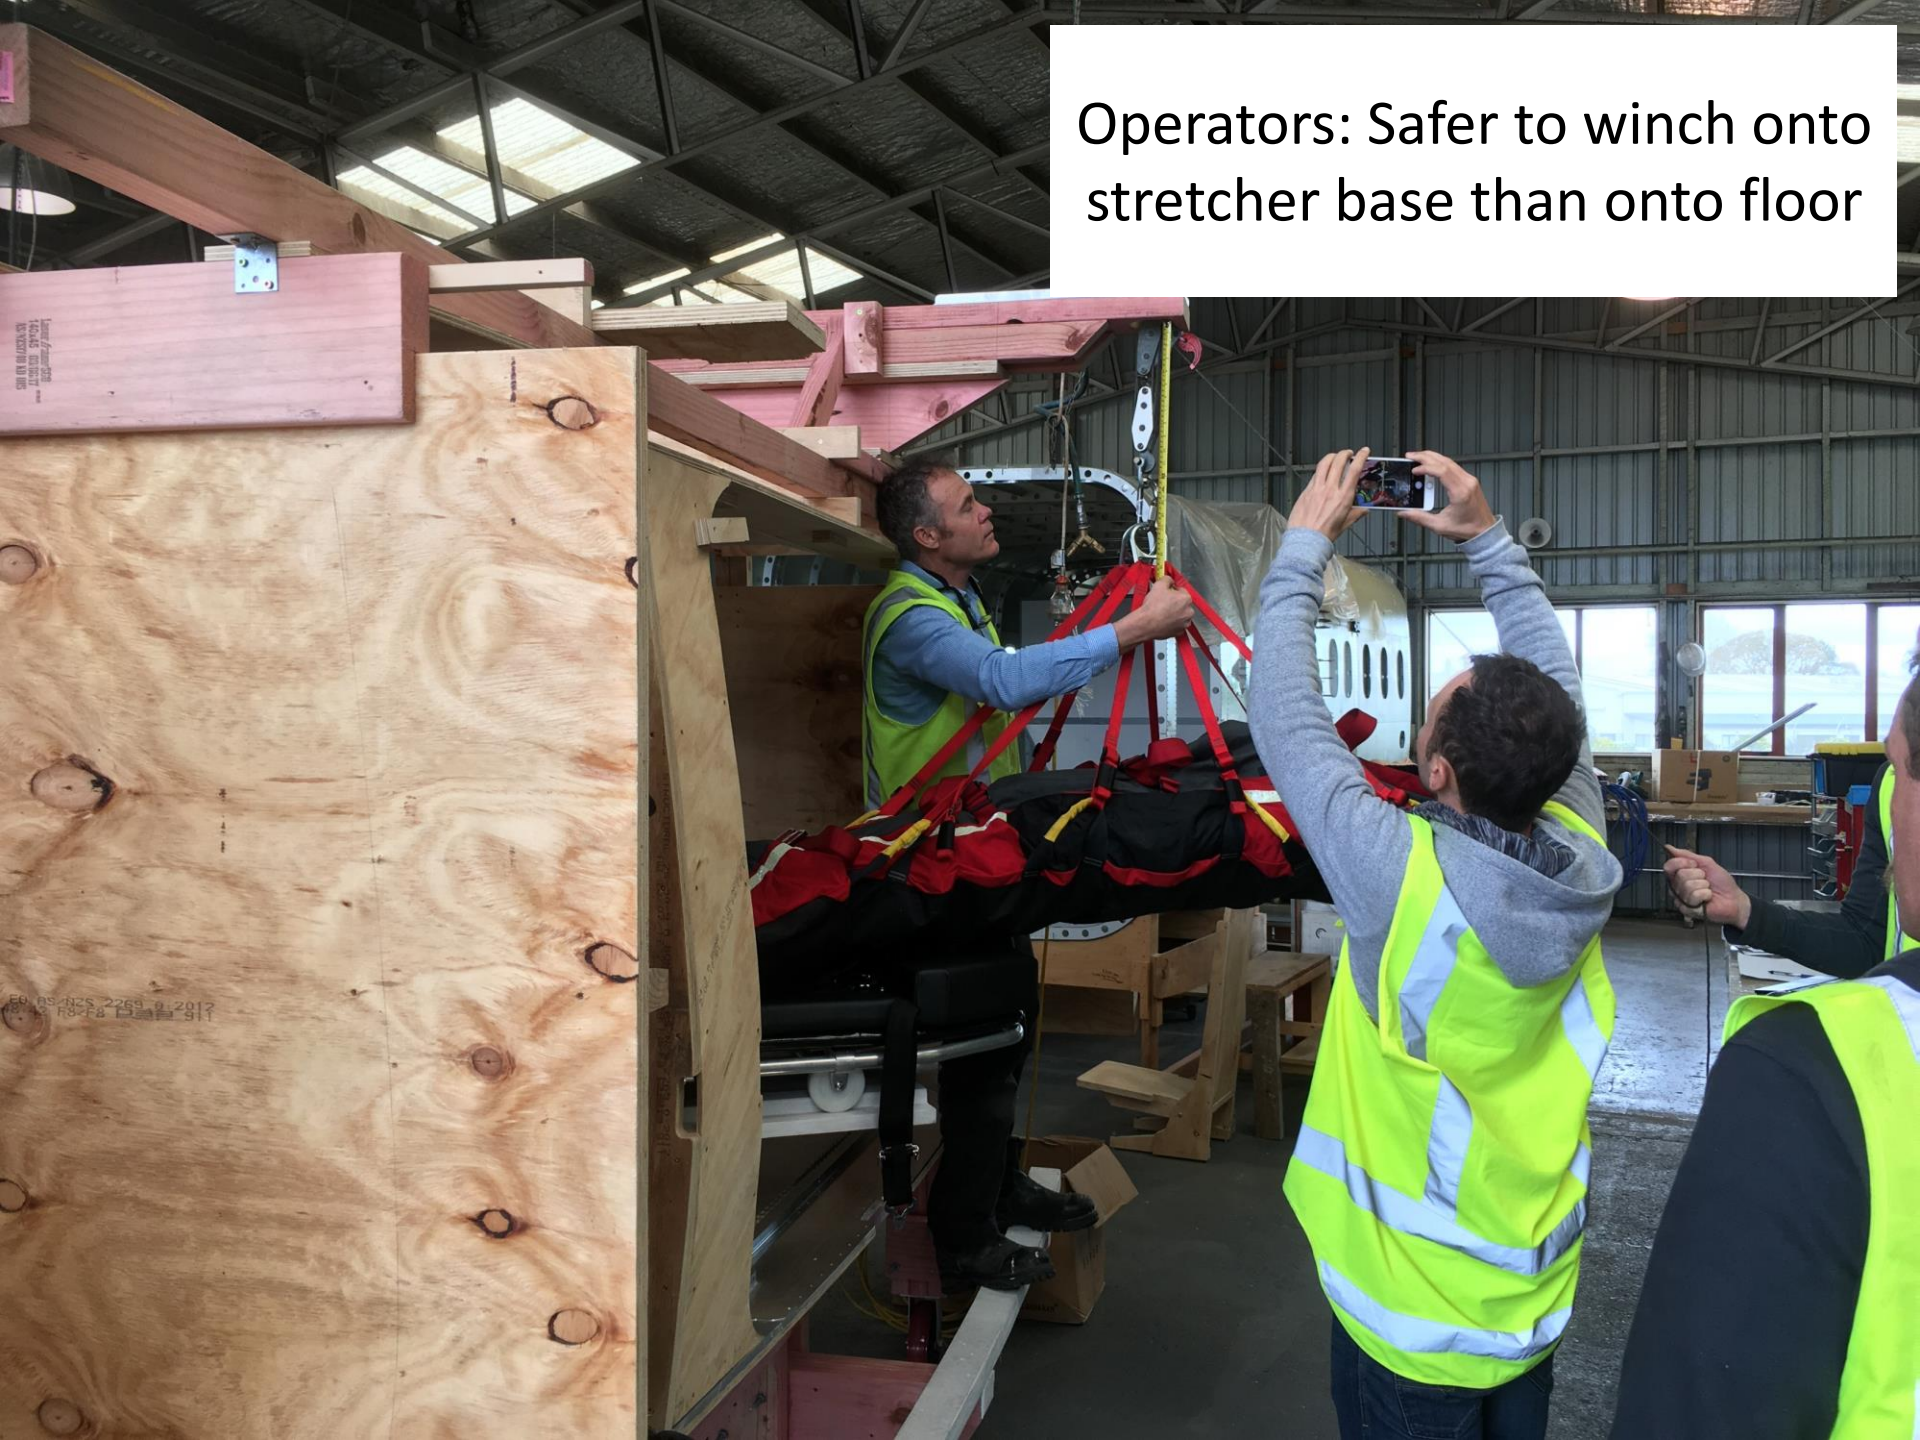
Operators: Safer to winch onto stretcher base than onto floor
